# MEASURING THE EFFECTIVENESS OF VOLUNTARY PLASTIC INDUSTRY EFFORTS: AMRF'S ANALYSIS OF OPERATION CLEAN SWEEP

C.J. Moore, G.L. Lattin, A.F. Zellers

*Algalita Marine Research Foundation, 148 N. Marina Drive, Long Beach, CA 90803, USA*

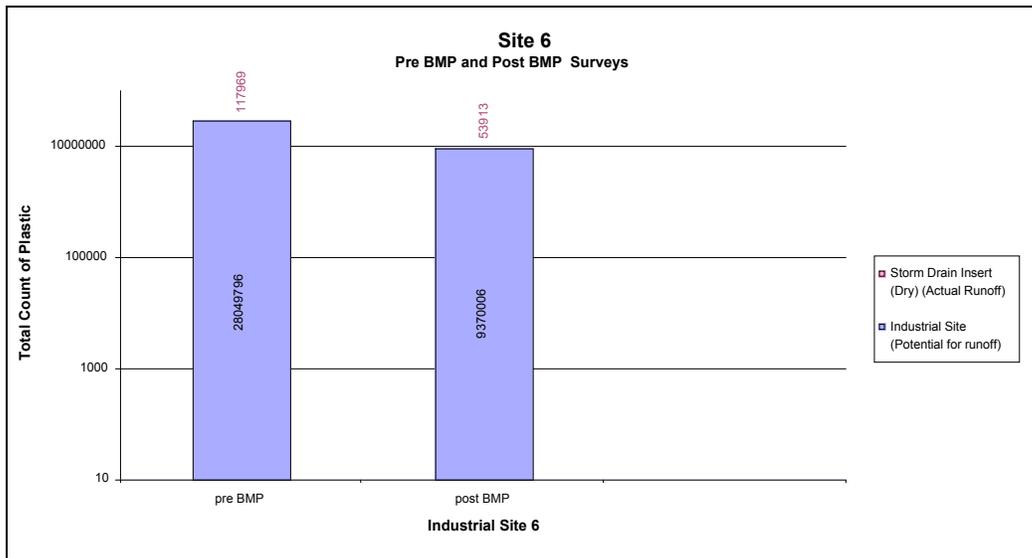
### Site 6

The following areas are on the outside grounds of the facility where spilled pellets observed by project personnel have the potential to enter the storm drain system:

1. On the parking lot.
2. By the pellet storage silos on the west and east sides of the main building.
3. By the loading docks.

4. Covering the gravel on the railcar delivery area .
5. On the paved machinery and equipment storage area.
6. Next to the neighboring building on the east side of the facility.

All of these areas continued to contribute lost pellets to the runoff caught by the catch basin insert post BMP.

By comparing the pre BMP and the post BMP surveys, this facility has improved. However, even though the west area of the facility was cleaner, and there were fewer larger spills at the railroad track area, this facility continues to have a high rate of pellet loss on the ground. Many of these pellets are making it to the storm drain system. On several occasions, project personnel have observed the pellet trail from the facility to the catch basin. Going from one hundred thousand pre BMP to fifty thousand pellets post BMP in the catch basin insert samples while representing an improvement, still constitutes excessive pellet loss.

New BMP measures reported by the management include designating an employee to clean up spills inside the factory. Project personnel observed the use of two sock booms that had been placed in the drainage areas on the west side of the facility. Both booms had pellets trapped on the upstream side of the boom, with only a couple of pellets downstream. There was no evidence of vacuuming in the yard.

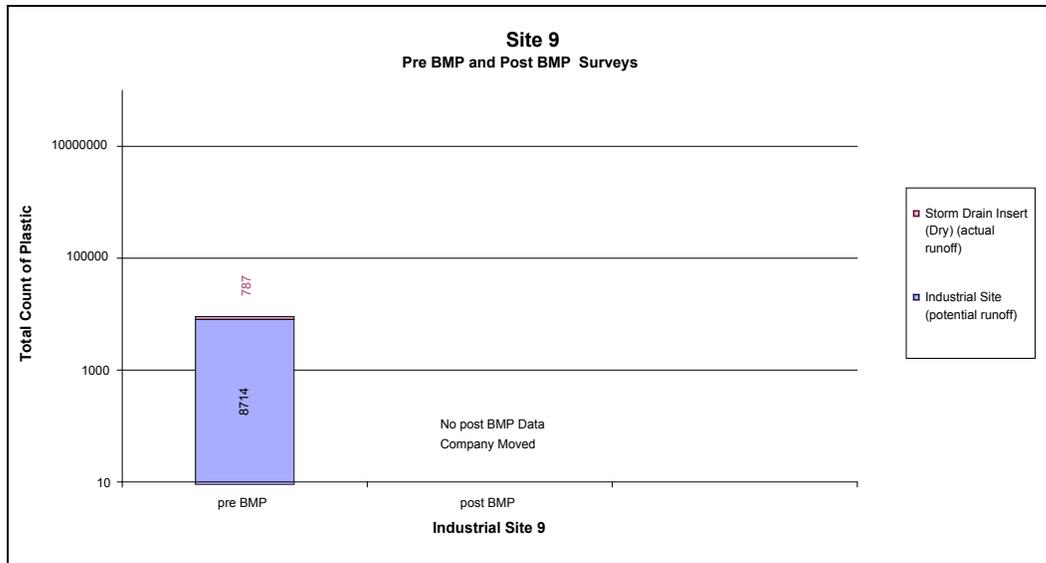
### Site 9

Outside locations where plastic pellets and fragments have a potential to enter the storm drain system.

1. On the parking lot.
2. In the driveway by the loading dock.
3. On the platform by the silos.
4. On the gravel at the railcar delivery area.

5. On the paved machinery and equipment storage area.

There were no post BMP Industrial Site samples at this facility. The company moved. They gave permission to the project to install a catch basin insert in a sump by the loading dock. Although this sump does not connect to the storm drain system, during a rain event, it would overflow and floating pellets would come out and possibly flow to a storm drain. This catch basin was sampled during a wet period. It was the only post BMP sample that was taken. There was no indication that the company was moving. When project personnel arrived to do the post BMP sample the facility was under reconstruction. A new layer of gravel had been added at the railroad tracks, covering up many small spills. Project personnel could take pictures, but were not able to obtain permission to take samples.

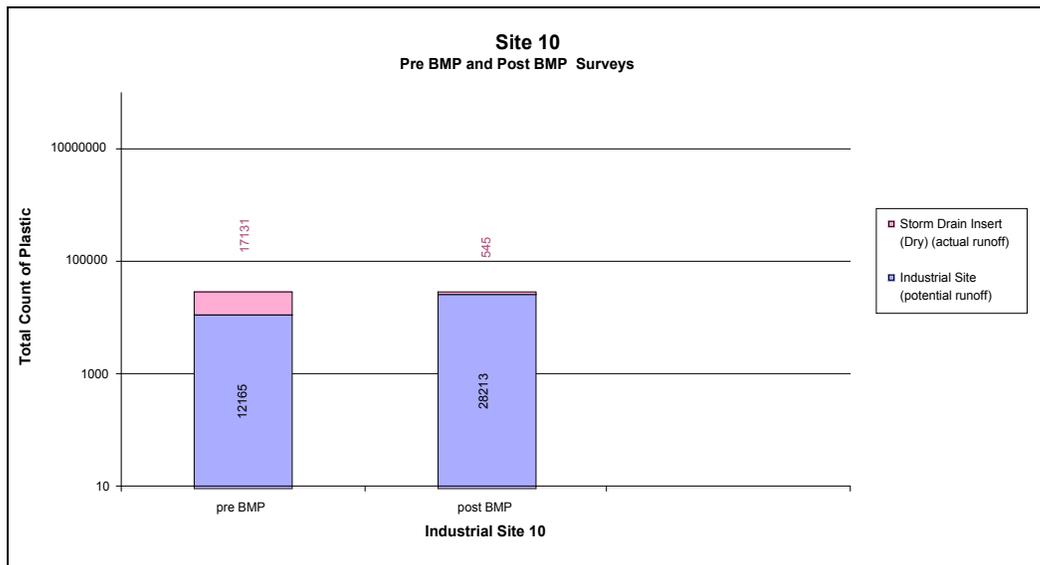
Site 10

Areas where pellets have the potential to enter the catch basins are:

1. The parking lot.
2. The driveway leading to the storage area.
3. The waste bin area.
4. The rear storage area.

By comparing the pre BMP and the post BMP surveys, this facility has remained almost the same, continuing to be a clean facility.

New BMP measures reported by the management included; 1) they change the storm drain insert every 90 days, 2) a vacuum was placed outside as recommended, 3) the Gaylords were covered as recommended, and 4) the dumpster was covered as recommended. Project personnel observed the continued use of the vacuum sweeper, as well as hand sweeping. The storage yard and driveway are both clean, except for very recent small spills.

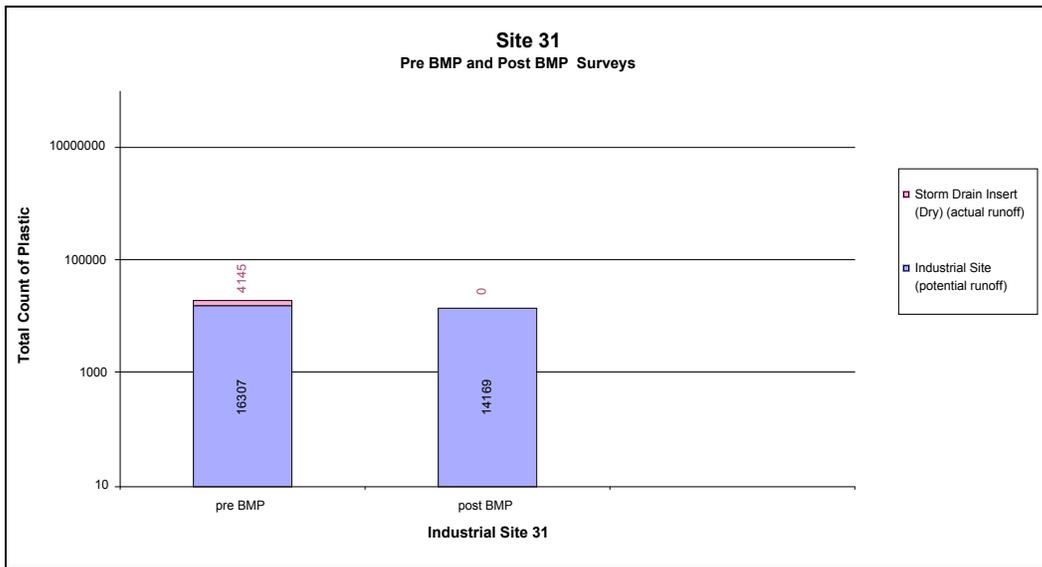
### Site 31

All outside areas of the facility that plastic could enter the storm drain system.

1. The parking lot.
2. The loading dock areas.
3. The two rail car siding areas.
4. Pellets and dust were also found on the edge of the creek.

By comparing the pre BMP and the post BMP surveys, this facility has slightly improved, but is overall pretty much the same. Some pellets and dust are on the ground in the washout area. The asphalt surfaces in some areas are worn down, which traps the pellets. However only a few were observed, reflecting that the area had been cleaned recently.

Project personnel are not aware of any new procedures since the pre BMP monitoring. This is a very large and relatively clean facility, with a significant pellet loss problem during rain events (all catch inserts are pulled to prevent flooding). Project personnel observed the use of manual and driven vacuum sweepers.

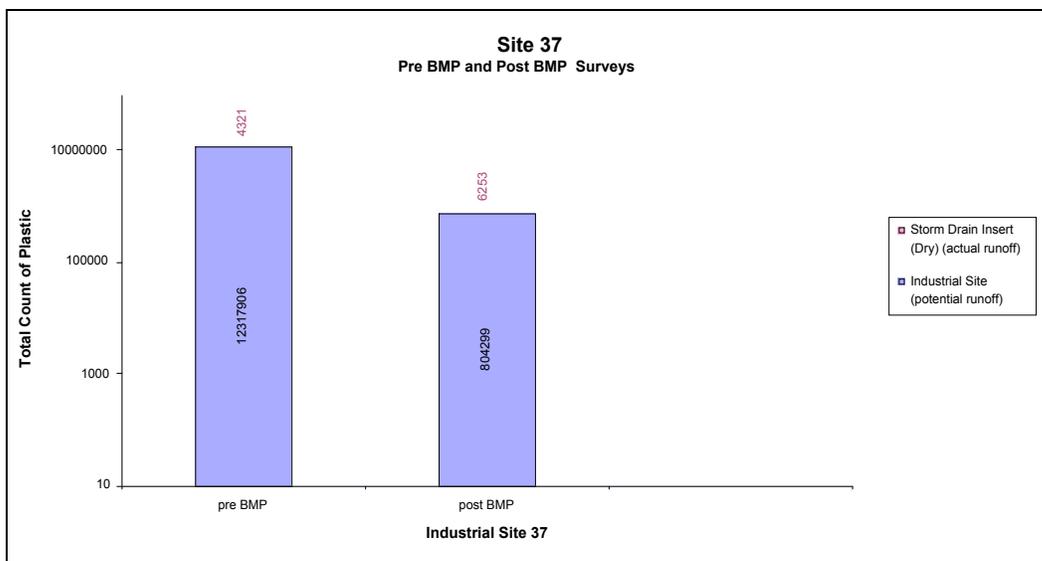
### Site 37

The areas outside the facility which project personnel were able to access for sampling purposes were:

1. The public sidewalk on two of the four sides of the facility.
2. The rail yard area behind the facility.
3. The public street and gutter.
4. The catch basin near the rail yard.

This facility has improved, although it was not formally part of the BMP Evaluation sites. We did not sample on their facility, but company personnel observed that the storm drain insert and surrounding areas were being monitored. They made an effort to clean the rail tracks behind their facility, especially nearest the street. There continues to be some pellet loss on the sidewalk and in the gutter leading to the storm drain.

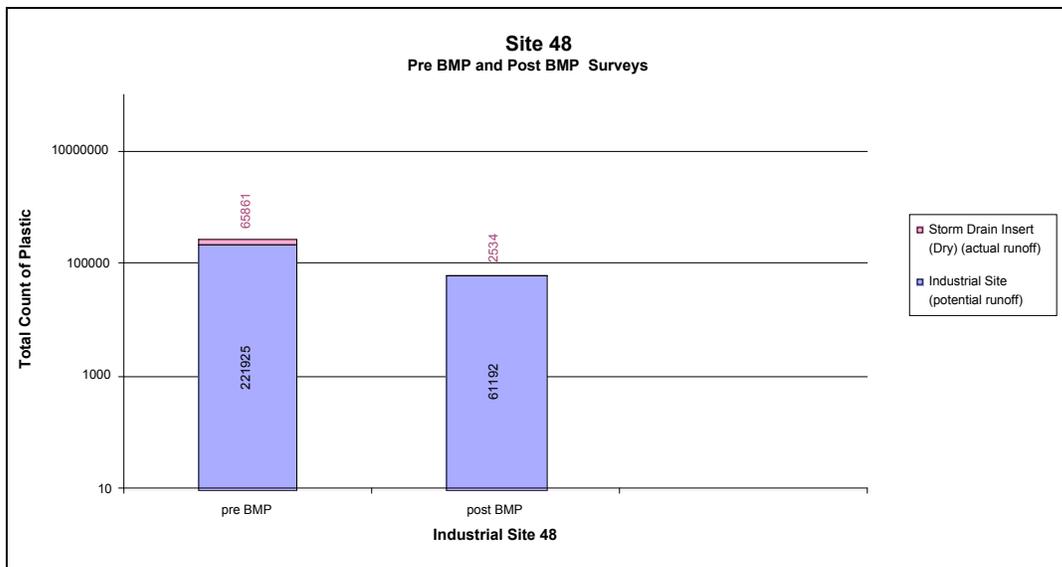
Site 48

The project had inserts put into both catch basins. Pellets could reach them from the following locations:

1. The front parking, loading dock area and the side of the neighboring building.
2. The waste bin area.
3. The driveway to the rear of the building.
4. The rear receiving dock area.
5. The bag house for the cutting operation.

By comparing the pre BMP and the post BMP surveys, this facility has improved.

This is the only company that has taken our advice to purchase a shop vac. It is used with a long extension cord to clean inside and outside. Deployment is based on visual assessment of need and there is no regular schedule for vacuuming. Each employee is trained to clean up spills at meetings to discuss pellet loss recommended by the project. They reported having had such meetings at the time of post BMP monitoring. They put up the OCS posters with clear acrylic sheet covers in prominent places in the warehouse front and back.

They have informed the dispatcher of delivery trucks that the truck drivers must inform warehouse employees if they are dirty and they will clean them out before they leave. No sweeping out of unloaded trucks is allowed in the parking lot.

They have looked for someone to recycle the relatively small amount of mixed pellets that they have, but have not found anyone. Trash pellets were bagged and put in the dumpster.

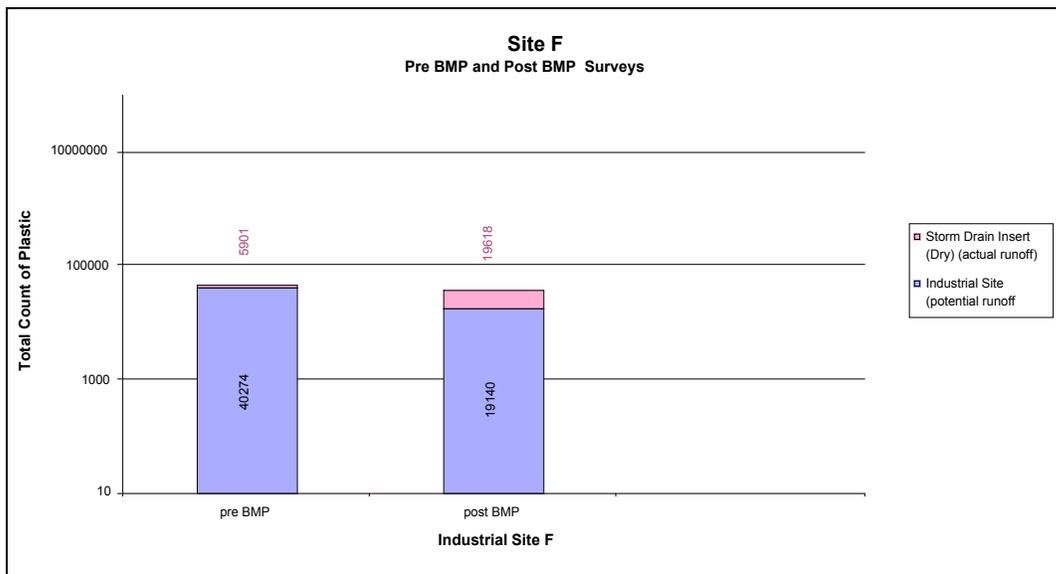
## Site F

Pellets could reach the catch basin from the following areas:

1. The rear silo area.
2. The delivery/storage area.
3. The sidewalk.
4. The dumpster area.
5. The gutter on the street in front of the company.

By comparing the pre BMP and the post BMP surveys, this facility has improved in pellets on the ground subject to runoff, but actual pellets in the catch basin inserts have gone up.

No suggestions for BMPs were adopted. Management stated that they sweep up and recycle pellets every other day based on visual inspection at the beginning of the shift. They have one cleanup person, but others can help. Owner said he saw a delivery company sweeping pellets back into the delivery truck.

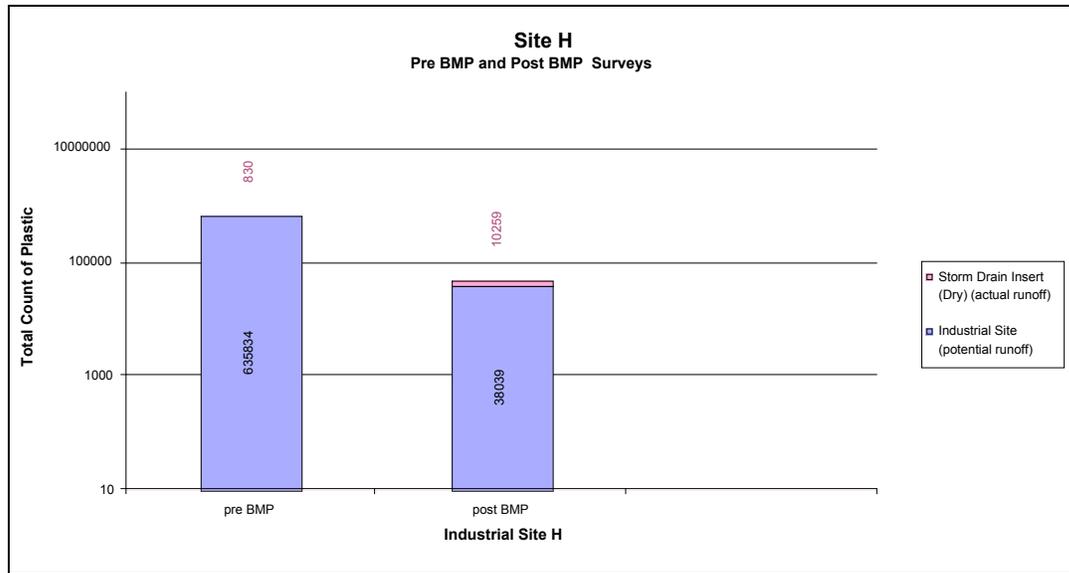
## Site H

Areas where pellets and dusts could enter the storm drain system are:

1. The pipe storage area on the side of the building.
2. The parking lot.
3. The sidewalk and gutter on the street.

This facility has improved, although it was not formally part of the BMP Evaluation sites. They did allow us to sample front of the facility during the pre BMP monitoring and allowed us to come back for the post BMP monitoring to do the same area. They continue to have spills of

plastic fragments (regrind) and pellets in the driveway, and at the side of the driveway. There was considerably more plastic present in the post BMP catch basin samples.

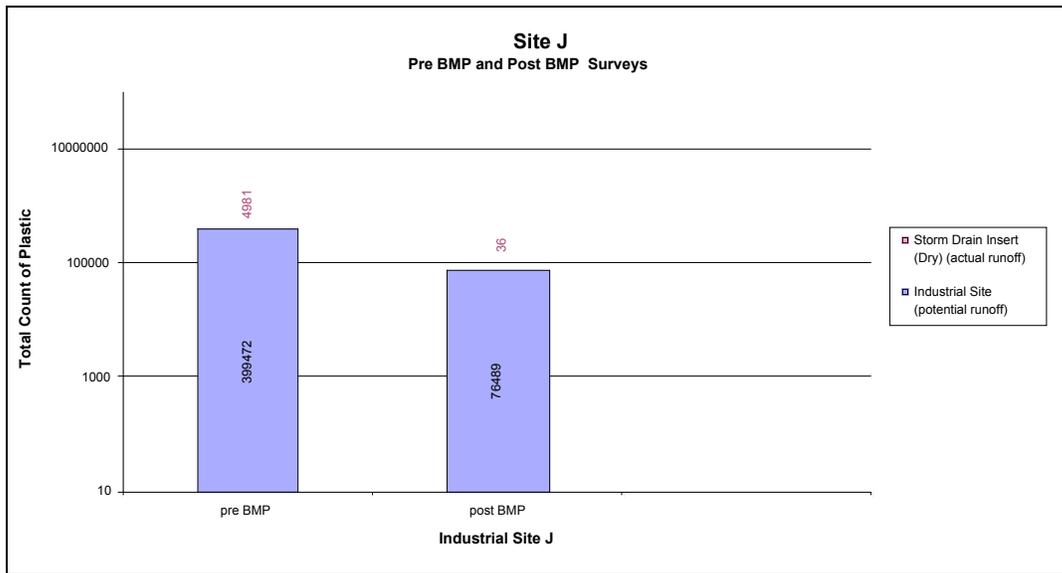
#### Site J

Outside areas where pellets and powders were observed include:

1. Street level loading and unloading areas.
2. Box and bag handling areas.
3. Regrind/recycling areas.
4. Warehouse storage area.
5. Waste disposal dumpster area.

By comparing the pre BMP and the post BMP surveys, this facility has improved.

New BMP measures reported by the management are being established all the time. They have established cleanup stations and each employee does their cleanup. The manager also said they had had a training session. They have put plastic bags inside their Gaylord containers that they use for Roto Mold Scrap to prevent sawdust from escaping. However some sawdust had escaped and was on a pallet. There was plastic debris observed on both sides of the street though in a lesser degree. Plastic shavings were observed on the sidewalk and in the tree wells. Spills of plastic feedstock powders (blue, red and green) were visible in the parking lot. And plastic dust was visible on the vertical face of the curb on the public street.

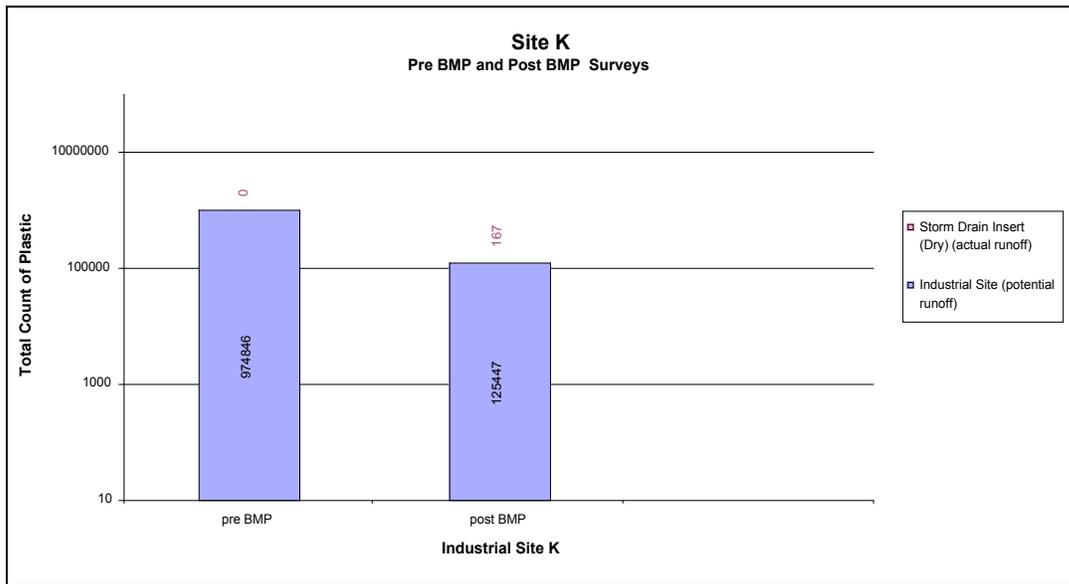
## Site K

Areas where pellets and powders could wash to the sump are:

1. The parking lot and dumpster area.
2. The truck delivery and loading area.
3. The rail yard which is partially paved.
4. The area behind the facility where powders are filtered out of the pellet delivery system.

By comparing the pre BMP and the post BMP surveys, this facility has improved.

New BMP measures were observed at the back of the facility in the dust collection system, which now has a sock taped around the automatically opening valve which blows out dust, so the amount that reaches the ground is reduced. A way in which pellet loss is worse is that there were no pans under the railcar valves, and the spills on the ground by the railcars were not contained. Pellets were in evidence in the ditch leading to the storm drain by the rail car. The dumpsters had only a small amount of pellets around them, and the dumpsters were covered.
