MERCURY MINE WASTE EROSION INVENTORY: RANCHO DE GUADALUPE AREA SIERRA AZUL OPEN SPACE PRESERVE

April 13, 2011
(Revised)

Midpeninsula Regional Open Space District
330 Distel Circle
Los Altos, CA 94022

TIMOTHY C. BEST, CEG
ENGINEERING GEOLOGY AND HYDROLOGY

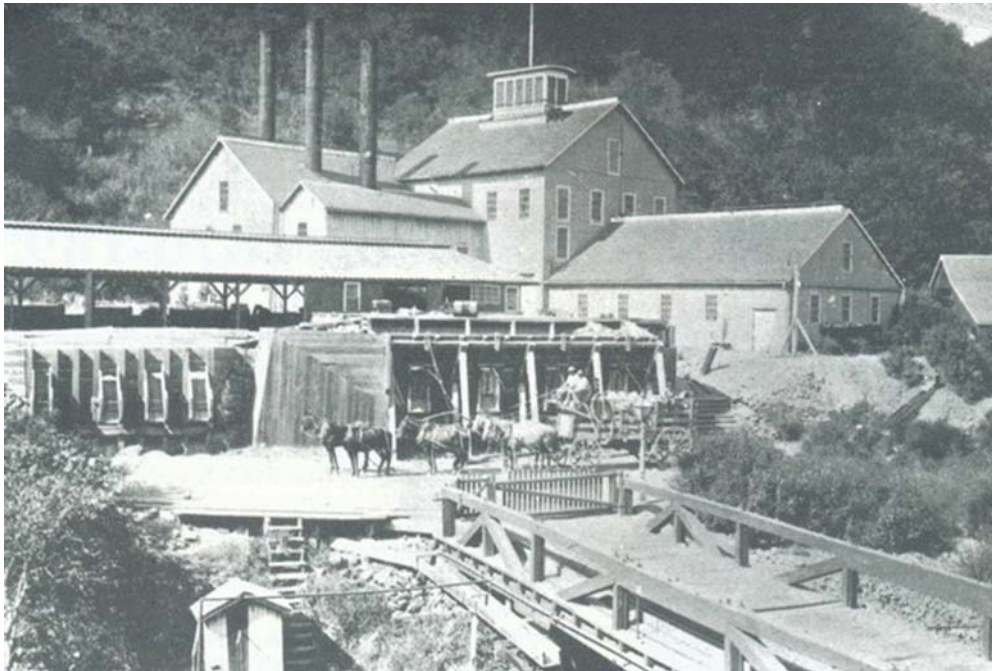
Photo 1: Historic photo of the old Engine Shaft workings. Note waste or chutes below the bench and overburden/tailings pushed over the edge.

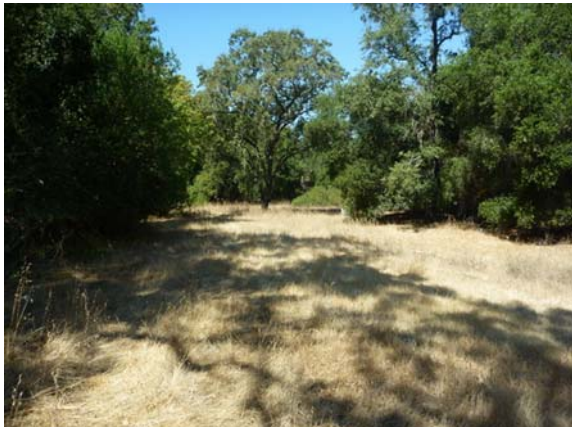
Photo 2: Graded bench at Engine Shaft

The surface of the graded pad is vegetated with light grass and without evidence of concentrated surface runoff or erosion. No seeps or wet areas were observed. The potential for erosion and the rate of sediment yield is low.

The site is found to have a low treatment priority based on 1) low bioavailability and 2) low sediment yield. The preferred alternative is to maintain existing vegetation and visually monitor for future erosion, utilize soft BMP’s to control erosion, and work with County Roads Department to minimize disturbance by maintenance activities. Removing the mine waste or constructing retaining walls to further stabilize it in place does not appear warranted given the minimal net sediment reduction benefit and likely high costs and potential adverse impacts involved with constraints associated with Hicks Road.

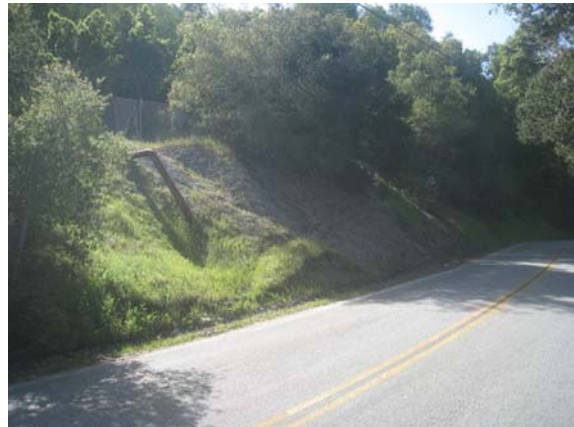
The western end of the upper embankment exposes mixed angular clasts of dark grey greenstone, sandstone and serpentinite in a sand matrix. This portion of the embankment is lightly vegetated with grass. The slope is oversteepened with shallow instability noted along the lower portion of the embankment. Failed debris is deposited on the road surface where it is either eroded away by ditch flow or removed by county maintenance crews.

Photo 3: Western end of upper embankment below Engine Shaft. Pipe extends to shaft. Serpentinite and fill exposed in embankment

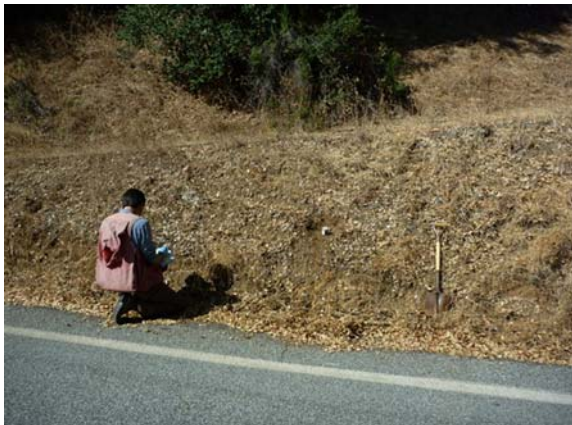
The eastern most end of the embankment exposes rust orange brown sand and angular gravel. Based on configuration of the site the material is likely fill or tailings but appears similar in composition to native soils. The embankment is vegetated with grass. The rate of erosion appears low.

Photo 4: Eastern end of upper embankment below road leading to Engine Shaft site

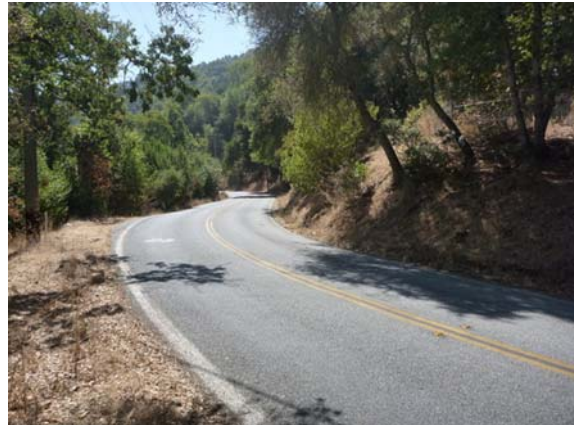
Photo 5: Eastern end of upper embankment below Engine Shaft site to right, and top of lower embankment to left.

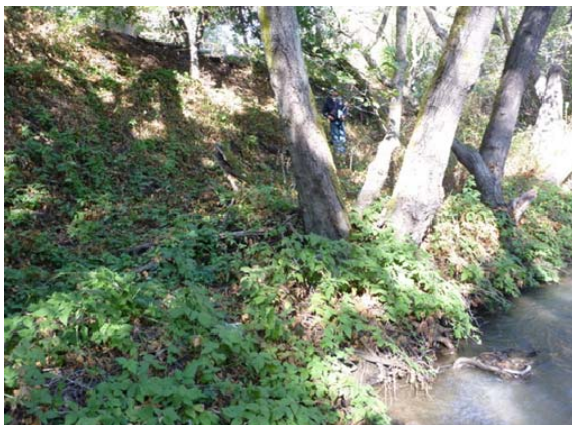
Most of the lower embankment appears to be comprised of fill that includes coarse mine tailings and overburden. Bailey and Everhart (1964) map the material as mine dump. Tailings and overburden are exposed along the 130 foot long segment of unretained embankment between the concrete flume and upstream concrete wall. In this area the base of the embankment consists of clast supported angular cobble size rock consistent with mine tailings. Capping the rock is a finer grained soil that incorporates recent trash and debris that were dumped off of Hicks Road at a much later time. The lower embankment is well vegetated as evident in the photo’s below.

Photo 6: Lower unretained embankment below Hicks Road, densely vegetated.

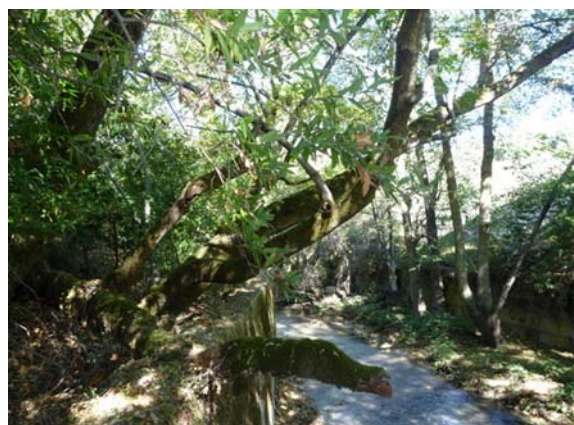
Photo 7: Concrete flume below Hicks Road, lower retained embankment.

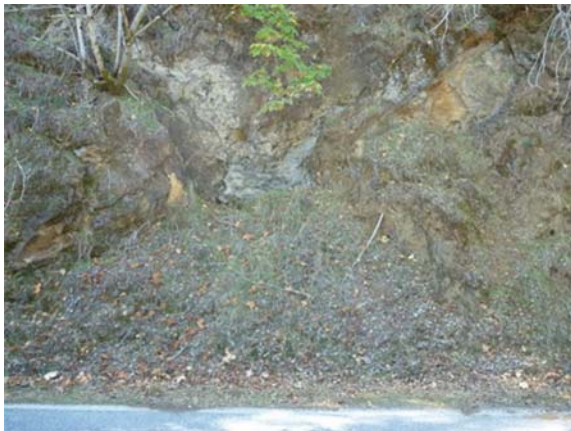
The entrance is sealed with concrete grout. There is no evidence of mine waste and none have been reported in previous studies (Cox, 1995; Geologica, 2004).

Photo 8: Sealed adit at Road Tunnel

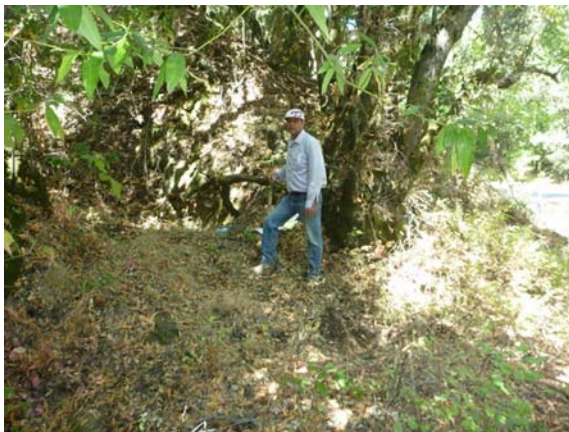
The shaft occupies a small 750 sf area on the west side of a narrow and steep sided intermittent watercourse. The site consists of a small 8 foot diameter, 3 foot deep pit dug partway into the steep hillside. About 25 cy of fill and mine tailings extends downslope of the pit and protrudes into the narrow valley bottom. The pit and spoils pile have subdued morphology indicating that these features are quite old. Fill material consists of orange brown sands and gravels which are consistent with native soils. Silica carbonate rocks were not readily apparent.

Photo 9: Lamb Shaft. Pit is in background

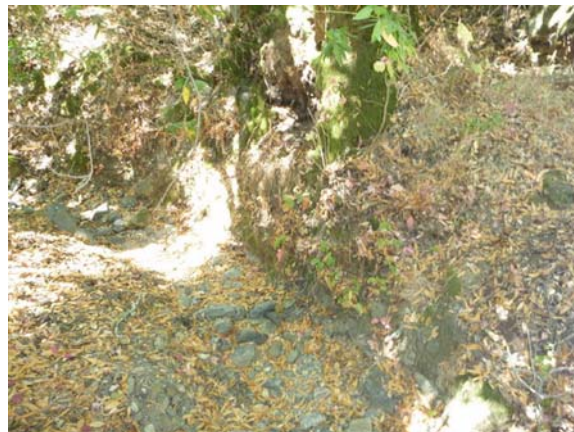
Photo 10: Intermittent stream channel at Lamb Shaft

The intermittent stream occupies a narrow and steep gradient valley draining a 110 acre watershed. The channel is 2 to 5 feet wide, sand and cobble bedded, and with a moderate channel gradient. Native side slopes leading into the stream exceed 80% gradient. Natural stream sediment transport and load is high based on conditions observed immediately upstream of the site. Spoils from the Lamb Shaft appear to protrude 10+ feet into the narrow valley bottom and this may have pushed the watercourse into the opposite bank. The channel itself does not appear to have been narrowed. The channel bank along the base of the spoils is 2 to 3 feet high and armored with rocky material. Even though the upstream channel is now directed into the spoil pile there appears to have been very little erosion since the time the shaft was abandoned 90+ years ago. For this reason the rate of sediment yield is found to be very low at less than 10 cy over the past 50 years.

The location of the site along the bank of an intermittent stream places the site at moderate to high risk for continued stream bank erosion. However, the rate of erosion and amount of sediment yield from the site is very low. Total volume of material residing at the site is less than 25 cy. The rate of sediment yield is found to be very low at less than 10 cy over the past 50 years.

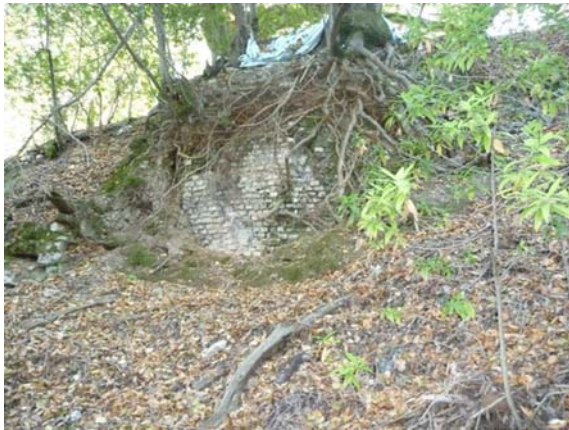
Photo 11: Old bricks of the Lime Kiln

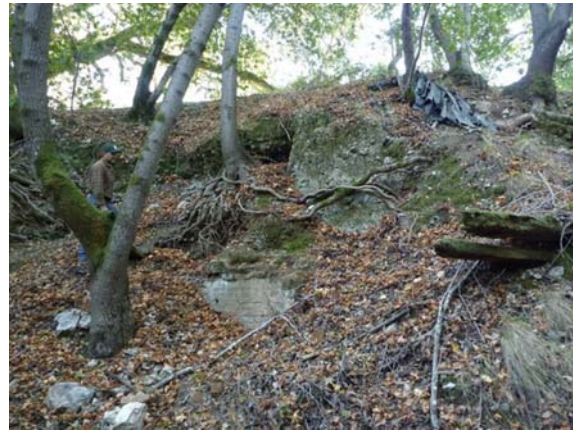
Photo 12: Photo shows some of the processed limestone within the old kiln.

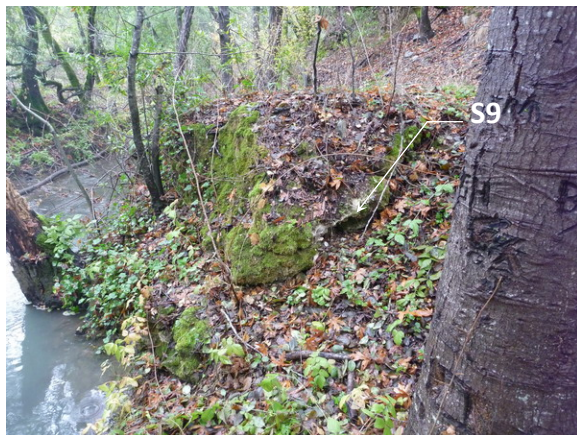
Photo 13: Cemented processed limestone waste along Guadalupe Creek immediately downslope of the Lime Kiln. Sample S9 was taken from this site

Downslope of the kiln is a heterogeneous deposit of cemented buff white processed limestone with fragments of darker grey limestone. This deposit extends along the Guadalupe Creek bank for about 50 feet downstream of the kiln. The deposit is visually similar to the in place material within the kiln and interpreted to be waste material from the kiln that was probably pushed into the stream after processing. There is no evidence of processed mine waste and similar deposits were not observed on the opposite (north) side of Guadalupe Creek.

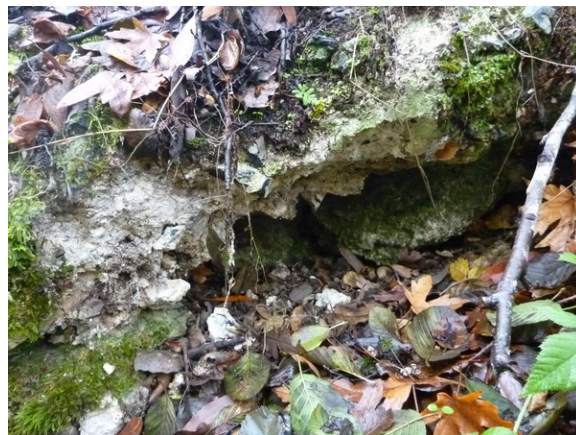
Photo 14: Close up of Sample S9

We are uncertain as to why there is a high and variable mercury concentration within Sample S9. High levels of mercury would not be expected at the lime kiln since available records indicate mercury rich ore was not being mined or processed. Further elevated mercury was not observed in the other 5 samples taken at and near the site. As discussed in Section 3.1.1 Sampling and mercury testing (page 8), mercury concentration varied in several other samples and could be attributed to the heterogeneous composition of the samples. Based on available information we believe that this sample is an outlier and is not representative of the site as a whole.

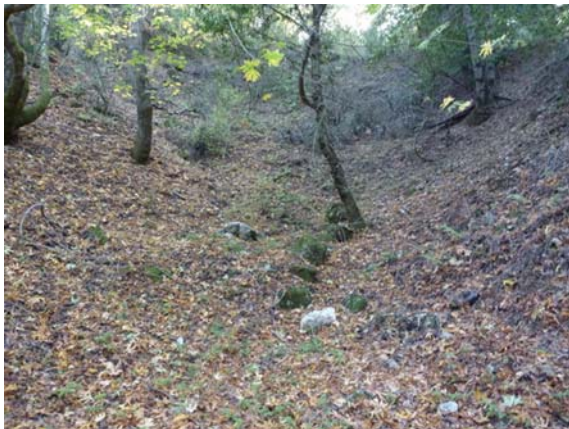
Photo 15: Old limestone quarry pit

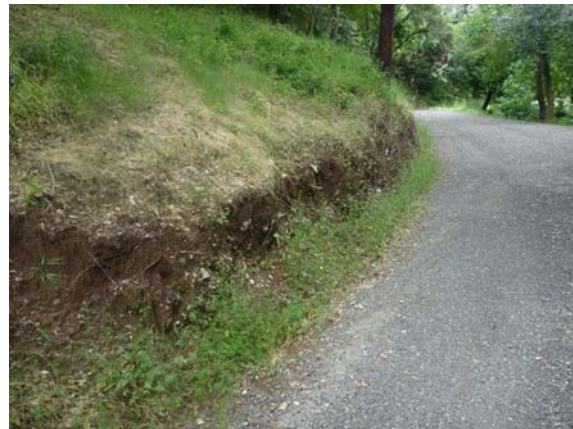
Photo 16: Road cut along Hicks Ranch Road

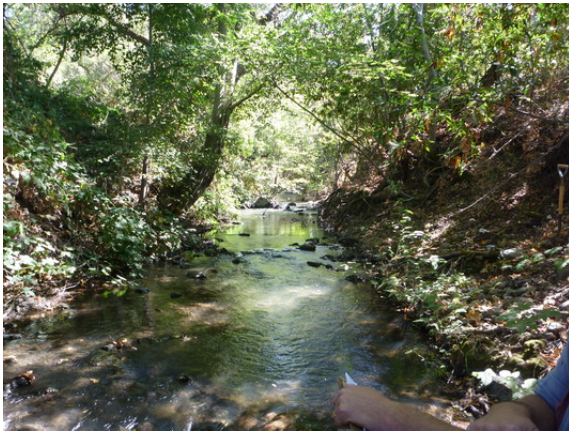
Photo 17: Upstream view of Guadalupe Creek

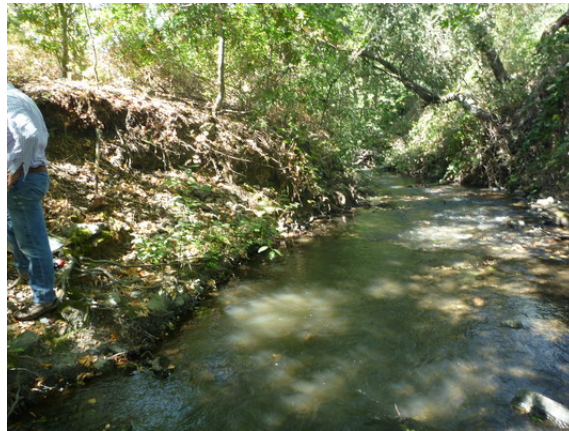
Photo 18: Downstream view of Guadalupe Creek. Elevated mercury levels detected in soils exposed in the escarpment to left of the photo

The calcine deposits appear to be largely above the low flow channel, but are at risk for erosion under high flow conditions. The steep channel bank is partially vegetated and locally covered with moss suggesting a low rate of bank erosion. The calcine deposits themselves are partially cemented and in general are not highly prone to erosion. A few small old scour features are evident and these have been significant enough to have undercut the nearby Hicks Road.

Based on field observations it is estimated that less than 2 feet of bank erosion has occurred within the past 50 to 75 years. Assuming an average mine waste thickness of 4 feet, annual sediment input along this segment of stream is estimated to be less than 1.5 cy per year.

The erosion potential along the embankment face is high per RWQCB ranking criteria. The rate of sediment yield, however, is low to medium.

Given the substantial physical constraints at this location involving Hicks Road, the relatively low rate of erosion and small area involved, no treatment is recommended at this time.

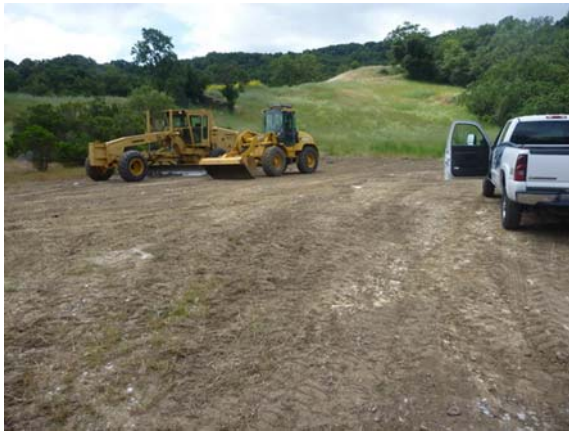
Field and air photo review found no evidence of surface mining or mine waste at the site. Previous studies have similarly found no evidence of mine waste at the site (Cox, 1995; Geologica, 2004; SRK, 1989, 1992). The access road has been rocked with limestone.

Photo 19: China Flat

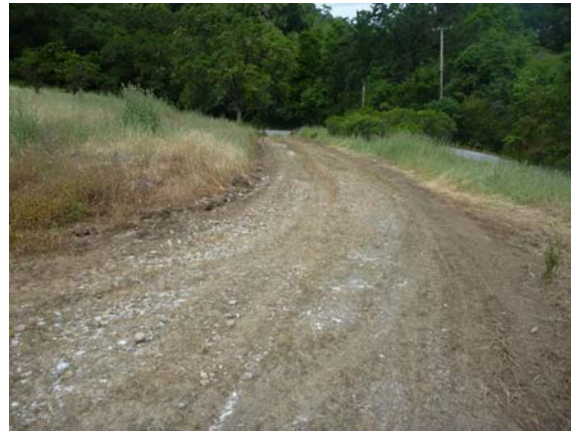
Photo 20: Road leading to China Flat
