INTERACTION BETWEEN POWER ELECTRONIC COMPONENTS AND DISTRIBUTION TRANSFORMERS – RISK EVALUATION AND MITIGATION TECHNIQUES

Gerd Voss¹, Sidney Mattatia², Gerd Bajog³
 ABB Sécheron SA¹, Services Industriels de Genève SA², Bajog Elektronik GmbH³
 Switzerland

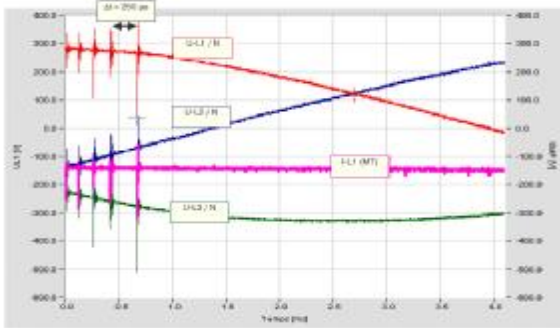
Fig. 1 and 2 show two different ways of presenting distortions acting on a transformer in a transformer station where several units were destroyed. Fig 1 is a representation in function of time and fig. 2 is the perturbation spectrum in function of the frequency.

Fig.1 Typical distortions in a shopping center (phase voltage vs. time)

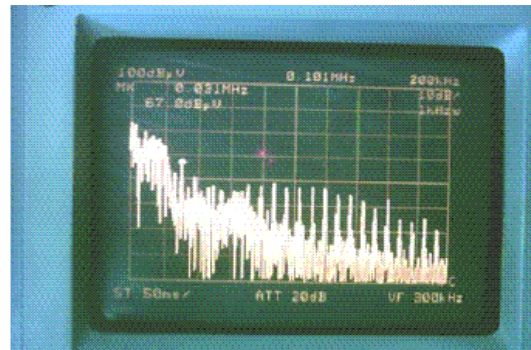
Fig.2 Perturbations spectrum in the range 10 – 200 kHz (dBmicroV)

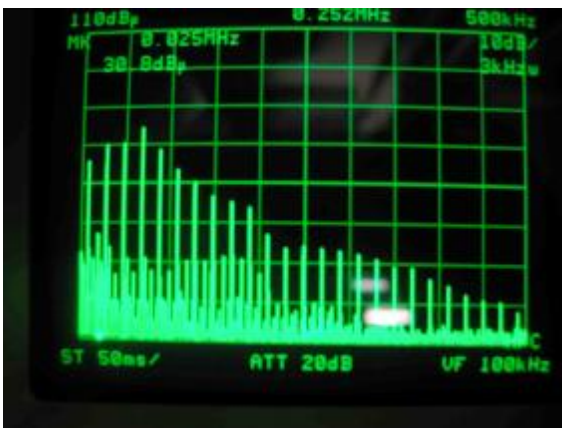
Figure 3 shows that a lift drive without sufficient spike suppression in an apartment building destroying several machine controls and 5 PCs.

Fig.3 Network analysis in an Munich apartment building

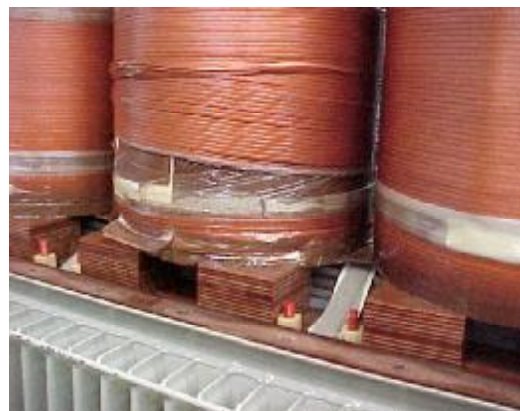
Failed transformers showed a fault in the isolation at the mid of the medium voltage coil (Fig. 4), at a zone where the electric stress from steep voltage fronts are normally not very high.

This leads to the assumption that resonance phenomena may be the cause. The inspection of the coil of damaged transformers and their isolation as well as an oil and gas analysis did not show any premature ageing. Other transformers of the same manufacturing lot , being in service since 6-7 years, have been retested under the same condition as the new ones (100 % applied voltage test).

Fig.4 Primary windings of distribution transformer after a failure.

Generally a reinforcement of the winding isolation is indispensable and may result in an isolation class one step higher (i.e. BIL 175) than required by the standards. In certain applications even shield windings may be necessary.

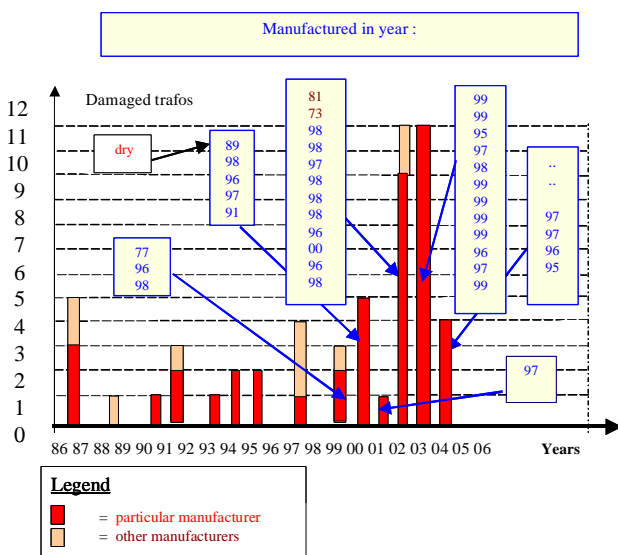
At 2004, 26 units have been exchanged as a preventive measure in the said network because of the non-delivery of electricity which had reached 44 MWh. Relying on statistics does not help at all: The interruption of 6800 customers due to transformer failures has reached 9 % in the reliability statistics, whereas the transformers manufactured prior to 1996 showed < 0.1%.

Fig.5 Damaged transformers in the said network since 1996 (no. vs. years)
