# **LANDSLIDES IN THE HIGHWAY 1 CORRIDOR: GEOLOGY AND SLOPE STABILITY ALONG THE BIG SUR COAST**

**Highway 1 along the Big Sur Coast  
Between Point Lobos in Monterey County  
and San Carpoforo Creek in San Luis Obispo County  
SLO-1-71.4/74.3  
MON-1-0.0/72.3**

**Prepared for: Caltrans District 5**

**Prepared by: California Department of Conservation  
Division of Mines & Geology**

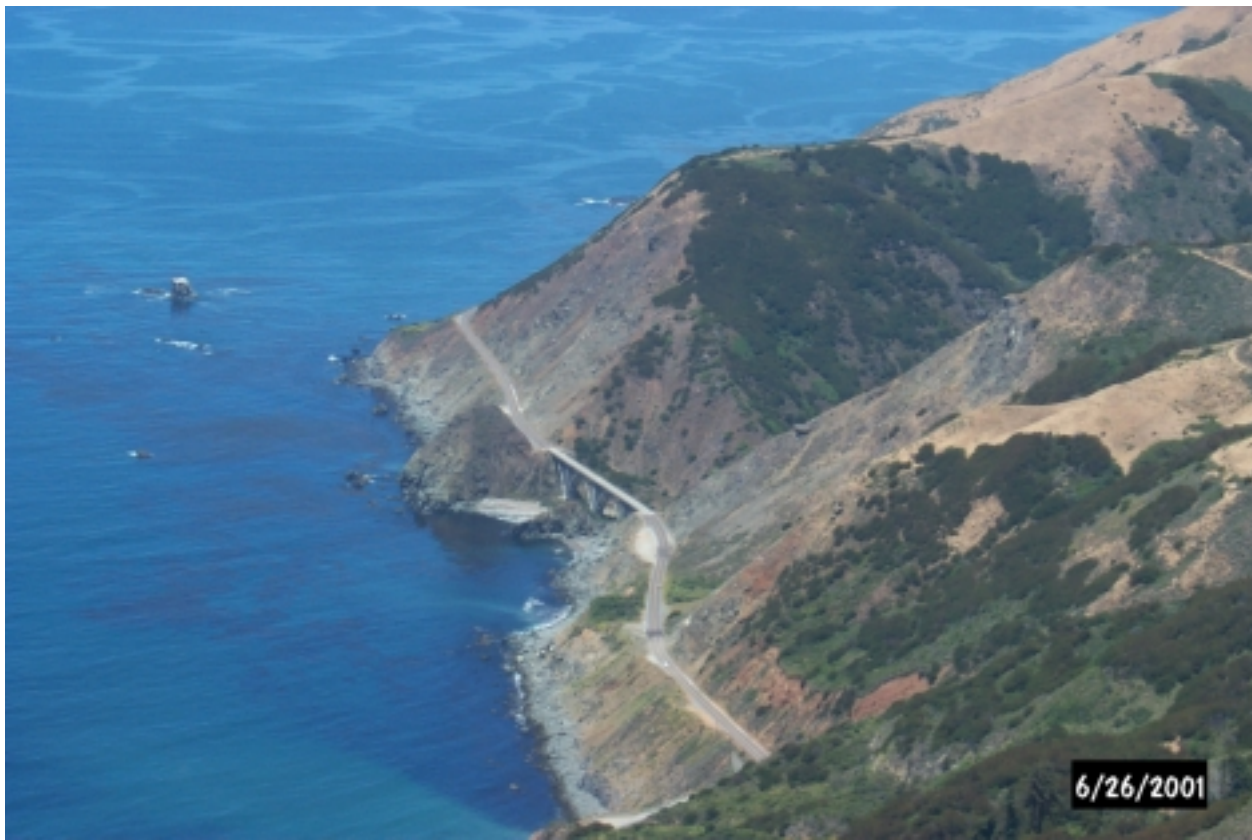
**Figure 1. View of Highway 1 at the mouth of Big Creek, where the road crosses several extensive landslide areas south of the bridge and a large area of rock fall and debris slides north of the bridge. View looking Northwest. Photo by C.J. Wills.**

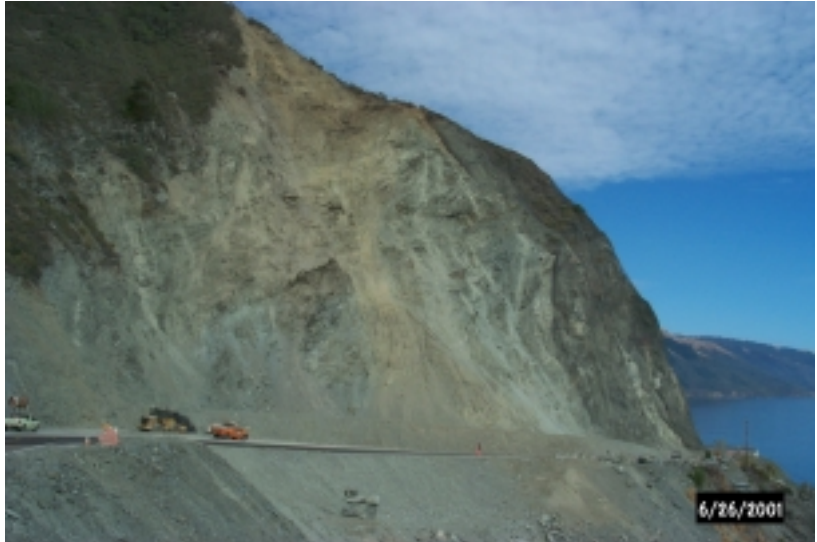
Even when blasting was not used during construction, creating a cut slope in marginally stable material can trigger small slides. If an extensive area of weak rock or soil extends upward from the cut, small slides in the cut can reduce the stability of somewhat larger areas on the adjacent slopes. If the larger areas fail, that can reduce the stability of larger adjacent areas. This form of landslide, which develops from a small failure in a cut slope to a much larger failure in slopes that are largely natural, is called a retrogressive landslide failure. This type of sliding was probably extensive in the 10 to 20 years after construction of the highway. More recently, repairs and maintenance have led to similar failures. One example of a retrogressive failure related to highway maintenance may have occurred at "Pitkin's Curve" (P.M. 21.5) where a landslide below the highway led Caltrans to move the highway to the southeast, off of the slide. A cut slope was required to move the highway inland. That cut slope in weak, loose debris and weathered rock rapidly failed, leading to retrogressive failure of the entire slope above the cut to the ridge crest (Figure 4)

**Figure 4, Debris slides above the highway at "Pitkin's Curve" may have formed due to retrogressive failure starting in a road cut.**

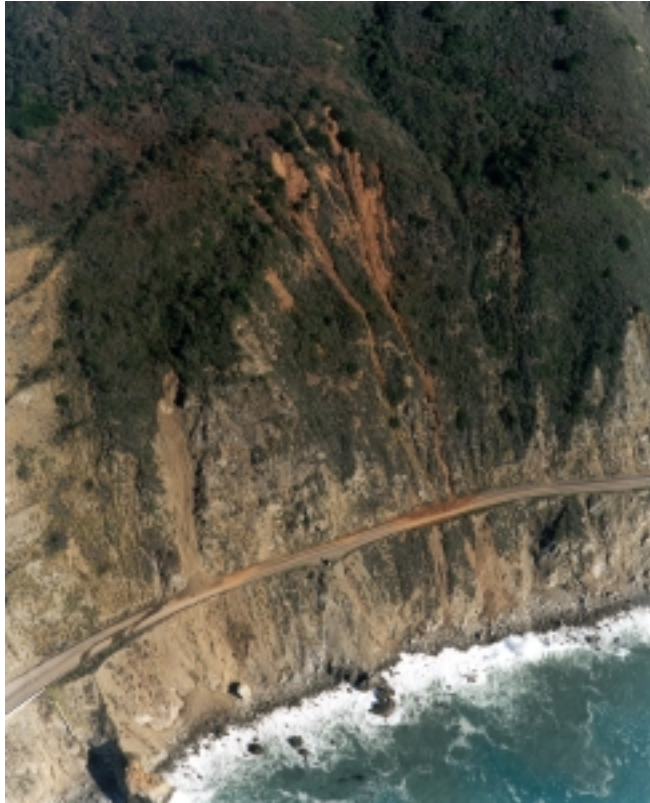
**Figure 5. Cut slopes south of Limekiln State Park were subject to small shallow landslides in 1998. These slides included debris slides from loose, slightly weathered rock, on the left, and debris flows from older, dark reddish brown colluvium, on the right. Photo by L. Highland, Caltrans.**

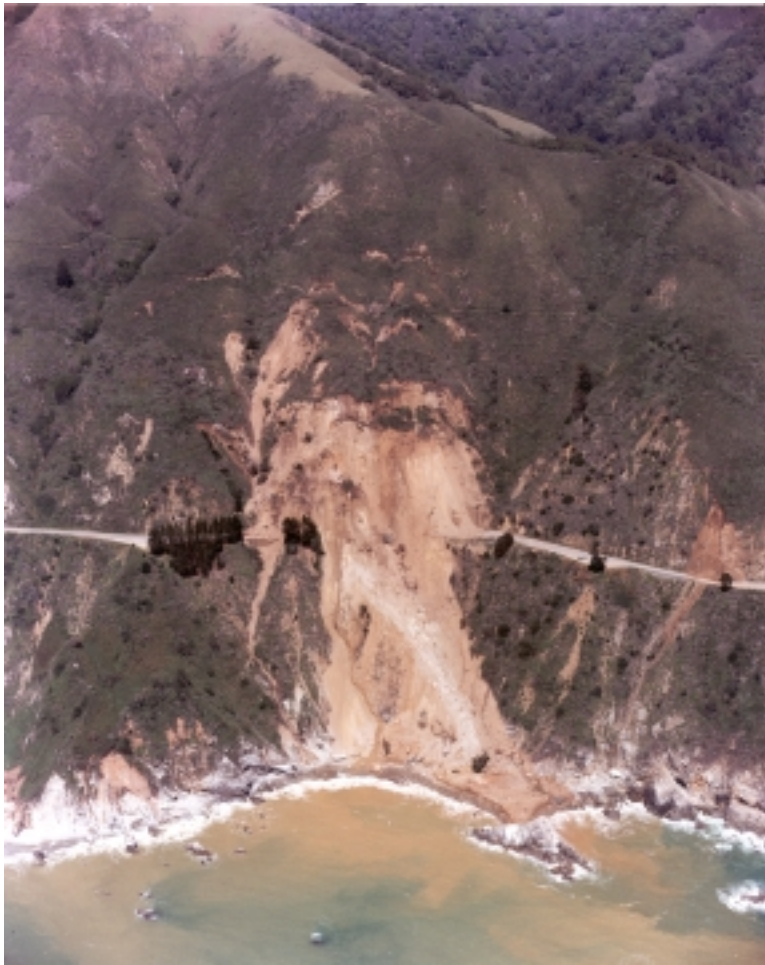
Figure 6. Aerial view of the McWay slide of 1983. Photo by Lynn Harrison, Caltrans

Overall, this segment has a moderate potential for landslides, largely related to small rockfalls and debris slides, but there are zones of weakness in the tonalite, and major landslides have occurred in exceptional circumstances. The heavy rainfall in the winter of 1983 was one such circumstance, because it triggered not only the largest slide on this segment, the McWay (or J.P. Burns) slide at P.M. 36.25 (Works, 1984; Figure 6), but also a similar slide at Sycamore Draw.
