## **NRC research on field performance of rehabilitated concrete bridges**

**Cusson, D.; Qian, S.Y.**

**NRCC-44679**

# NRC Research on Field Performance of Rehabilitated Concrete Bridges

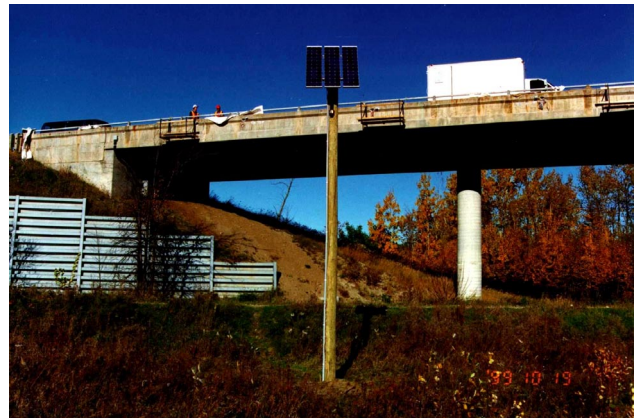
**Figure 1: View of the west half of the Renfrew bridge**

A 4-year partnership with the Ministry of Transportation of Ontario was formed in 1999 to study the deterioration mechanisms and to evaluate the long-term performance of different concrete patching systems under field conditions on a highway bridge (Figure 1).
