Micropile Underpinning of the Mandalay Bay Hotel & Casino

Presented at:
University of Minnesota
54th Annual Geotechnical Engineering Conference
St. Paul, Minnesota
February 17, 2006

Micropile underpinning of the Mandalay Bay Hotel & Casino

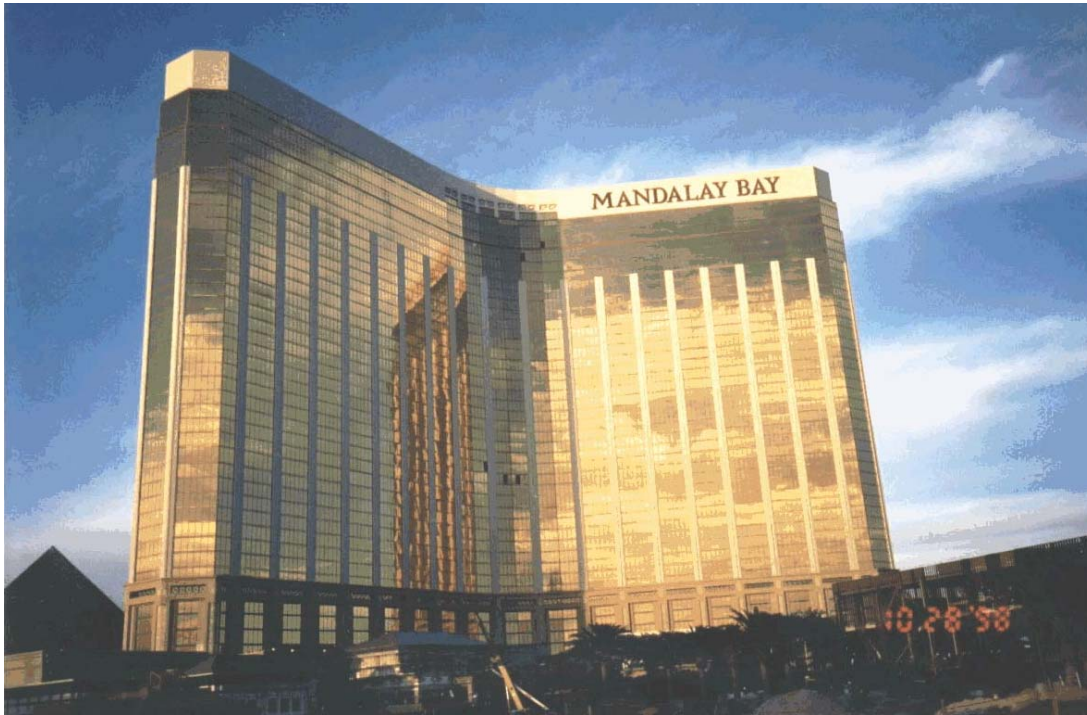
Figure 1. Overall elevation view of Mandalay Bay in 1998.

The center core was built on a 10-foot thick mat foundation at about 20 feet below grade. In early July of 1998, after the reinforced concrete structure was topped out, it was recognized that the vertical movements, and particularly differential movements between the tower core and the wings, were unacceptable. The structure, consisted of heavy reinforced concrete columns, that supported relatively flexible post-tensioned concrete floor slabs. If the movements were not stopped structural damage would occur. The center core at this point was sinking at a rate of about $\frac{1}{2}$ to $\frac{3}{4}$ inches per week and the wings were sinking at a slower rate thereby increasing the differential distortion between column bays. It was imperative to quickly develop and implement a plan for supporting the structure. Micropiles (previously marketed by Nicholson as Pin Piles), installed with small equipment, inside the structure and adjacent to the large concrete shear walls that surrounded the elevator shafts were proposed and accepted by the owner and his engineers.

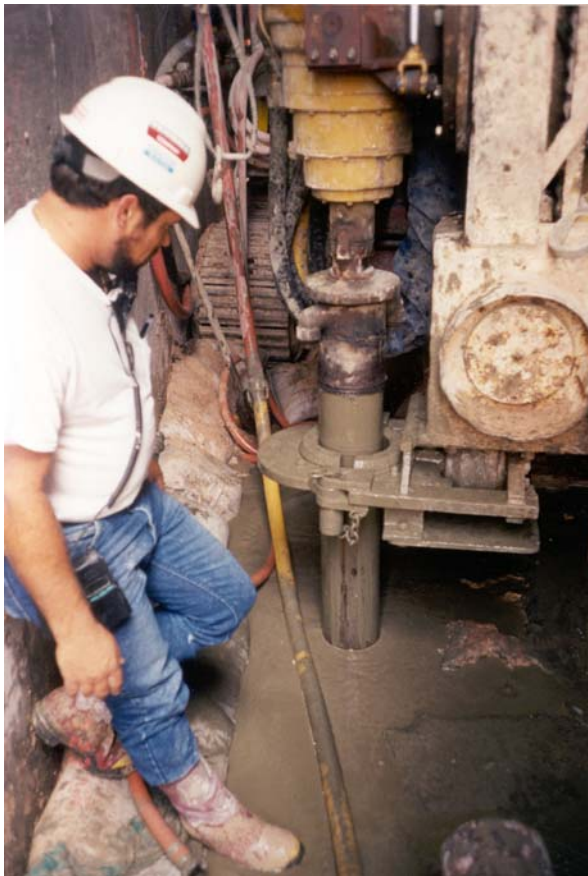
Figure 2. Externally flushing with grout.

Each micropile consisted of 7-inch OD 80 ksi pipe sections drilled down with threaded flush jointed 10-foot long pieces. The lead piece had an 8-1/2 inch diameter roller bit attached to it so that an oversized hole was drilled. External flushing with water and polymer additives assured that the heavier soil particles were lifted around the annulus of the pile and ejected. The external flush drilling also provided very rapid advancement of the casing. In other cases, duplex drilling may have been selected as a lower risk option; however, the increased production obtained with external flushing far outweighed any ground loss risk, particularly given the predominantly clayey sands and sandy clays underlying the mat. A preliminary methods test hole was drilled outside the work area and cutting captured to prove this method would not cause major loss of ground.

Once the casing reached the desired bottom elevation, a flexible tremie pipe was lowered inside the pipe casing to the bottom of the hole. Neat cement grout, mixed in high shear colloidal mixers, with water to cement ratio of 0.45 and a super-plasticizing admixture was then pumped through the tremie pipe. This very fluid grout would often travel a significant distance up the annulus just under the head of the tremie. Finally, full external grouting was completed by attaching the drill head back on the casing, and pumping additional grout through the head of the drill until it was observed to be flowing up from around the outside of the pile (Figure 2). This technique of fully grouting around the pile annulus was developed in order to assure that the potential ground loss that may have been created with the external flush drilling was immediately restored in each case with the grout filling. Additionally, the fully bonded piles proved to act as reinforcement against ground movement, and improved the situation as the installation progressed.

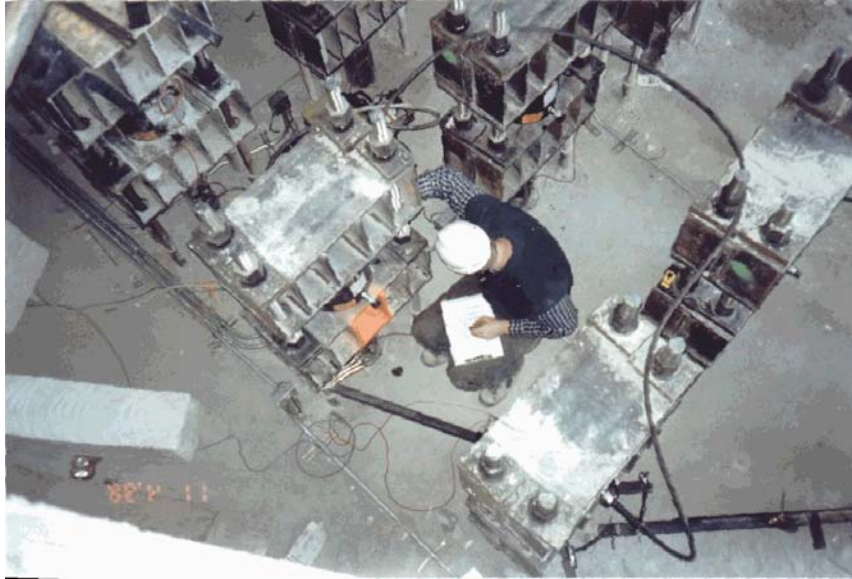
Figure 4. Overhead view of pile attachment frames.

Each pile was cyclically load tested (Figure 4) with its own jack to 600 kips and finally locked off at a nominal load of 50 kips. This testing also tested the grouting of the reaction bars into the mat. This unprecedented level and magnitude of pile testing was a major selling point to the Engineers and Inspectors.
