Kulla: A Traditional Albanian House Type in Kosovo

Sahar Rassam, Architect

SUMMERY

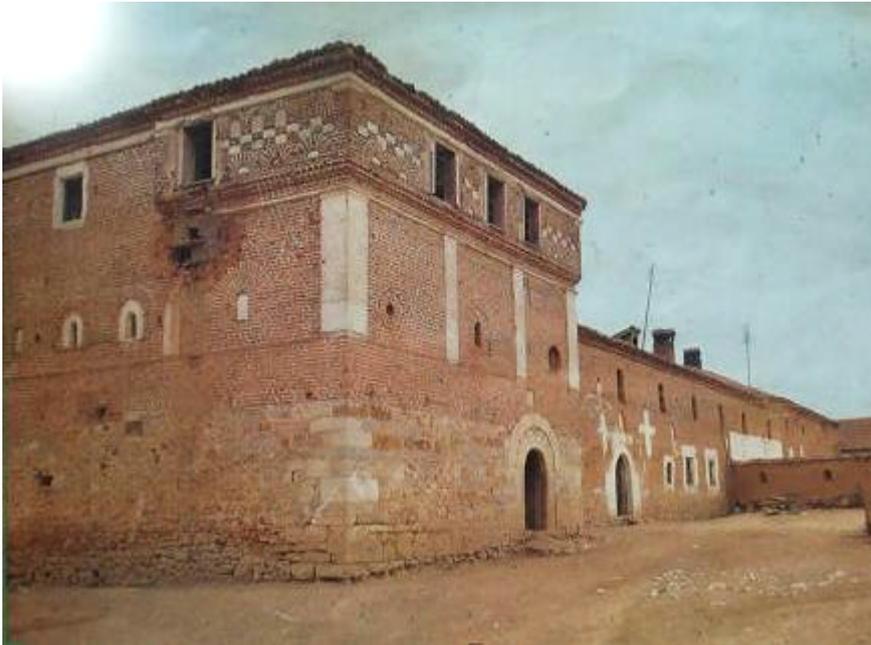
Figure 1: kulla of M. Gega, Gjurrakoc, Istog, as it used to be with the attached annex. Constructed of stone and brick. Taken from an old picture [2].

The kulla has either two or three floors and is mostly square in plan. They were usually utilized by the men of the family, while women and children lived in an attached annex having the same number of floors or less (Fig.1). Animals were kept in the ground floor and the upper floor was used by the men of the house and their guests. There are usually two entrances and staircases. One for the guests, from the main entrance, leading directly to the upper floor and the guest room without passing through the family private quarters. Another for the

The exterior walls are about one meter thick at the ground level and decrease upwards. They are constructed of stone (Fig.2), brick (Fig.3) or both (Fig.1) having the ground floor constructed of stone and the other floors of brick, with various patterns. The stones were excavated locally. The bricks are usually Harasan bricks, which were made of sand, chalk, water and a little cement, hand made and baked in kilns, or occasionally mud bricks. Interior walls are constructed of mud bricks with mud as the binding material and occasionally constructed of wood. The front door is through an arch opening in the wall. Small arched windows pierce the rather massive elevations. Many kullas have cantilevered parts and windows in the upper floor, constructed of the same material as the kulla, i.e. stone or brick with various decorative patterns, or of wood in the style of cardak with wooden arches and decorations (fig.4). There are also very small openings called (fringji) used for firing artillery and defense purposes. In fact, the architecture of the kulla, is as defensive as a fortress and must have provided excellent security during its history.

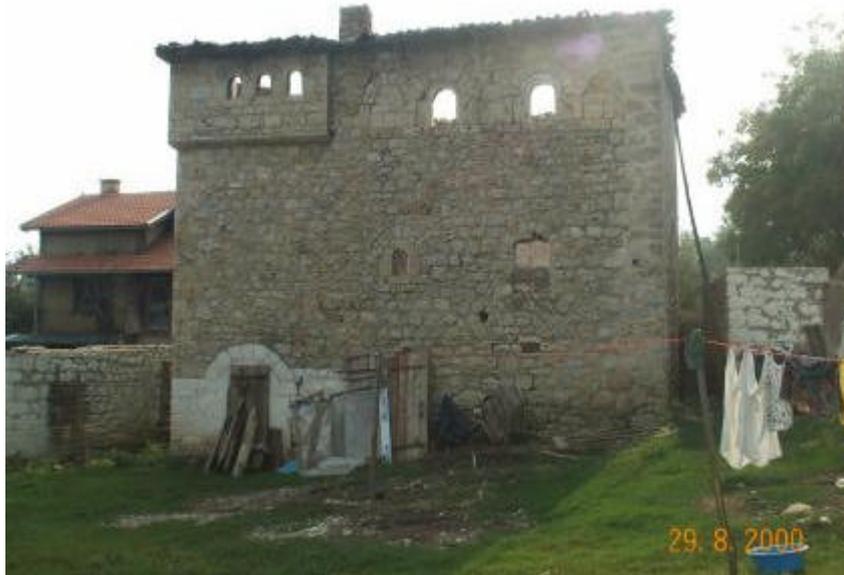
Figure 2 : Kulla of K. Fazlia, Lubozhda, Istog, constructed of stone [2].

- 1- Badly destroyed or reduced to part walls or rubble (Fig.11).
- 2- Outer walls in various rates of damage but nothing was left of the interiors and the roof (Fig.2).
- 3- Outer walls in good or repairable condition and need some restoration of the interiors and roof.
- 4- In a fairly good condition and are inhabited.
- 5- Altered and rebuilt and their facades had undergone significant changes (Fig.12).

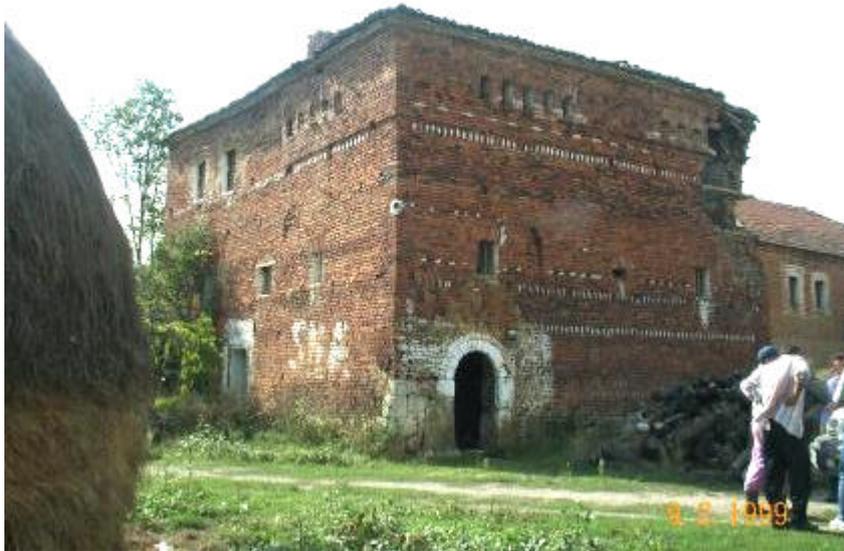
Figure 3 : Kulla of C. Ahmetaj, Zabllac, Istog, constructed of brick [2].

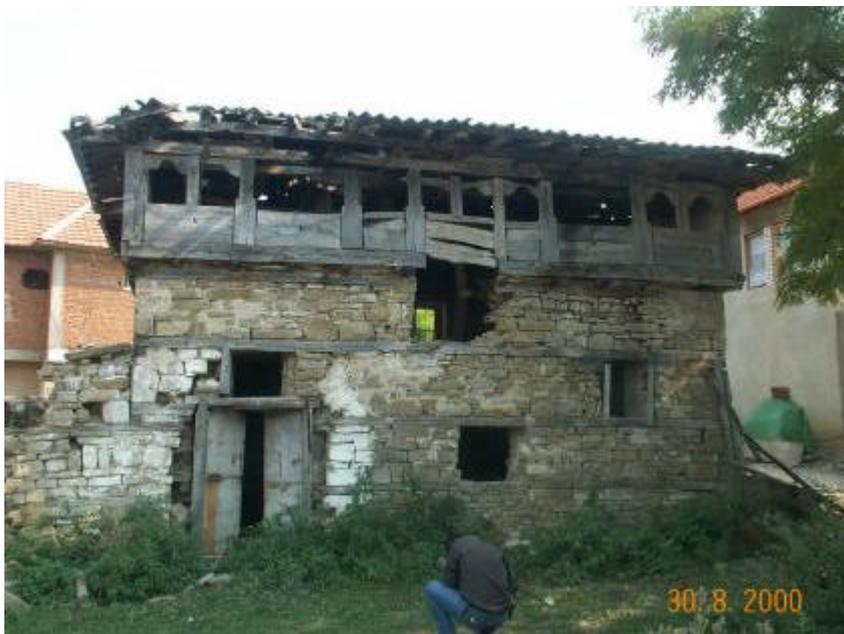
Figure 4: Kulla of S. Mata, Doberdol, Klina, with cardak style cantilever [2].

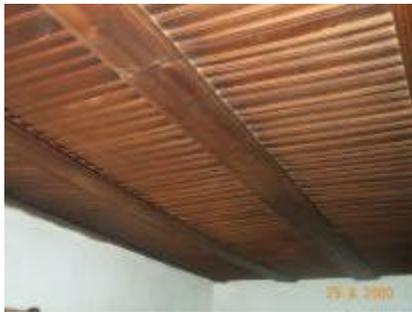
Fig. 5: inner ceiling [2].
Kulla of H. Maxharraj, Gramnik, Klina

The floors were constructed of tree trunks and the upper floor ceiling was covered from the inside with decorated wooden planks. The roof was topped with stone sheets which have later been mostly replaced with roofing tiles (Fig.6). Many details were incorporated in the design. Some kullas have the Qibla, a vertical niche in the wall pointing in the direction of Mekka and used for prayer. Certain rooms have fireplaces which were gradually blocked with birds' nests and later were built and closed. There are also wooden hangers attached to the ceiling above the fireplaces for drying clothes (Fig.7), built in wooden ornamented cupboards for storing coffee in the guests room (Fig 8), stone built-in boxes in front of windows and fringjis, stone sinks with an opening to the outside for drainage (Fig 9), and traditional eastern type toilets which were either built originally with the house or added at a later time (Fig.10).

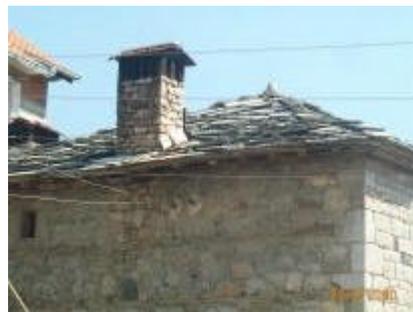
Fig. 6: stone sheet roofing [2].
Kulla of H.Maxharraj Gramnik, Klina

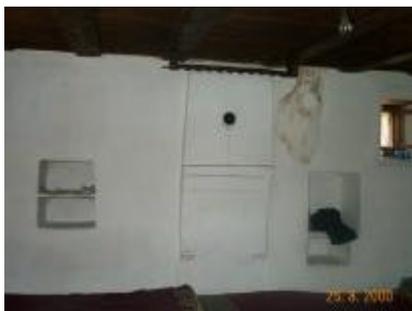
Fig. 7: closed fireplace with hanger [2]
Kulla of H. Maxharraj, Gramnik, Klina

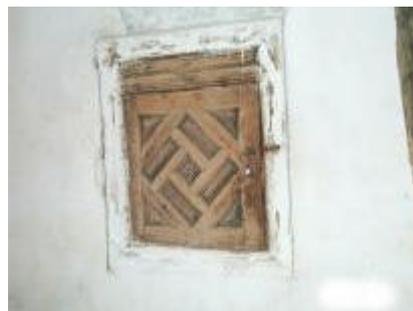
Fig. 8: built-in cupboard [2]
Kulla of U.Ukaj, Kaliqan, Istog

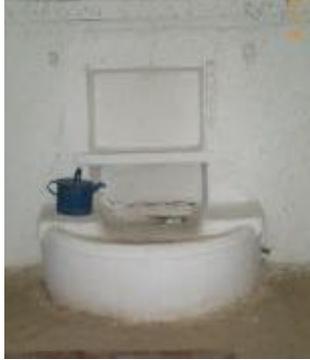
Fig.9: Stone basin [2]
Kulla of J.Jaku, Ranoc, Klina

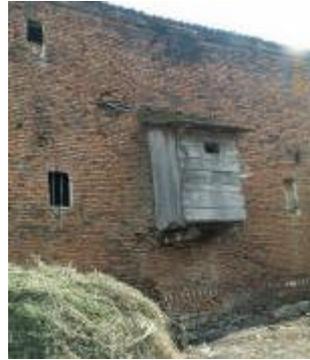
Fig.10: Added eastern toilet [2]
Kulla of C. Ahmetaj, Zabllac, Istog

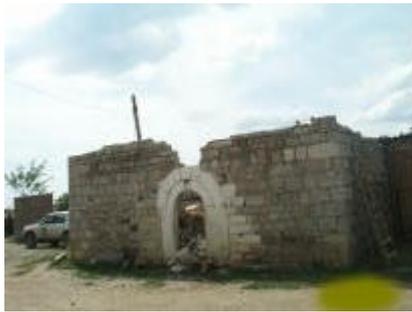
Fig.11: Badly destroyed kulla [2]
Kulla of F.Meta, Shushice e Ulet, Istog

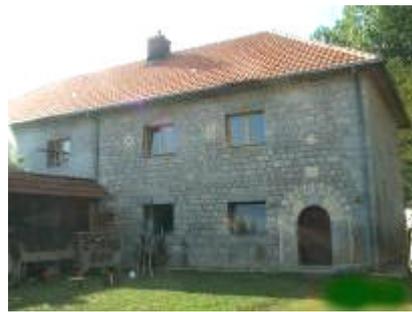
Fig.12: Altered and rebuilt kulla [2]
Kulla of N.Shatri, Tomoc, Istog
