JAMA Report Number 97-7530.68

Performance of Extensively Instrumented Buildings During the January 17, 1994 Northridge Earthquake

An Interactive Information System

by:
Farzad Naeim, Ph.D., S.E.
Director of Research and Development

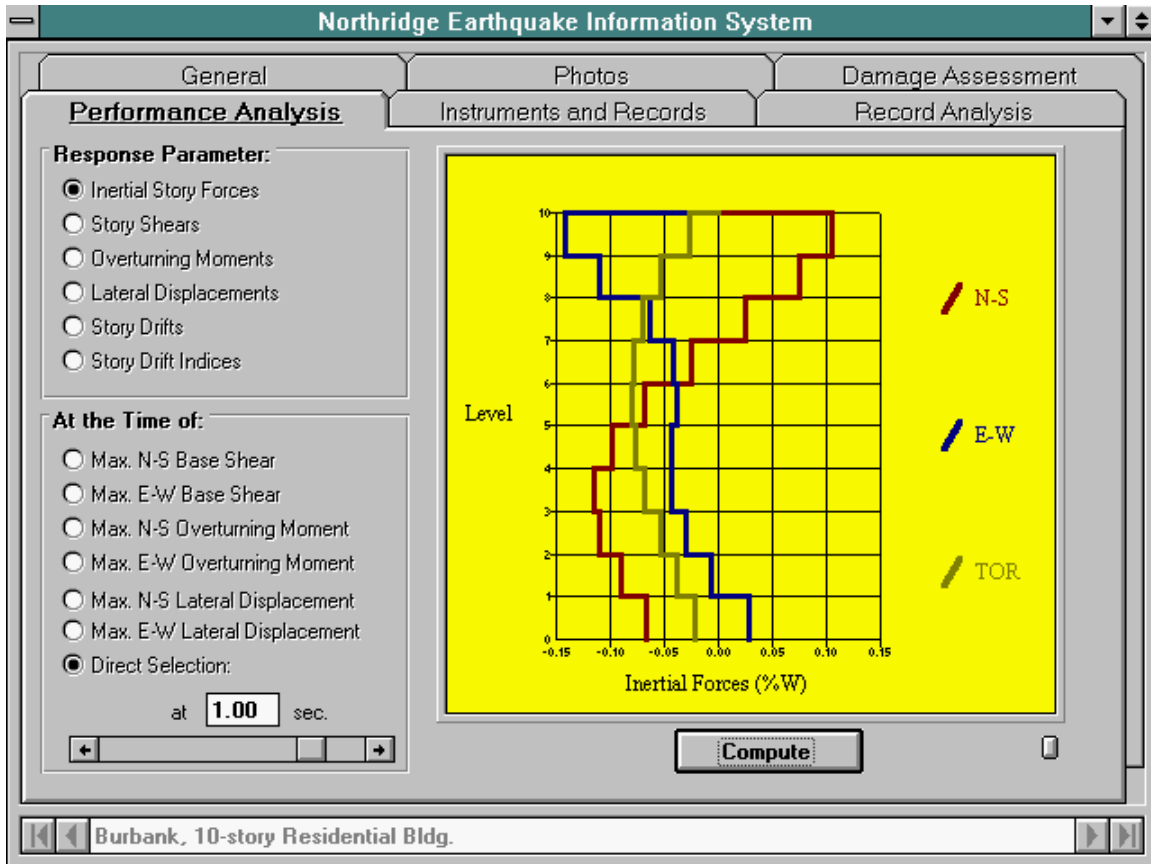
Figure 3-10. Approximate distribution of inertial story forces for a building at 1.00 seconds into the ground motion.

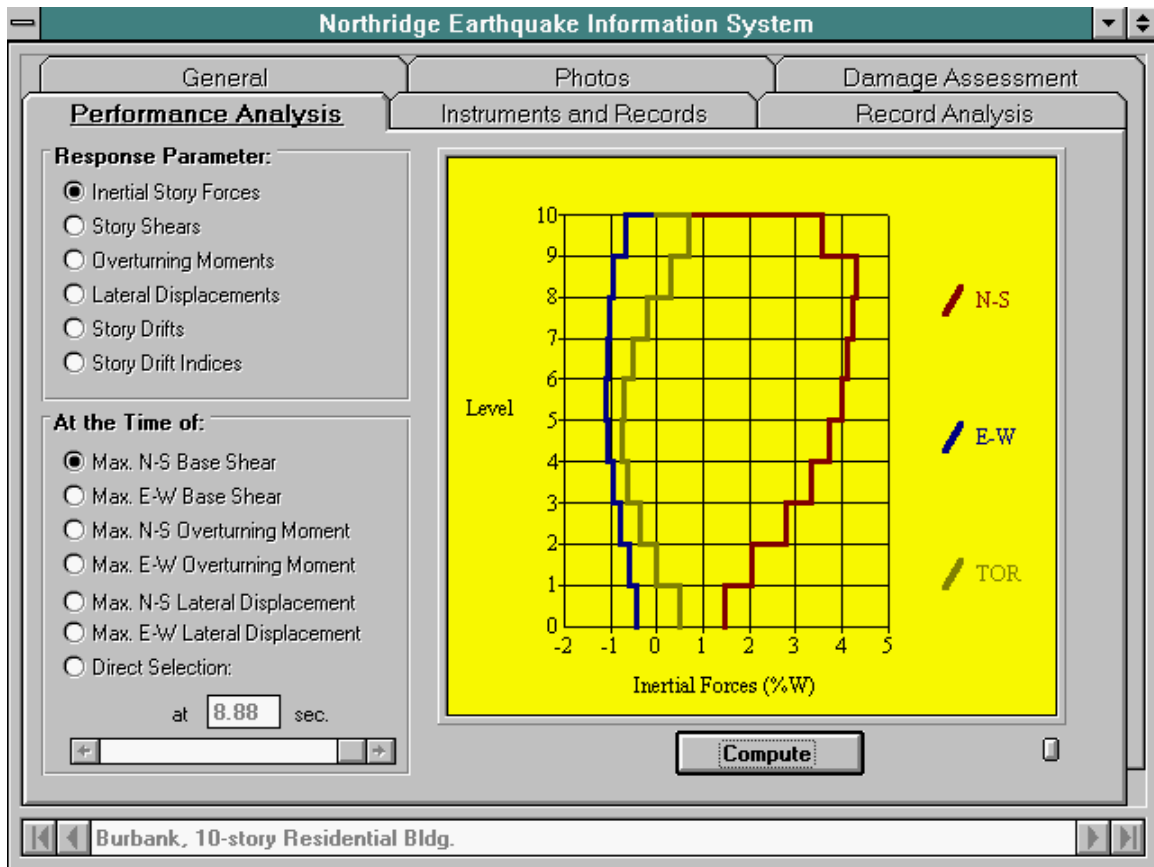
Figure 3-11. Approximate distribution of inertial story forces for a building at the time of maximum N-S base shear.

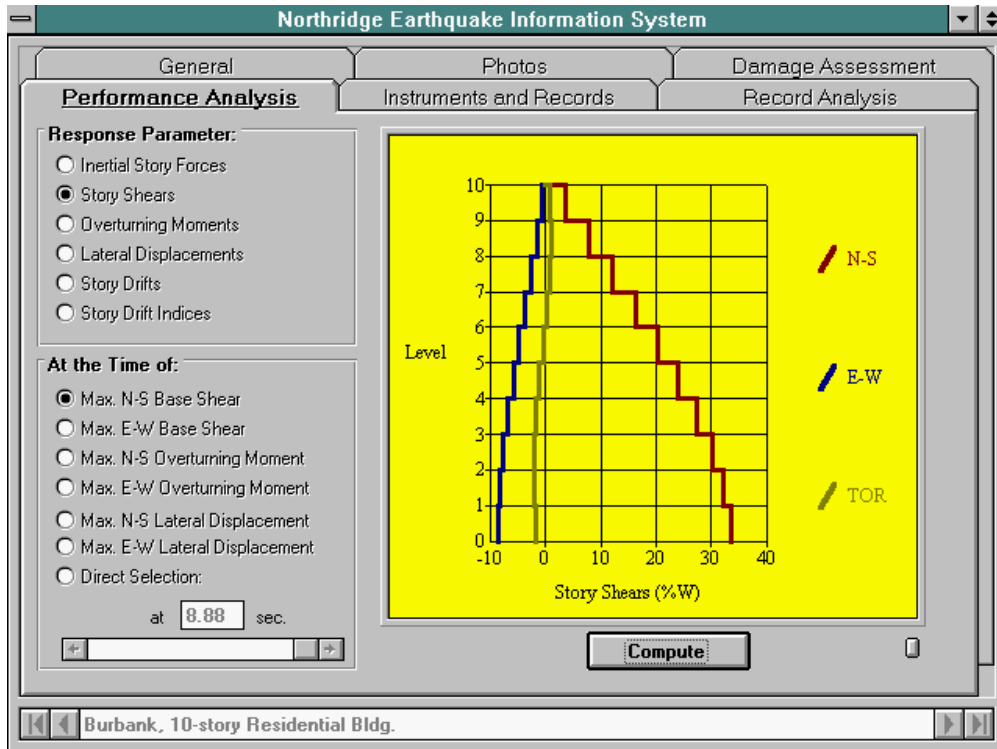
Figure 3-12. Approximate distribution of story shears for a building at the time of maximum N-S base shear.

Representative screens showing results of analysis for distribution story shears, lateral displacements and story drift ratios at various times of response maxima are shown in Figures 3-12, 3-13, and 3-14, respectively.

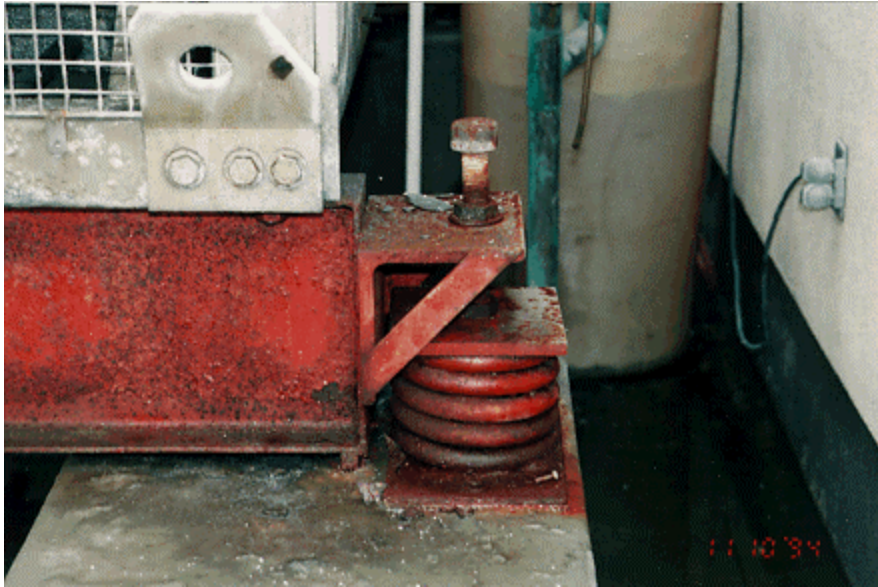
Figure 4-2. Mechanical equipment damage at the roof.

0.22W maximum base shear apparently experienced by the building in the E-W direction significantly exceeds both the 1976 and 1994 UBC strength design base shears of $1.4 \times 0.07W = 0.10W$ for UBC-76, and $1.4 \times 0.052W = 0.07W$ for UBC-94 (see Appendix B for backup calculations). At the time of writing this report, we are not aware of any inspections performed on the beam-column joints of this building. Our visit to the building and interviews conducted revealed no sign of structural damage. Most of the content damage was caused by tearing of a small water pipe at the penthouse which resulted in flooding of the building. The anchorage of a roof mechanical equipment was also damaged (Figure 4-2). Consult the information system for more photos and observations.

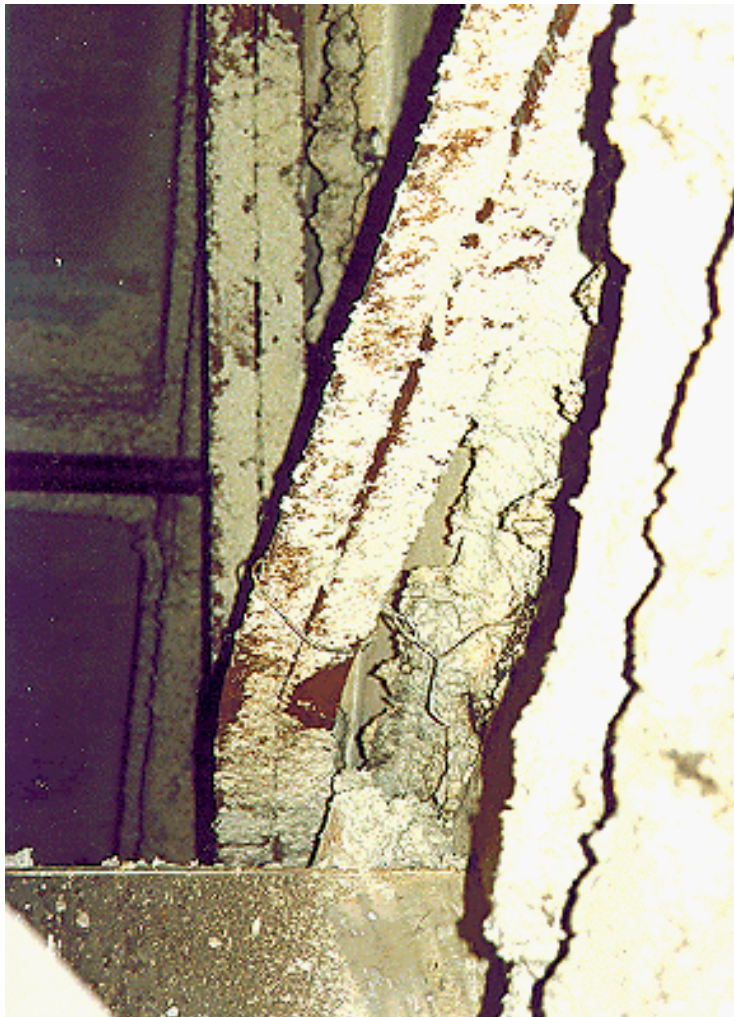
Figure 4-6. Buckled brace at the penthouse.

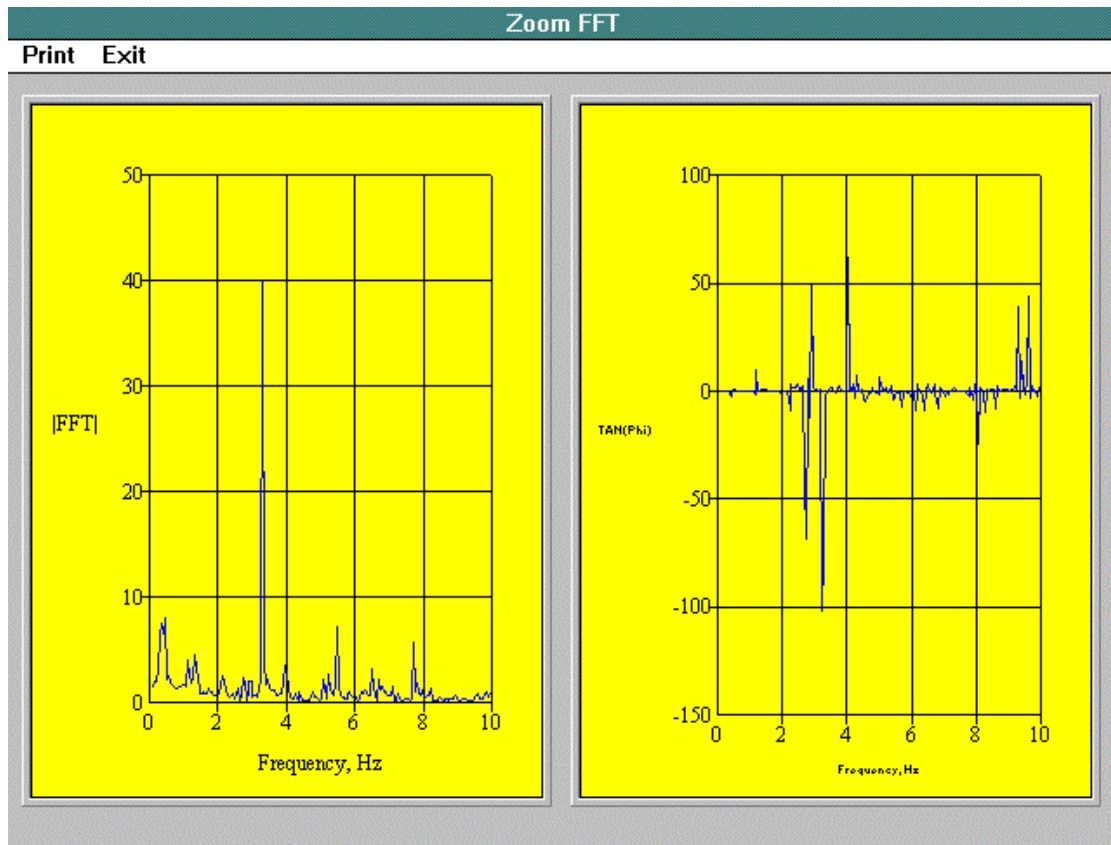
Figure 4-36. A zoomed view of an FFT analysis for the N-S response.

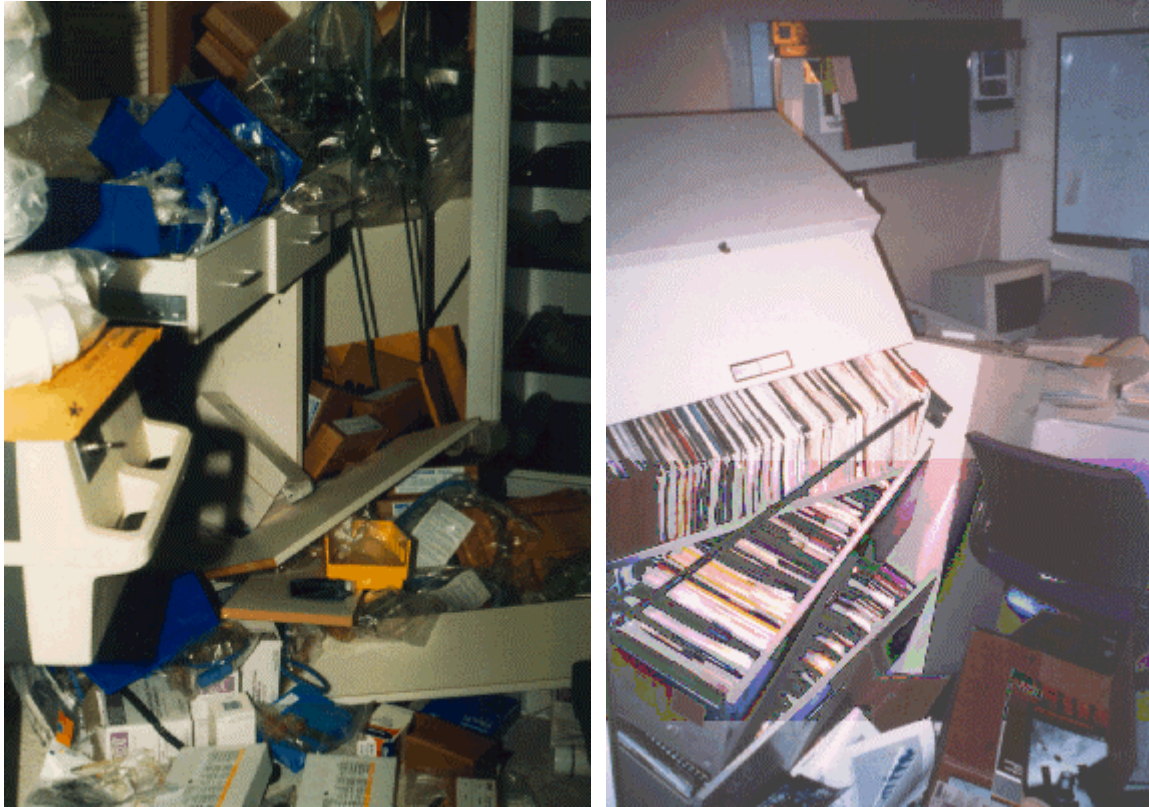
Figure 4-42. Examples of content damage

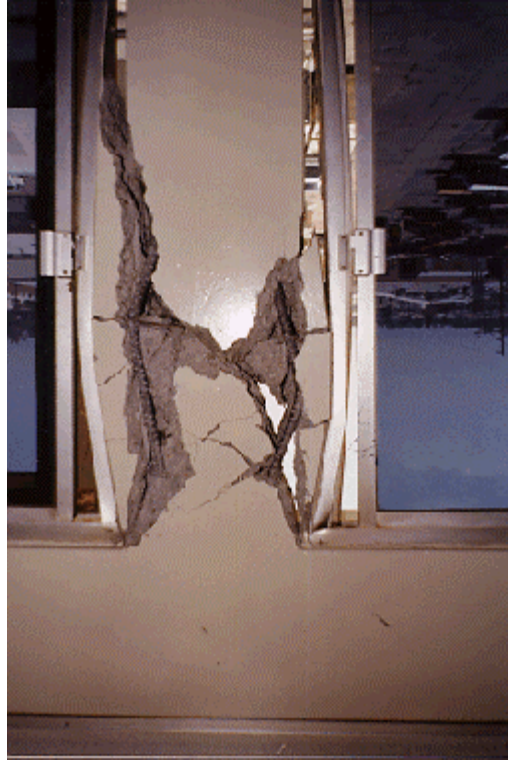
Figure 4-47. Shear failure of column at the fourth floor (view from inside).

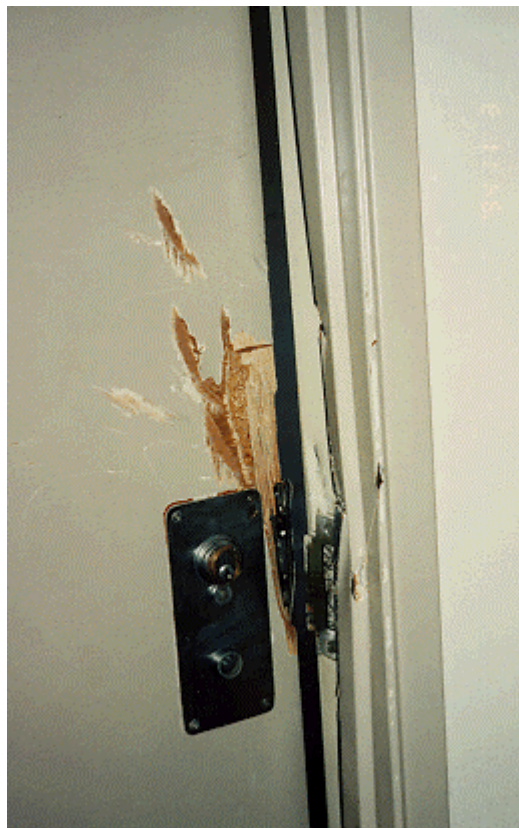
Figure 4-48. Doors had to be opened with sledge hammers.
