Pictorial Review

Cochlear Implant Failure: Imaging Evaluation of the Electrode Course

R. JAIN, S. K. MUKHERJI

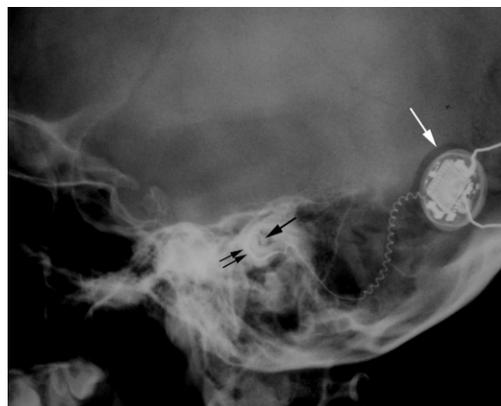
Fig. 1 – Skull radiograph showing the normal implant electrode positioning. Electrode in the basal turn (double black arrows) and its tip in the middle turn of cochlea (single black arrow). Cochlear implant device (single white arrow).

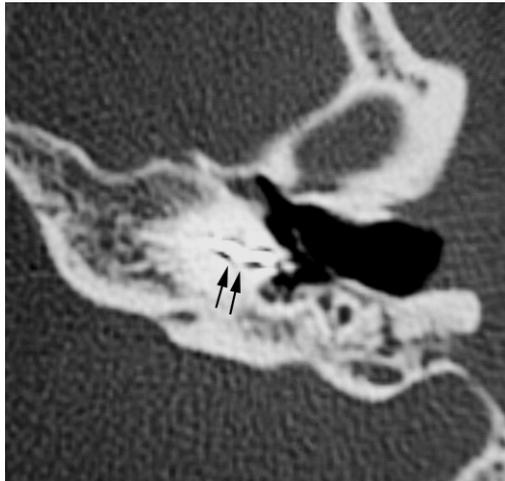
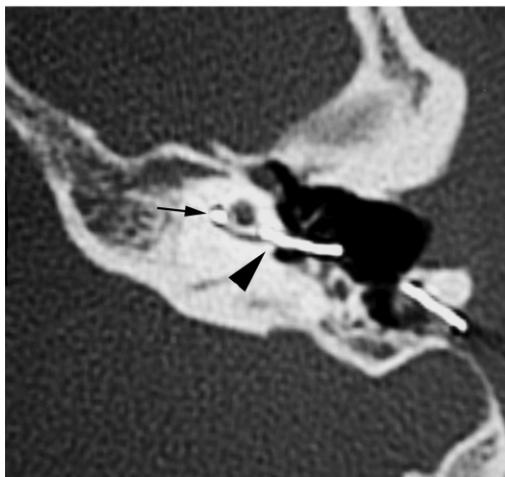
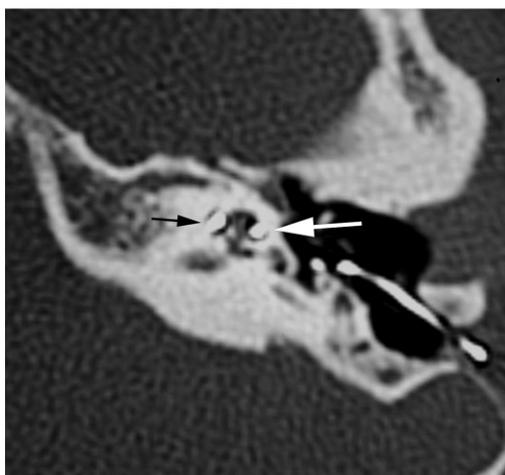
Fig. 2 – Axial CT showing the normal electrode positioning. (a) Electrode in the basal turn of cochlea (double arrows), (b) electrode entering the round window (arrowhead) and (c) electrode in the proximal part of basal turn (single black arrow) and at the junction of basal and middle turns (single white arrow).

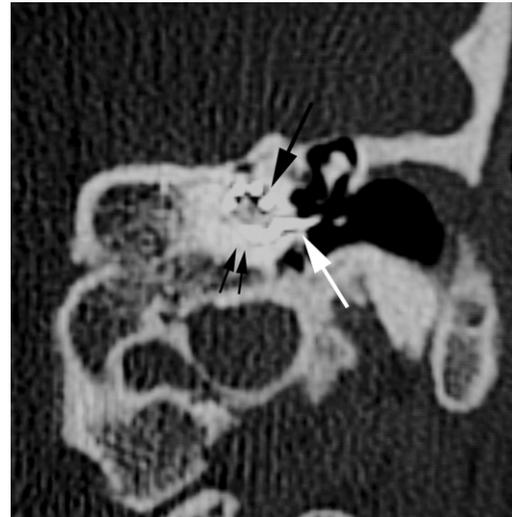
Fig. 3 – Coronal CT showing the normal electrode positioning. Electrode entering the round window (single white arrow), coursing through the basal turn (double black arrows) and its tip in the middle turn of cochlea (single black arrow).

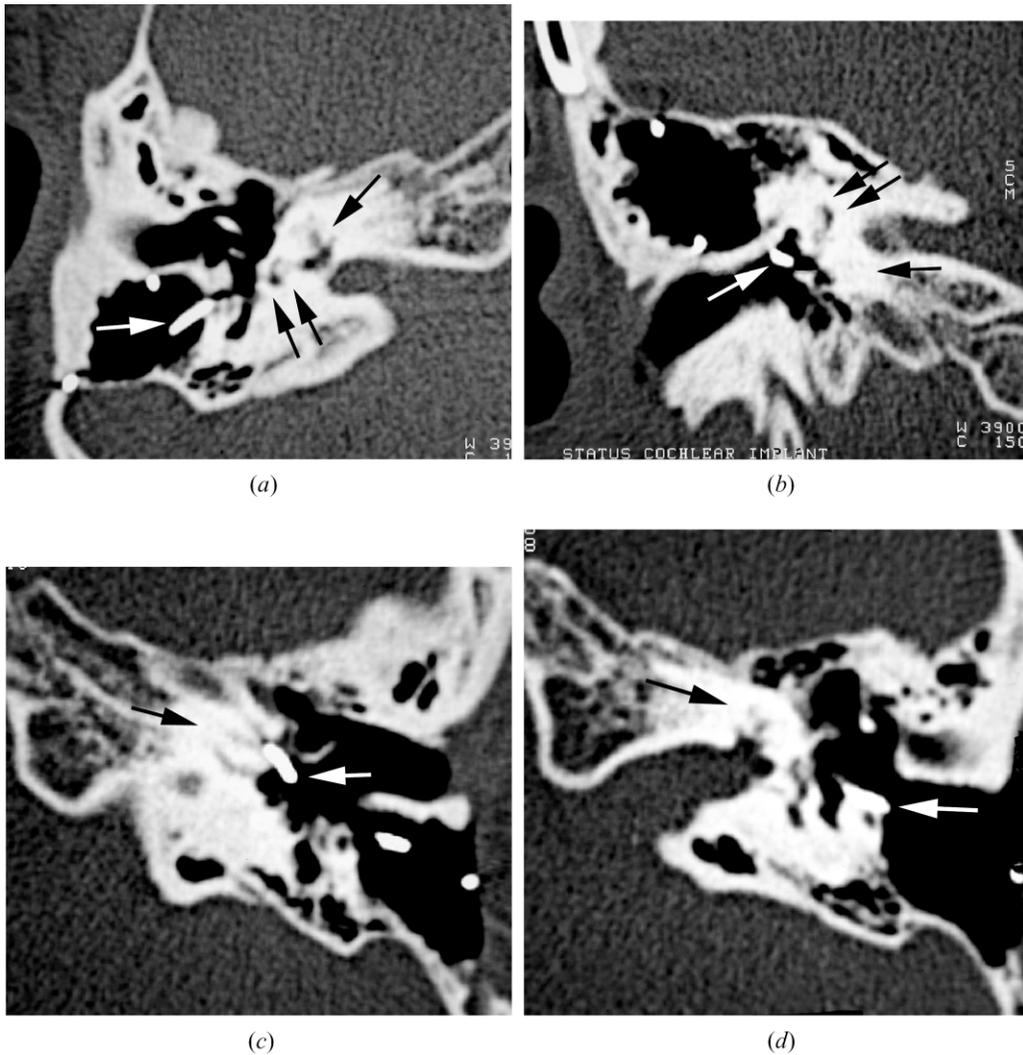
Fig. 4 – Case 1. (a) Axial and (b) coronal CT of right temporal bone showing complete ossification of the cochlea (single black arrow) and the vestibule (double black arrows). The electrode is not entering the basal turn of cochlea and is rather coiled in the middle ear cavity and mastoid bowl (single white arrow). (c) And (d) axial CT of left temporal bone in the same patient showing the electrode (single white arrow) in the middle ear cavity and not entering the ossified cochlea (single black arrow).

The electrode was seen coiled into the middle ear cavity and mastoid bowl on both the sides (Fig. 4). It could not be advanced into the cochlea on either side. The patient had bilateral post-meningitis ossification of the membranous labyrinth identified on CT. Cochlear ossification is not a true contraindication to implantation as a significant number of spiral ganglion cells survive even in case of severe ossification, however, it complicates electrode insertion. Post-meningitis labyrinthitis ossificans and otosclerosis are the most common causes of device failure related to abnormal electrode insertion apart from the experience of the operating surgeon [3,4]. Multiple

electrodes can be inserted by antero-inferior transpromontory cochleostomies in these patients. However, pre-implant plain films and HRCT cannot detect ossification in all patients. In one series, the ossification was found surgically in 40% of the cases and plain films were falsely negative in 27% while CT was falsely negative in 22% [5]. Therefore, many authors recommend pre-implant evaluation

with heavily T2-weighted MR images to detect any fibrosis or ossification not identified on CT in patients with post-meningitis deafness.

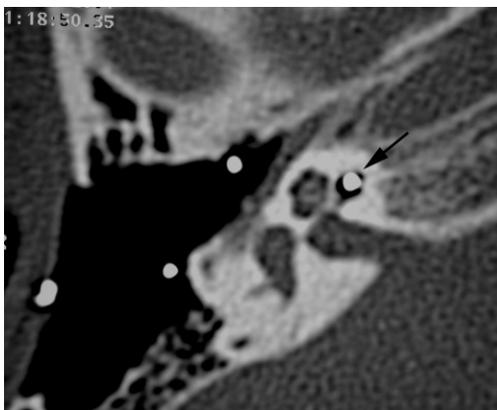
Fig. 5 – Case 2. Axial CT showing incomplete insertion of the electrode with its tip (single arrow) ending in the proximal part of the basal turn rather than in the middle turn.

The electrode was inserted through the round window, however, it could not be advanced completely (Fig. 5) due to surgically confirmed ossification in the proximal part of the basal turn. The patient presented with device failure, as the length of the electrode in the scala tympani was insufficient to obtain a properly functioning CI. The ossification was not detected on pre-implant CT.

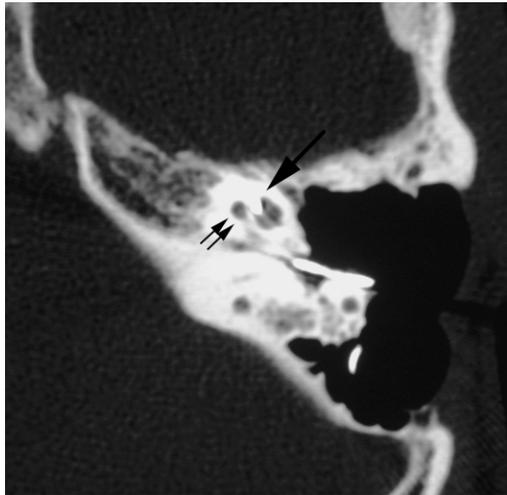
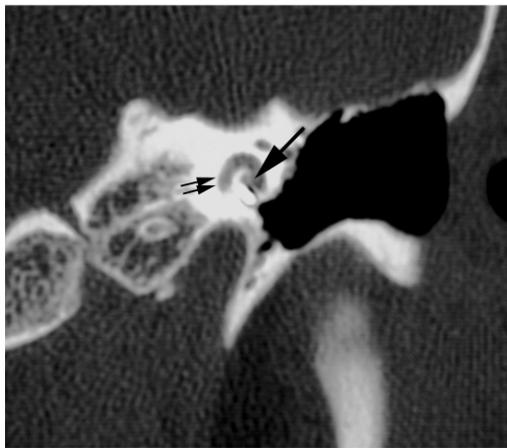
Fig. 6 – Case 3. (a) Axial and (b) coronal CT showing the electrode entering the middle turn of cochlea (single arrow) by piercing the bony septum between the basal and the middle turns rather than coursing through the whole of the basal turn (double arrows).

CT evaluation performed for device failure revealed that the

electrode entered the round window and directly extruded through the interscalar septum into the middle turn of cochlea rather than coursing the whole length of the basal turn (Fig. 6). The length of the electrode in the scala tympani was less than what is normally required for an active CI.

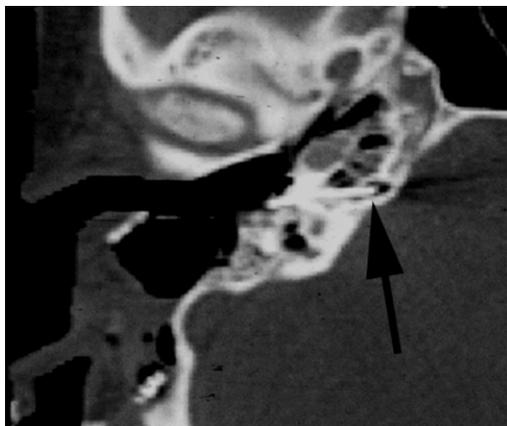
Fig. 7 – Case 4. Axial CT showing the electrode malpositioned into the cochlear aqueduct (single arrow).

The tip of the electrode was seen extending directly into the cochlear aqueduct (Fig. 7). The surgeon attempted to place the electrode directly through the round window rather than through a cochleostomy. The implant was removed without complications though the patient was at risk for developing cerebrospinal fluid (CSF) gusher syndrome. A “gusher” or rapid, profuse flow of CSF immediately upon entering the vestibule may be encountered occasionally, particularly in patients with anomalies such as enlarged vestibular aqueduct syndrome, common cavity, and wide internal auditory canal syndrome. These complications are best managed by packing the round window with fascia after implant insertion.

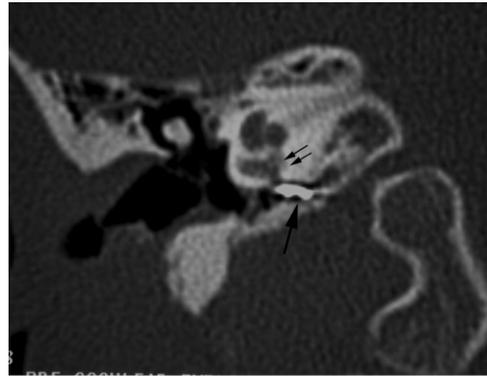
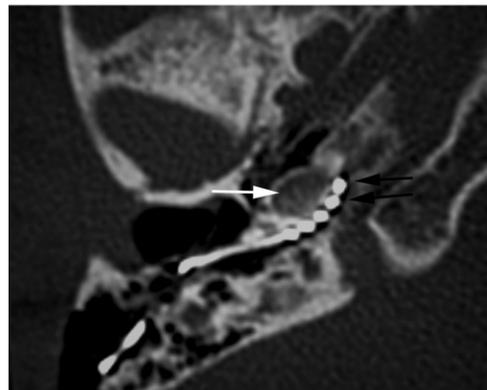
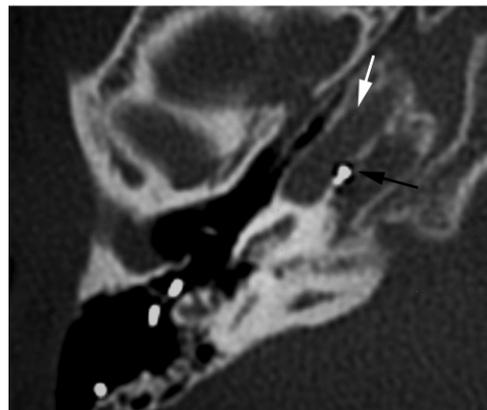
Fig. 8 – Case 5. (a) Coronal CT showing the electrode (single black arrow) missing the basal turn of cochlea (double black arrows). (b) And (c) axial CT showing the electrode (double black arrows) coursing postero-medial to the petrous carotid canal (single white arrow) before piercing the medial wall of carotid canal (single black arrow).

The tip of the electrode was identified in the petrous carotid canal in both patients. The petrous carotid artery is the closest to the cochlea at the junction of its vertical and horizontal segments. The bony septum between the cochlea and the carotid canal has been reported to be as thin as 0.2 mm [6,7]. This close proximity of the carotid artery to the basal turn becomes critical in cochlear drill-out procedure in patients with labyrinthitis ossificans. The carotid canal has a potential space as it also contains areolar tissue, venous plexus and parasympathetic nerves apart from the carotid artery, which can give a false sense of lack of resistance similar to the cochlea [8,9]. In case 5, the electrode travelled approximately 6–7 mm on the outside of the medial wall of carotid canal before piercing the medial bony wall (Fig. 8). In case 6, the electrode was seen tangentially missing the basal turn and pierce the bony septum close to the junction of vertical and horizontal segments of the petrous carotid artery (Fig. 9).

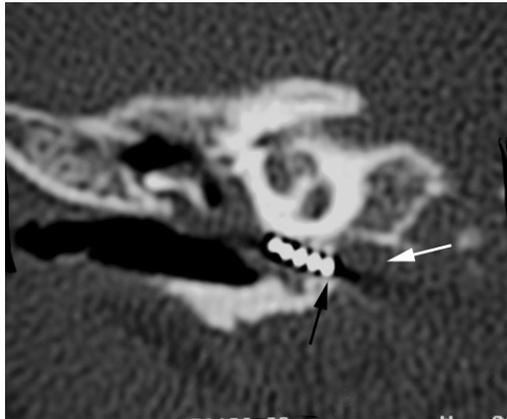
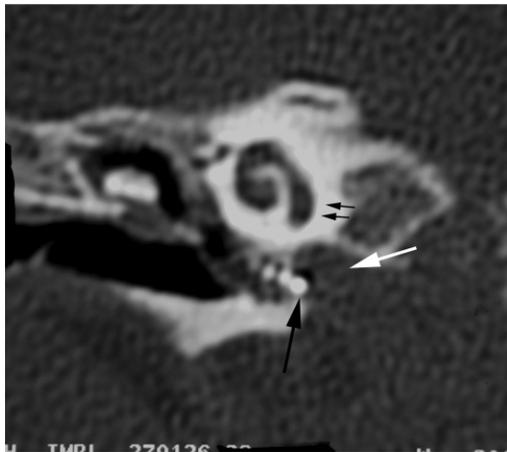
Fig. 9 – Case 6. (a) And (b) coronal CT showing the electrode (single black arrow) lying inferior to the basal turn of cochlea (double black arrows) and directly abutting the junction of the vertical and horizontal segments of the petrous carotid artery (single white arrow) after piercing the bony septum.

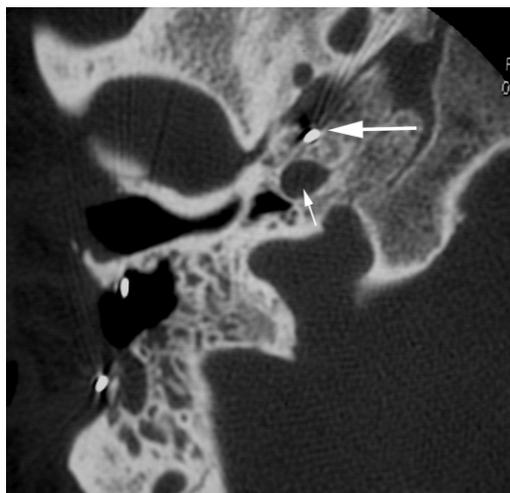
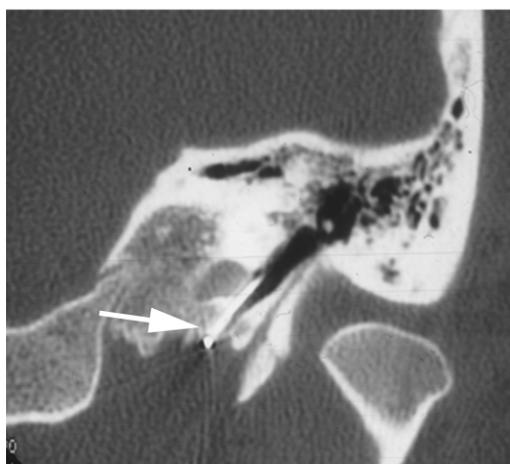
The electrode was seen entering the opening of the eustachian tube in the antero-inferior portion of the middle ear cavity (pro-tympanum). The electrode coursed through the eustachian tube and its tip was seen below the skull base in the nasopharynx (Fig. 10).

Fig. 10 – Case 7. (a) Axial CT showing the electrode in the eustachian tube (large white arrow) anterior to the carotid canal (small white arrow). (b) Coronal CT showing the tip of the electrode projecting into the nasopharynx (white arrow) through the eustachian tube.

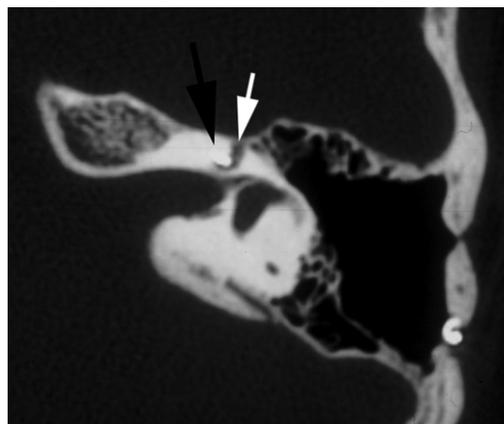
The tip of the electrode was seen abutting the labyrinthine part of the facial nerve. The patient complained of facial

twitching after cochlear device implantation. The distance between the basal turn of cochlea and the facial nerve is less than 0.5 mm and because of this close proximity the facial nerve trunk can be stimulated by electric signals from the implanted electrode [7]. In our case, however, the electrode was directly abutting the labyrinthine part rather than just stimulating the facial nerve due to the close proximity (Fig. 11). Facial nerve stimulation was seen in 3% of children in one study, most of who had post-meningitis deafness [1]. In adults this phenomenon occurs mainly in patients with otosclerosis or otospongiosis and is thought to be due to bone demineralization [10,11].

Fig. 11 – Case 8. Axial CT showing the electrode (black arrow) abutting the labyrinthine part of the facial nerve (white arrow).
