The Current State of Disc Cutter Design and Development Directions

Joe Roby
The Robbins Company, Kent, Washington

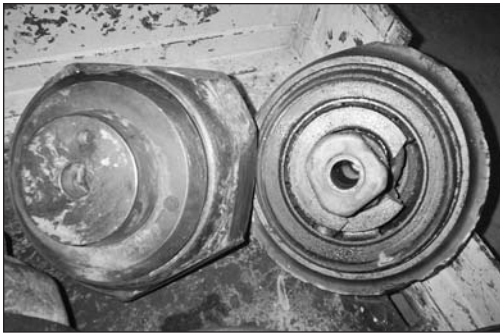
Figure 4. The cutter on the left quit turning and wore flat. The cutter on the right experienced a massive bearing failure that resulted in a damaged seal retainer and shaft.

When a cutter assembly fails catastrophically (see Figure 4), it is never easy to determine how the failure was initiated. A post mortem inspection is the only way to diagnose and remedy the problems. There is always some amount of doubt as to why the cutter assembly is full of tunnel muck, which results in some classic questions. Did a bearing(s) fail, allowing misalignment and letting muck pass the seals? Or did the seals fail and allow contamination of the bearing? Fortunately most cutter/bearing failures are not this severe and are usually detected and repaired/replaced before they get to this point.

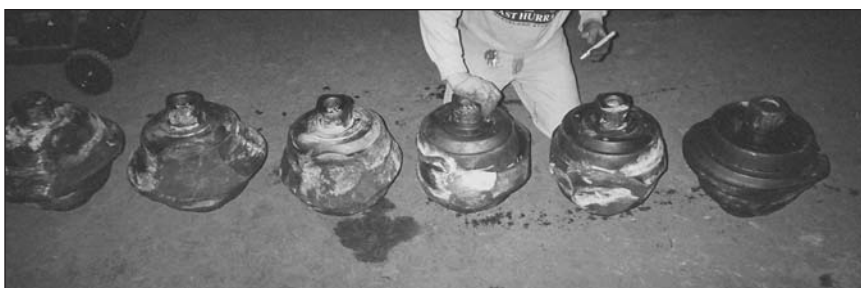
Figure 5. Example of a cutter wipeout phenomenon

Another problem with the early deployment of the 19-inch cutter was a tendency to be susceptible to multiple cutter, wipeout failures. In effect, if one cutter failed catastrophically (i.e., broken ring, failed bearing) there was a tendency for the cutters in the paths next to that cutter to fail also, and the failure

pattern might repeat until 5 to 10 cutters were failed in a group. This was eventually identified to be a result of the cutter spacing and was corrected over the following years. As cutterhead design evolved, 19-inch cutter data was collected from the field. With improvements made over the years in cutter rings, 19-inch ring life became very good and the weak link in the cutter seemed to be the bearing, once the strongest part of the design.

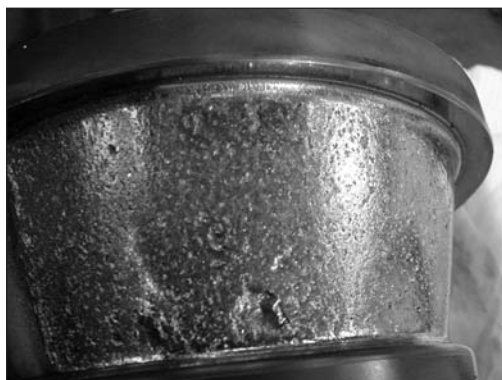
Figure 6. Close up of spalling in the load zone of the inner race

- Spalled or grooved raceways (see Figure 6)
- Worn or broken roller cage
- Damaged rollers
- Brinelling/false brinelling
