OSTEOLYSIS IN FAILED TOTAL KNEE ARTHROPLASTY: A COMPARISON OF MOBILE-BEARING AND FIXED-BEARING KNEES

BY CHUN-HSIUNG HUANG, MD, HON-MING MA, MD,
JIANN-JONG LIAU, PHD, FANG-YUAN HO, MS, AND CHENG-KUNG CHENG, PHD

Investigation performed at the Department of Orthopaedic Surgery, Mackay Memorial Hospital, and the Orthopaedic Biomechanics Laboratory, Institute of Biomedical Engineering, National Yang Ming University, Taipei, Taiwan

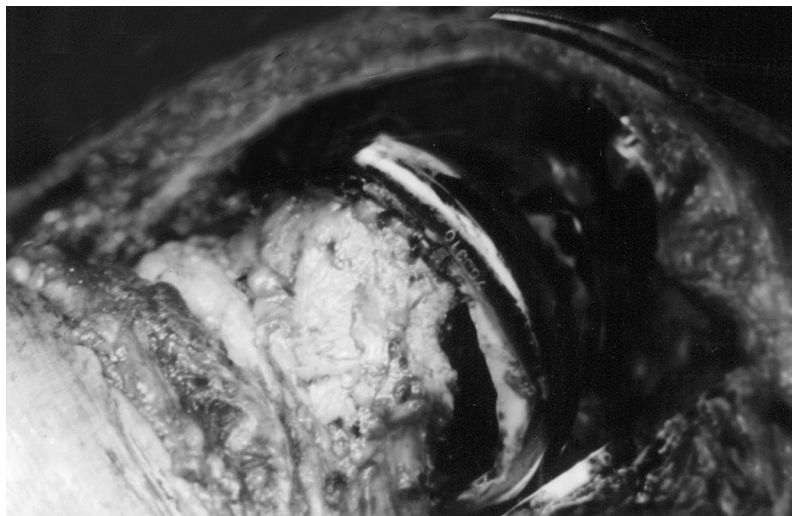
Fig. 1-A An osteolytic lesion was present in the posterior aspect of the femoral condyle at surgery. **Fig. 1-B** The lesion was not recognized on the prerevision radiograph.

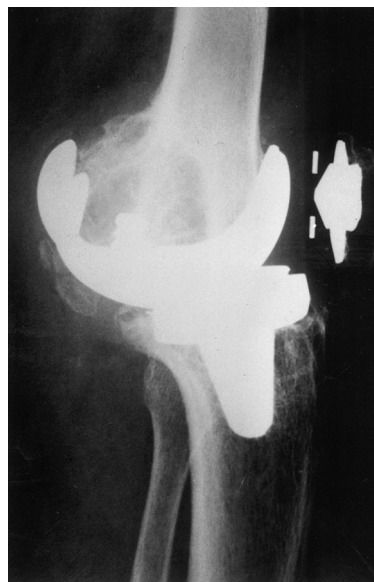
Fig. 2-A

An osteolytic defect in the femoral condyle was identified on a radiograph made before the revision (Fig. 2-A) and at the time of the revision surgery (Fig. 2-B).

Radiographic evidence of osteolysis in the proximal part of the tibia and the patella was associated with intraoperative observation of osteolysis. However, of the seventeen knees (thirteen in the mobile-bearing group and four in the fixed-bearing group) with defects in the femoral condyle that were identified intraoperatively, only five had had osteolysis on prerevision radiographs (Fig. 2).
