Biodeterioration of calcareous and granitic building stones in urban environments

NICK SCHIAVON

Abstract: Scanning electron microscopy in secondary (SEM) and back-scattered (BSEM) mode associated with energy-dispersive X-ray spectroscopy has been used to investigate decay features associated with biological colonization of calcareous and granitic building stones in monuments and rock outcrops in the UK, Portugal and Spain. In combination with physical decay caused by lichen hyphae penetrating the stone substrate, this study reveals how chemical attack by organic acid exudates derived from metabolic activity of lichens and leading to the crystallization and growth of inorganic salt compounds within the stone microfabric is contributing to the destruction and weakening of the building stone surface. BSEM analysis is particularly useful in showing extensive dissolution and corrosion of mineral surfaces underneath biological patinas. Both Ca-sulphate (gypsum) and Ca-oxalate (weddelite) precipitates are clearly associated with the presence of fungal hyphae and bacterial activity particularly in the case of calcareous building stones; the Ca-oxalates present in the example examined are

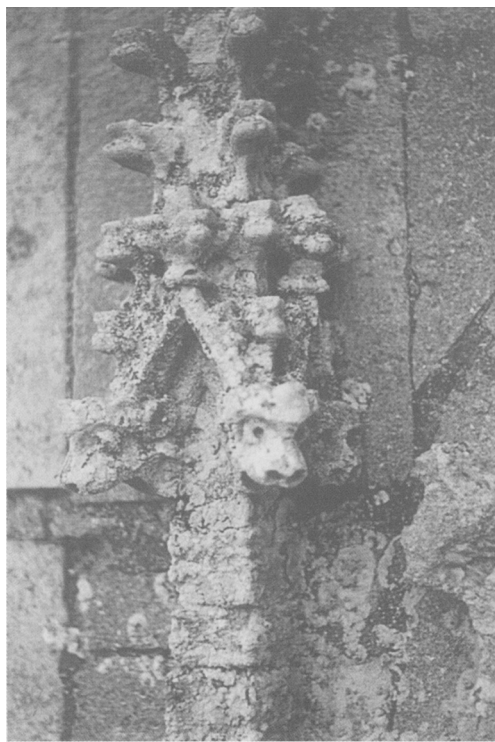
Fig. 1. Lichen colonization of chalk building limestone. Ely Cathedral, UK.

Surface weathered samples with or without a macroscopically evident biological cover (i.e. lichen colonization; Fig.1) of calcareous and granitic building stones have been collected from the following monuments/buildings and locations.

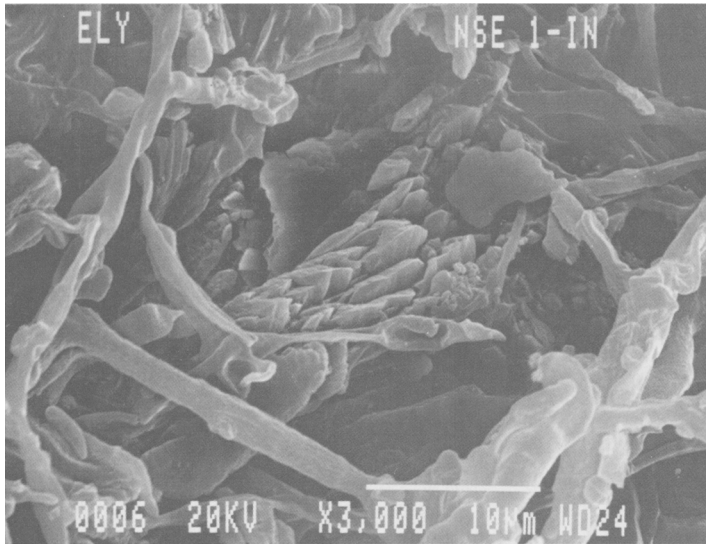
Fig. 2. SEM micrograph view of the exposed surface showing thick and dense network of lichen hyphae and rhizines on limestone. Ely Cathedral, UK.

Examination of the outer surface of the weathered stone colonized by epilithic lichens shows a thick and dense network of lichen rhizines and thalluses, masking the limestone–patina interface (Fig. 2). Associated with algal filaments, amorphous and well crystallized Ca-rich precipitates can be found. Crystals have been identified by BSEM and EDS (C/O ratio and Mg content) and by X-ray diffraction (XRD) as calcite (Ca-carbonate) and weddellite (Ca-oxalate). Clusters of Ca-oxalate crystals with bipyramidal habit and tetragonal symmetry are particularly frequent on the outer portion of the lichenous patinas within the lichen medulla and in an extracellular position (Fig. 3). Ca-sulphate (gypsum) is also present as small crystalline aggregates but is not common. Spherical aluminosilicate particles typical of air pollution from fossil fuel combustion together with quartz and K-feldspar particles from soil dust are present but not abundant. The growth of calcium oxalate crystals does not seem to affect the substrate directly but the contact between the

- (b) Secondary electron microscopy of rough surfaces of patinas reveals extensive biocolonization with cyanobacteria and lichen elements (hyphae, medulla, rhizines, fruiting bodies) adhering to the stone substrate (Figs 2, 5, 7).

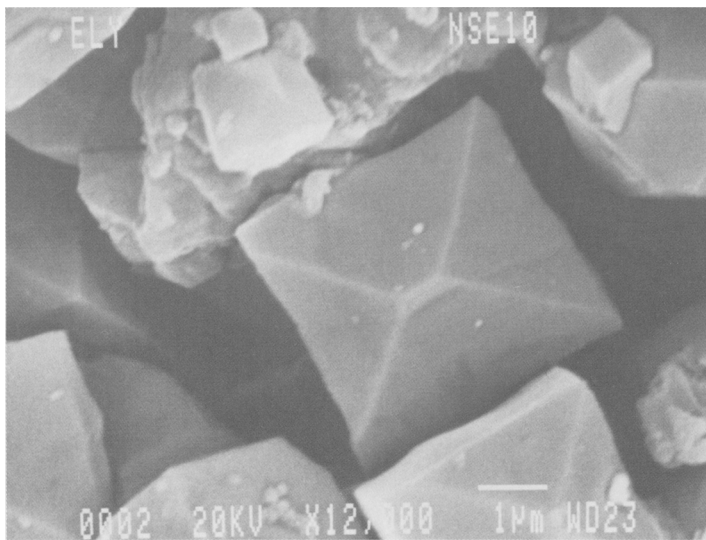
Fig. 3. SEM micrograph view of the exposed surface showing clusters of well formed authigenic Ca-oxalate crystals with bipyramidal habit within lichen biofilm on limestone. Ely Cathedral, UK.

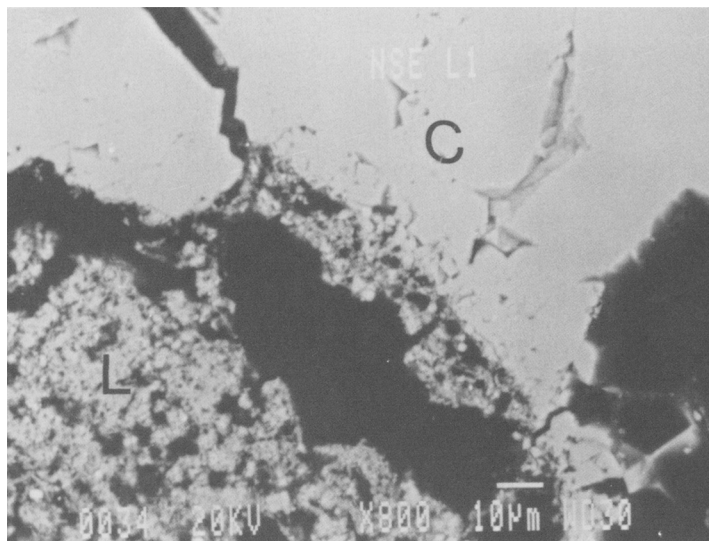
Fig. 4. BSEM micrograph of limestone–lichen patina interface. Calcite of the stone substrate (C) shows evidence of dissolution at the contact with biofilm (L). Ely Cathedral, UK.

patina and the underlying limestone shows episodes of dissolution and corrosion affecting in particular calcite grains (Fig. 4).

A Ca-rich substrate such as limestone provides Ca ions leading to the widespread precipitation of Ca-oxalate, Ca-carbonate and amorphous Ca-rich aggregates (Fig. 4). Of particular interest to stone conservators and scientists is the genesis of calcium oxalate films on works of art and monuments with the presence of Ca-oxalate being ascribed either to the degradation of past protective treatments applied to the stone (Lazzarini & Salvadori 1989), or to oxalic acid present as an air pollutant in urban areas (Saiz-Jimenez 1989), or to oxalic acid derived from metabolic activities of lichens and its reaction with Ca-bearing materials (DelMonte *et al.* 1987). The SEM evidence presented in this study showing extracellular precipitation of well formed, authigenic crystals of weddellite within lichen thalli growing on a limestone substrate supports the biological mechanism advocated by the latter authors; furthermore, the dissolution features present at the interface of lichen–Ca-bearing building stone suggests that the oxalate crystals grow at the expense of the limestone substrate. Despite the fact that biologically mediated Ca-oxalate has been found on rocks with low Ca content, the predominantly sodic plagioclasic composition of the granitic rocks investigated in this study does not seem to have favoured the precipitation of well-formed Ca-oxalate crystals which in fact have not been detected. Nevertheless, EDS analysis has shown a certain degree of Ca enrichment in amorphous deposits in the patinas; this Ca may derive from Ca-feldspars (plagioclases) in the granite (DelMonte *et al.* 1996), although, in this case, an external source such as leaching from adjacent mortar joints is more likely (Casal-Porto *et al.* 1989; Schiavon 1993).

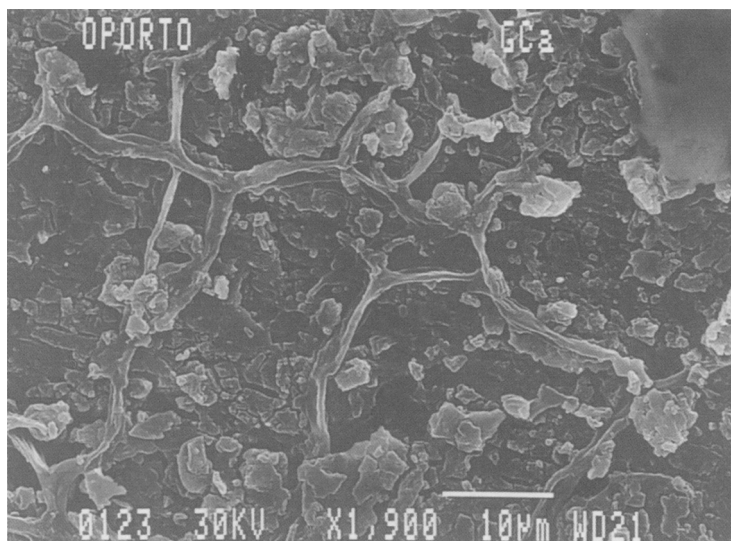
Fig. 5. SEM micrograph view of the exposed surface showing widespread colonization of K-feldspar by algal filaments leading to desegregation of granite superficial microfabric. Igresia dos Carmo, Oporto, Portugal.

intragranular cracks in quartz crystals, and resulting in intense desegregation of the stone fabric (Fig 5). Besides this decay action of a physical nature, episodes of dissolution/etching of mineral grains and precipitation of amorphous and crystalline compounds intimately associated with biological activity are evidence for biochemically derived decay. Etching pits and grooves and dissolution cavities are particu-

- (c) Decay features such as desegregation of the stone microfabric underneath weathered surficial patinas in urban areas (Figs 5, 6) are very similar to the ones observed in the unpolluted reference location in Dartmoor (Figs 10, 11) where there is no contribution to decay from air pollution.

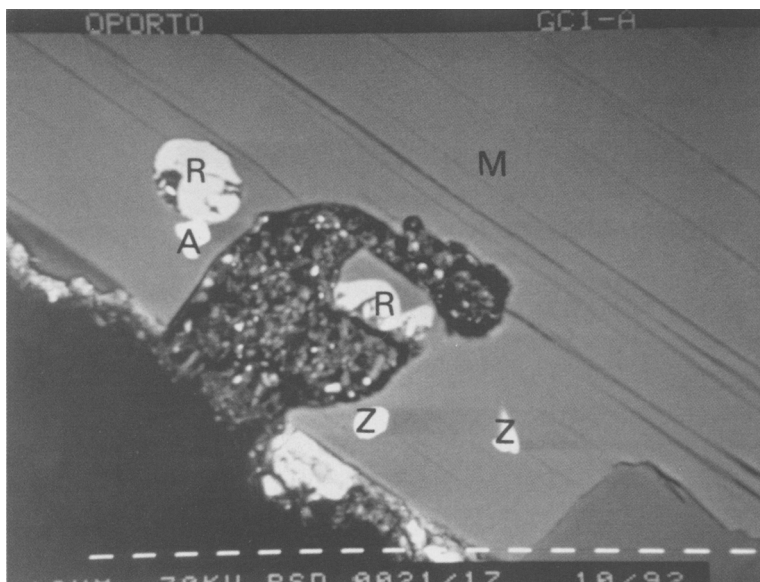
Fig. 6. BSEM micrograph of biological patina–granite interface. Weathering patina on granitic substrate shows selective dissolution of muscovite mica (M) relative to zircon (Z), allanite (A) and rutile (R) inclusions. Note how dissolution front cuts across cleavage planes in muscovite. Torre dos Clerigos, Oporto, Portugal.

larly frequent on feldspars and muscovite micas (Fig. 6) but are common also in more chemically resistant quartz surfaces and on other less soluble accessory granite minerals such as apatite. Chemical weathering fronts do not proceed preferentially along pre-existing mineral weakness points and lines (such as fractures and cleavage planes) but often cut across mineral cleavage planes (Fig. 6). Dissolution

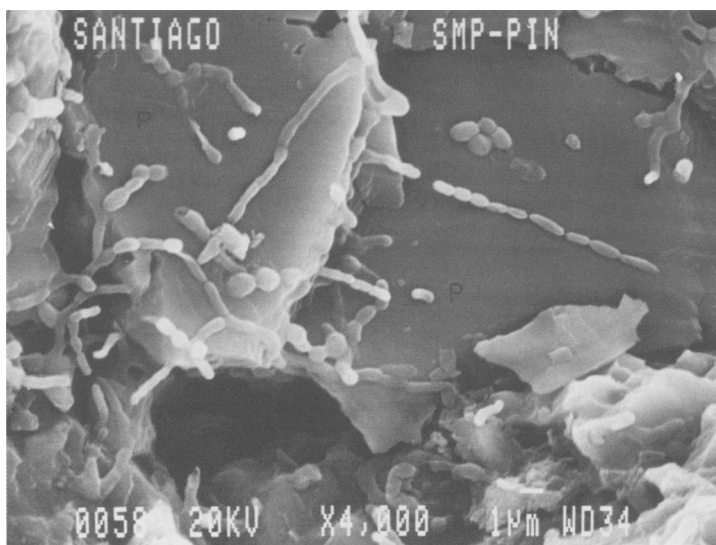
Fig. 7. SEM micrograph view of the exposed surface showing biocolonization by cyanobacteria of biotitic mineral surface leading to the precipitation of biofilm of polysaccharide nature. Monasterio de S. Pinario, Santiago de Compostela, Spain.

P-rich compounds, resembling polysaccharide gels (Fig. 7). The crystallization of gypsum with authigenic crystals displaying the typical monoclinic habit is often localized on algal filaments, suggesting a biologically mediated mechanism

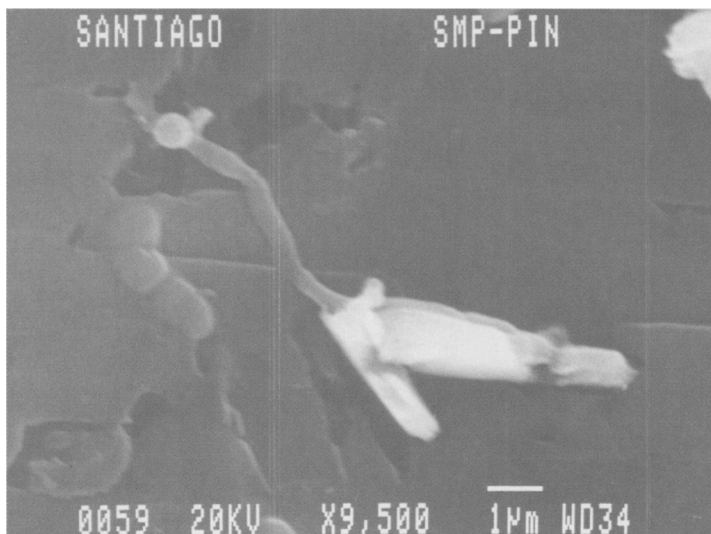
Fig. 8. SEM micrograph view of the exposed surface showing authigenic gypsum crystals nucleating on lichen hyphae on etched albite surface. Monasterio de S. Pinario, Santiago de Compostela, Spain.

of growth (Fig. 8). Dark patinas often displaying a reddish colour in field samples, a feature common to many sampling sites, reveal an Fe-rich composition under EDS analysis and a faintly laminated microstructure under BSEM (Fig. 9) resembling that of algal growth; underneath these thin dark patinas an area of intense decay of the granitic substrate is commonly present.

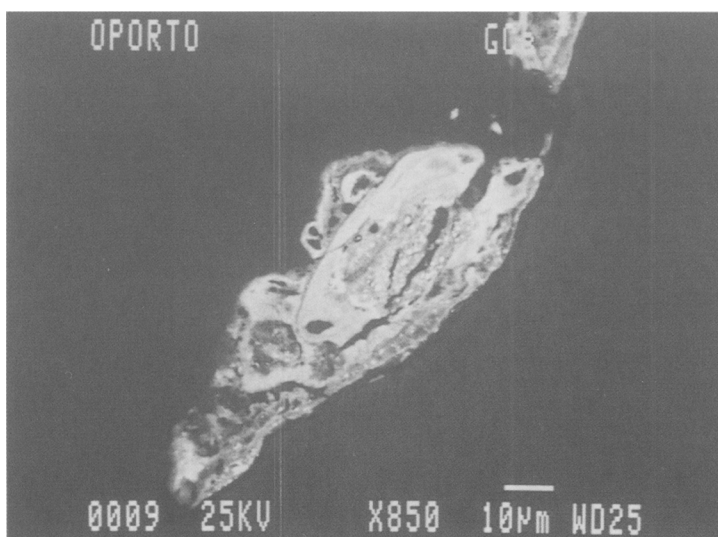
Fig. 9. BSEM micrograph of biological patina–granite interface. Dark, thin iron-rich (brighter areas) patinas on albite surface display faint lamination pattern and chemical attack of granitic substrate. Torre dos Clerigos, Oporto, Portugal.

- (a) Back-scattered electron microscopy detailing the microfabric of the patinas shows the development of a laminated 'stromatolitic' texture (Fig. 9) reminiscent of desert varnish deposits for which a bacterially mediated mechanism of growth is widely assumed (Krumbein & Jens 1981; Nagy *et al.* 1991).

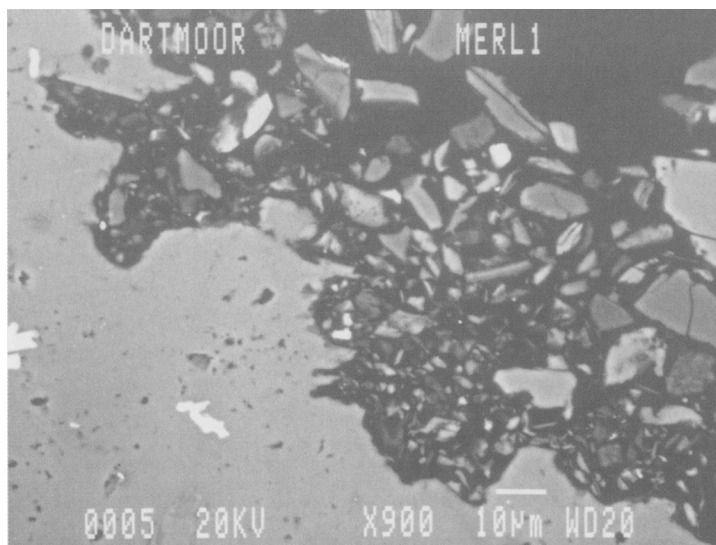
Fig. 10. BSEM micrograph of lichenous patina–granite interface. Note deep chemical corrosion of quartz with incorporation of quartz fragments in growing weathering patina. Dartmoor National Park, UK.

desegregation of the granite surface with incorporation of fragmented material clearly derived from the building stone underneath into the biological patina. In fact, the patina is largely made up of fragments of granitic minerals, i.e. micas, feldspars and quartz (Fig. 10). The depth of the weathered zone from the lichen–stone interface ranges from few micrometres up to 0.5 cm. The EDS chemical analysis of these patinas confirms an elemental composition consistent with that typical of granite apart from higher levels of Ca and Fe. Iron-oxidized outer rims are often visible on weathered granite minerals. Besides physical decay particularly active on biotite crystals where it causes the splitting of biotite flakes along cleavage planes, the electron microscopy investigation shows evidence for etching and chemical attack on quartz (Fig. 10), feldspar and biotite (Fig. 11) surfaces; etch pits are common and the examination of thin sections previously treated with concentrated H_2O_2 to remove the organic fraction, clearly shows the casts of dissolution trenches and pits on mineral surfaces (Fig. 12).

The Si-rich and Al-Si amorphous deposits are mainly associated with feldspar and quartz mineral surfaces which again show dissolution features and evidence of leaching (Figs 10, 12). Eckhardt (1985) has shown in leaching experiments using 0.1M oxalic acid, substantial extraction of K from micaceous silicate minerals. Microbially produced organic acids and complexing compounds are also known to increase the solubility of silicate and quartz minerals (Bennett & Siegel 1987). Taking into account the widespread occurrence of iron oxides in the investigated patinas, it is interesting to note that redox reactions involving iron have been reported to lead to increased solubility of quartz in laboratory experiments (Morris & Fletcher 1987), probably because of breakdown of an ultra-thin ferrous iron/silica complex formed on the quartz surface with accompanying liberation of silica. On the other hand, quartz solubility is also greatly increased under alkaline conditions (pH > 9) and studies have shown that conditions resulting from the production of alkaline compounds (ammonia and sodium carbonate) by micro-organisms and lichens can promote the solubilization of silica (Robert & Berthelin 1986; Leite-Magalhes & Sequeira-Braga 2000).

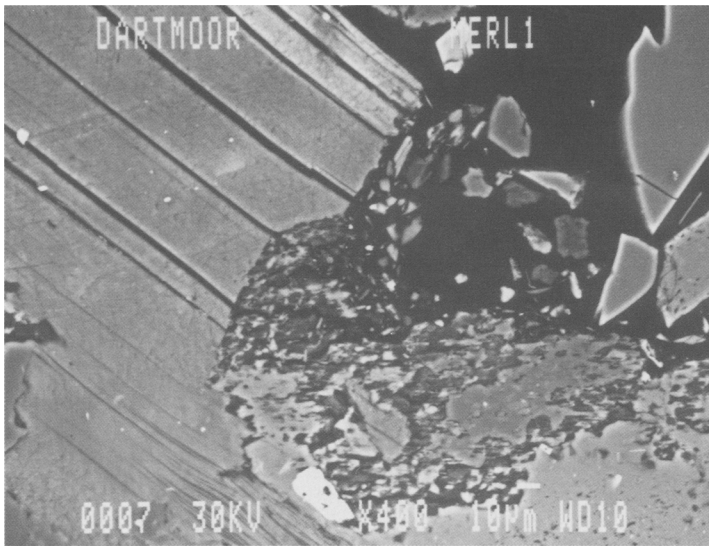
Fig. 11. BSE micrograph of lichenous patina–granite interface. Physical and chemical decay of biotitic mineral substrate underneath the biological cover leads to the desegregation of the stone fabric. Dartmoor National Park, UK.

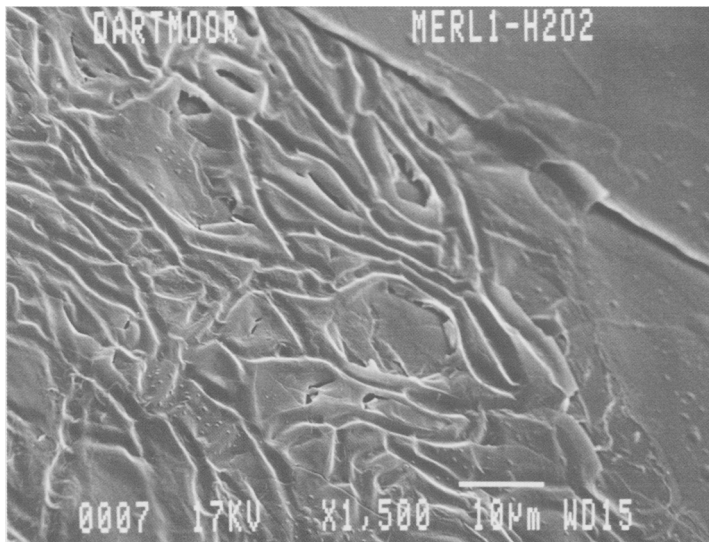
Fig. 12. SEM micrograph view of the surface of the granite after treatment with H₂O₂ to remove the biological patina. Dissolution trenches left on mica surface after removal of the organic cover are clearly visible. Dartmoor National Park, UK.
