STRUCTURES TECHNICAL MEMORANDUM 400

FLUTTER CLEARANCE TESTS ON A TRANSAVIA  
PL-12/T-400 SKYFARMER

SUMMARY

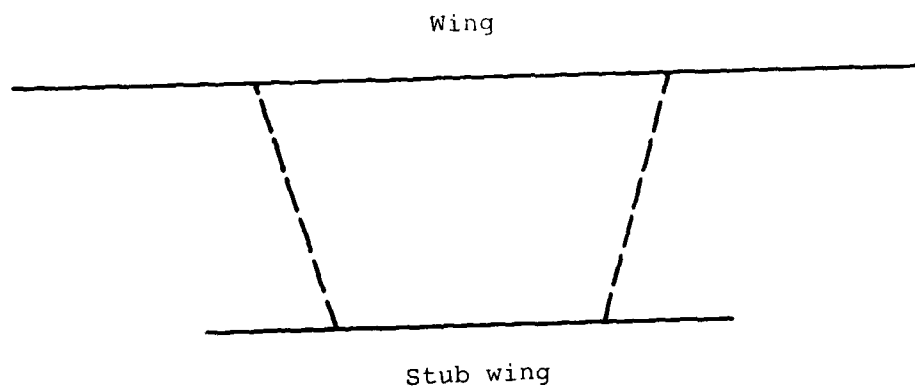
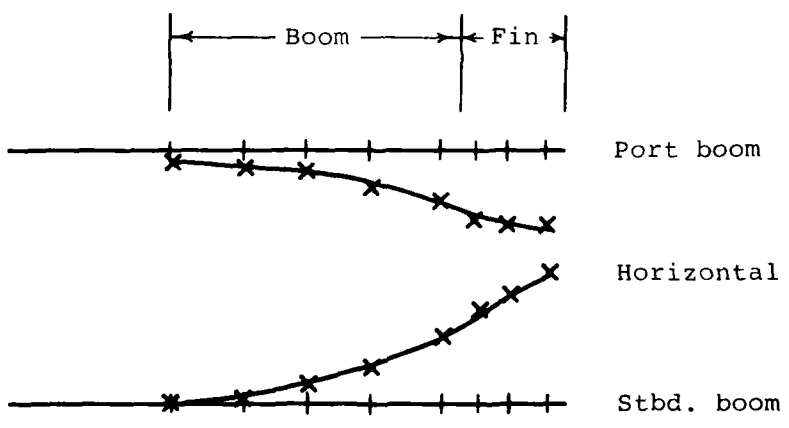
FIG. 8(a) MODE AT 3.8 Hz

**Mode at 3.8 Hz. (Fig 8) -**

This mode is the symmetric lateral boom bending mode and could be excited quite readily using a single shaker on the port fin.

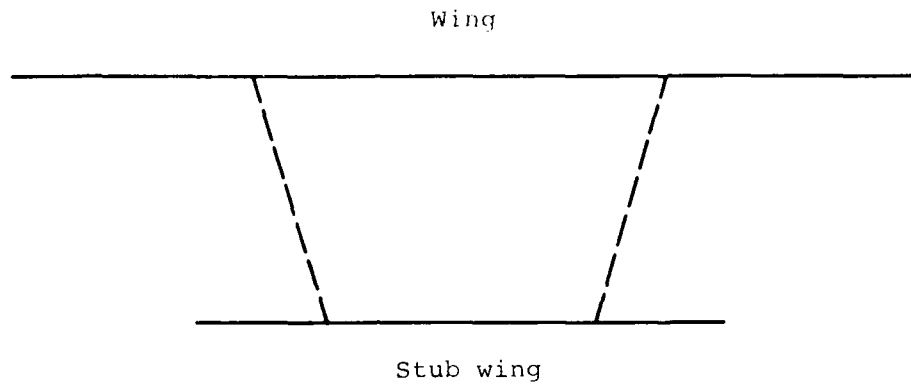
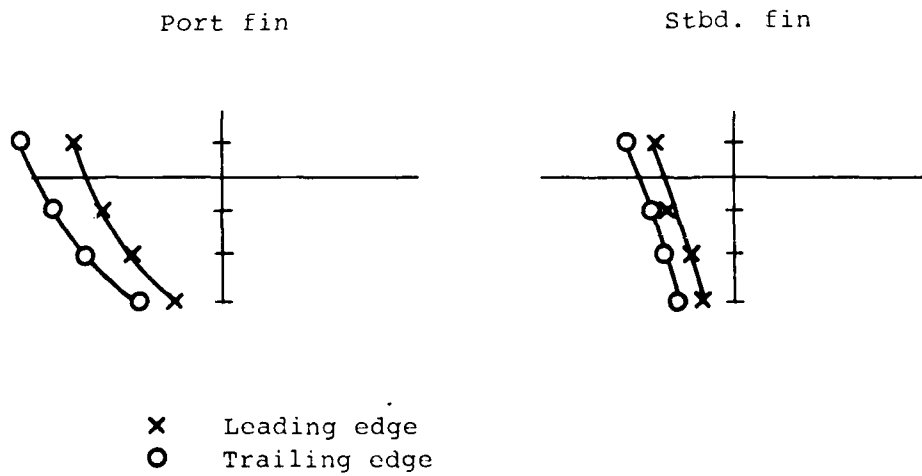
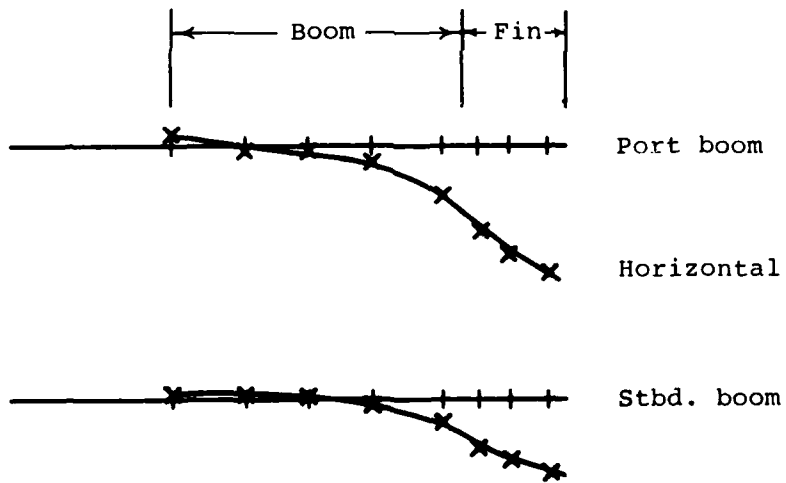
FIG 9(a) MODE AT 4.4 Hz

**Mode at 4.4 Hz. (Fig 9) -**

This is the antisymmetric lateral boom bending mode and was equally easily excited using the single shaker input.

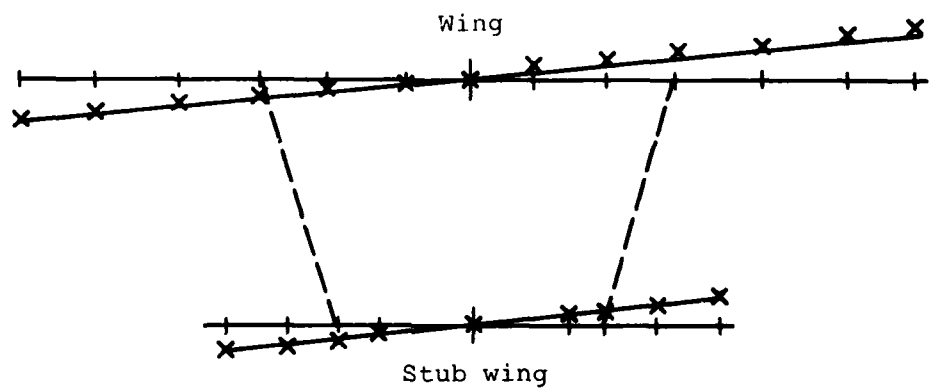
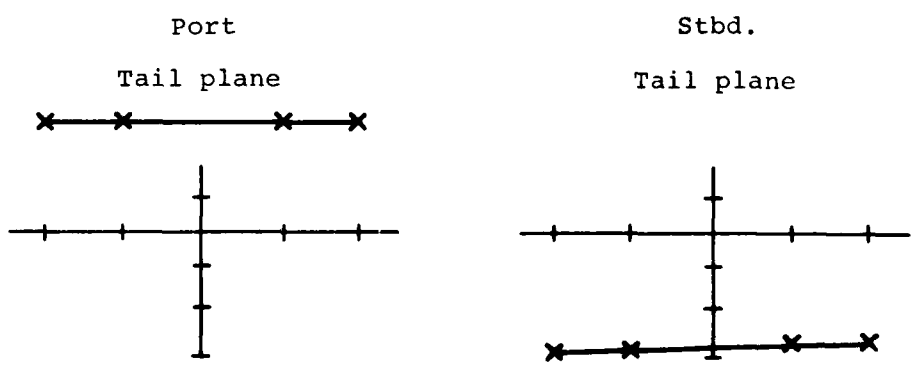
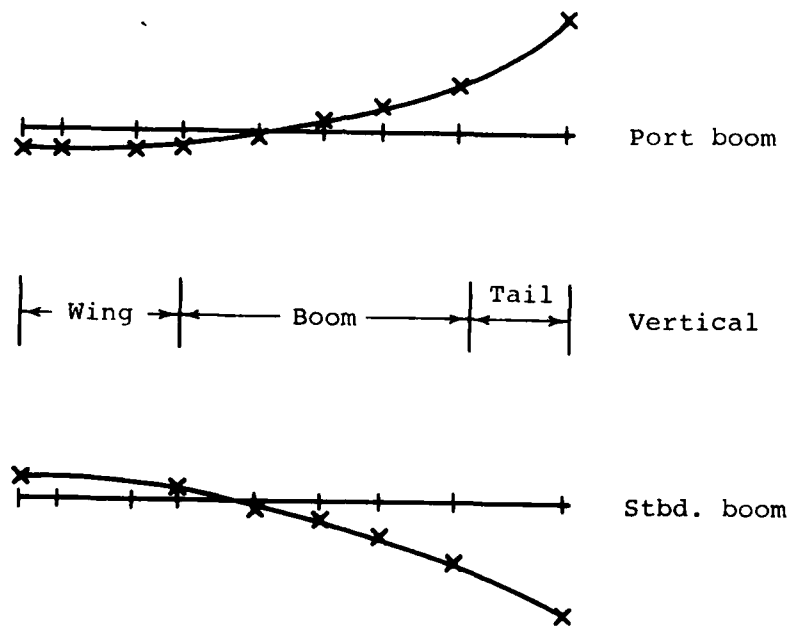
FIG. 10(a) MODE AT 4.8 Hz

**Mode at 4.8 Hz. (Fig 10) -**

This is the antisymmetric vertical boom bending mode. The motion of the wing and stub wing is essentially rigid-body motion.

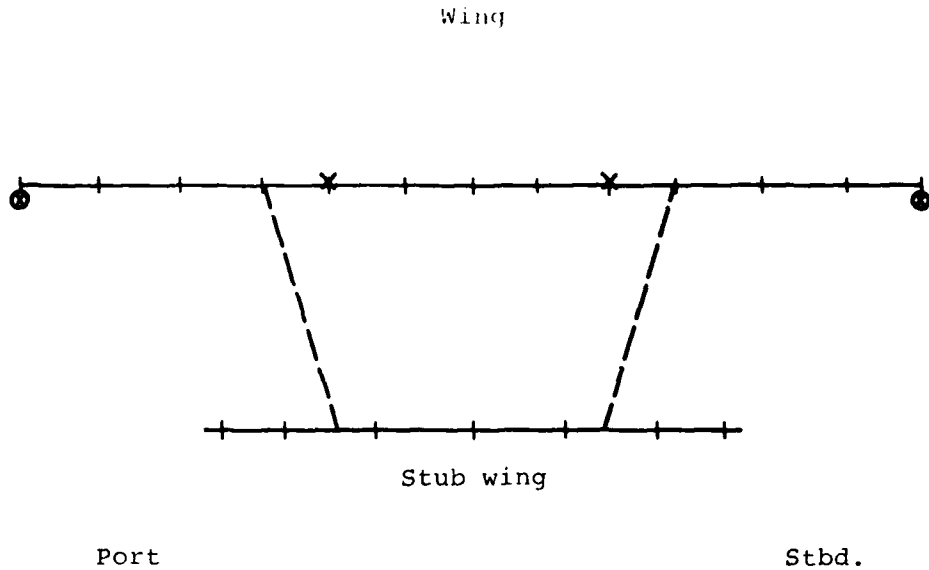
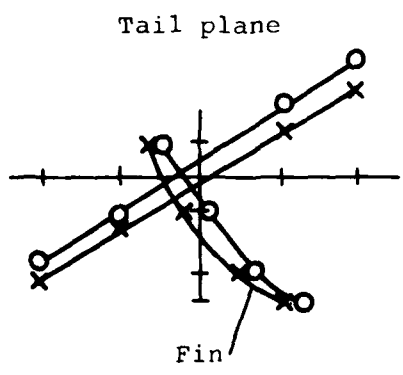
FIG. 12(a) MODE AT 9.23 Hz

**Mode at 9.23 Hz. (Fig 12) -**

This is the symmetric torsion mode of the tail booms. Because of the mass of the tail plane assembly, some bending of the boom and fin appears in this mode.

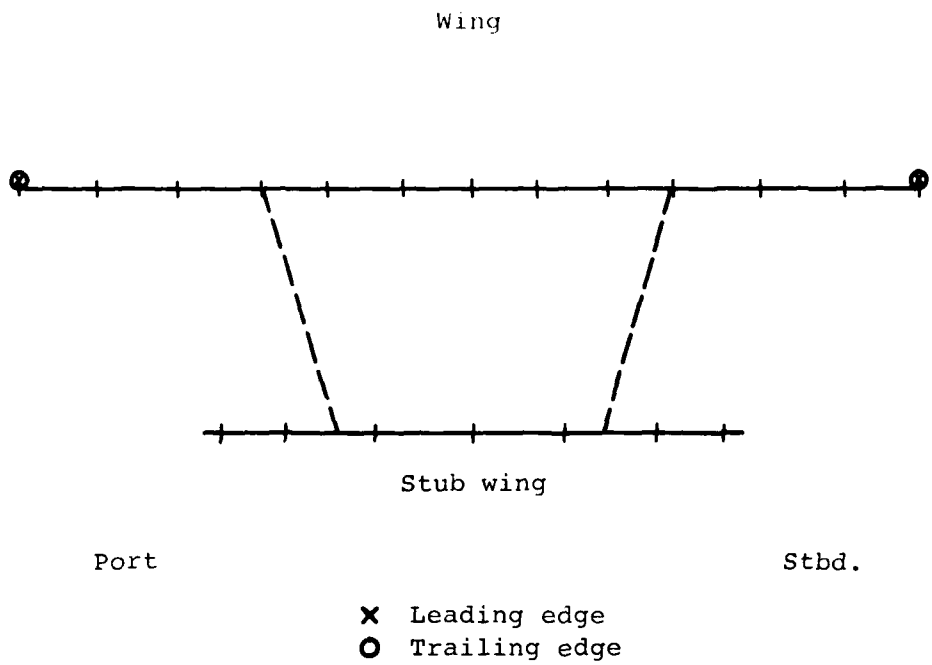
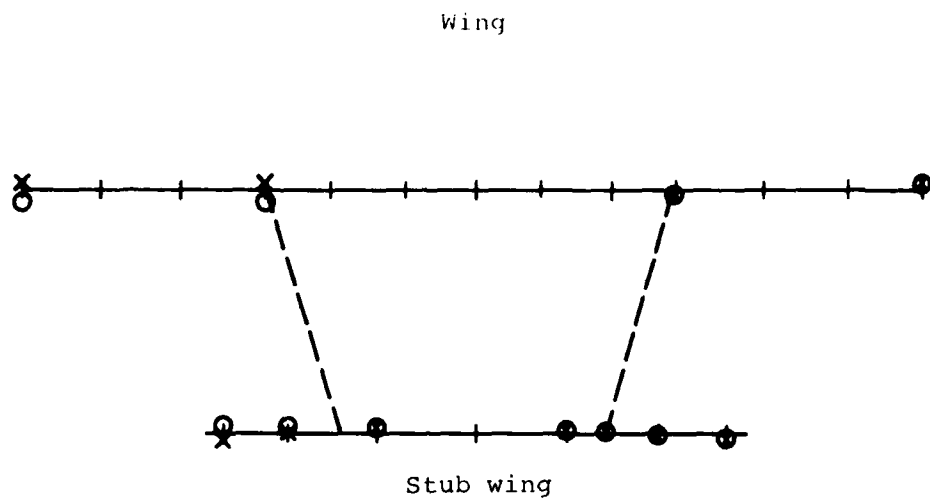
FIG. 13      MODE AT 9.43 Hz

Mode at 9.43 Hz. (Fig 13) -

This is the antisymmetric torsion mode of the tail booms, and a similar boom bending to the previous mode is apparent.
