## **Soft Shore Protection as an Alternative to Bulkheads— Projects And Monitoring**

*Jim W. Johannessen*

*Coastal Geologic Services, Inc.*

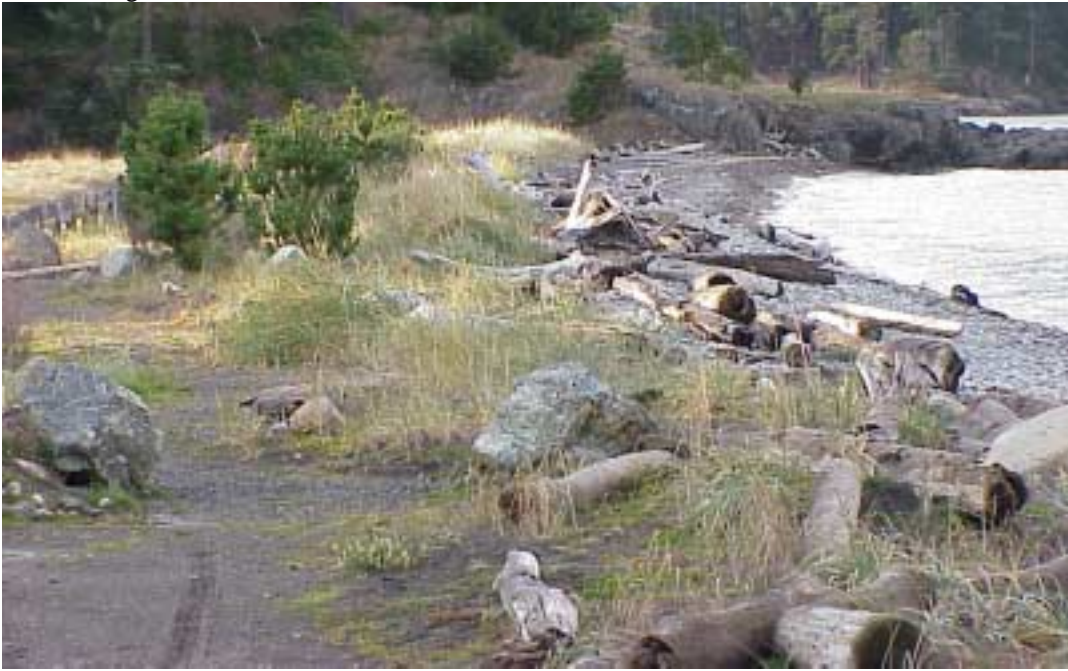
upper berm and backshore area. A barge was used to import gravel from an approved upland gravel pit in Whatcom County. The barge was equipped with a high capacity conveyor system for direct offloading directly to the upper beach. The conveyor was adjustable and had sufficient length to allow for offloading (at high tide) without grounding the barge. The imported gravel consisted of 1,600 cy (cubic yards) of washed, rounded gravel. The berm gravel was a custom product with a size range of  $\frac{3}{4}$  to 4 inch. Gravel was spread to a uniform slope on the beachface that extended up to a berm crest at +12.0 ft MLLW (Figure 2).

**Figure 2** Driftwood Beach, Blakely Island, looking NW on 4/2/01.

As of summer 2000, the vast majority of the backshore area was vegetated with appropriate native plants (Figure 2). Watering was required in summer months and repeated weeding has been carried out. Native dune grass (*Elymus mollis*) was doing exceptionally well, as is shore pine and a host of native herbaceous plants. Vegetation extended from the community property line waterward to the +12.5 to +13 ft MLLW elevation. This area also contained a "nature path" in the place of the wide pre-project gravel road (to nowhere).

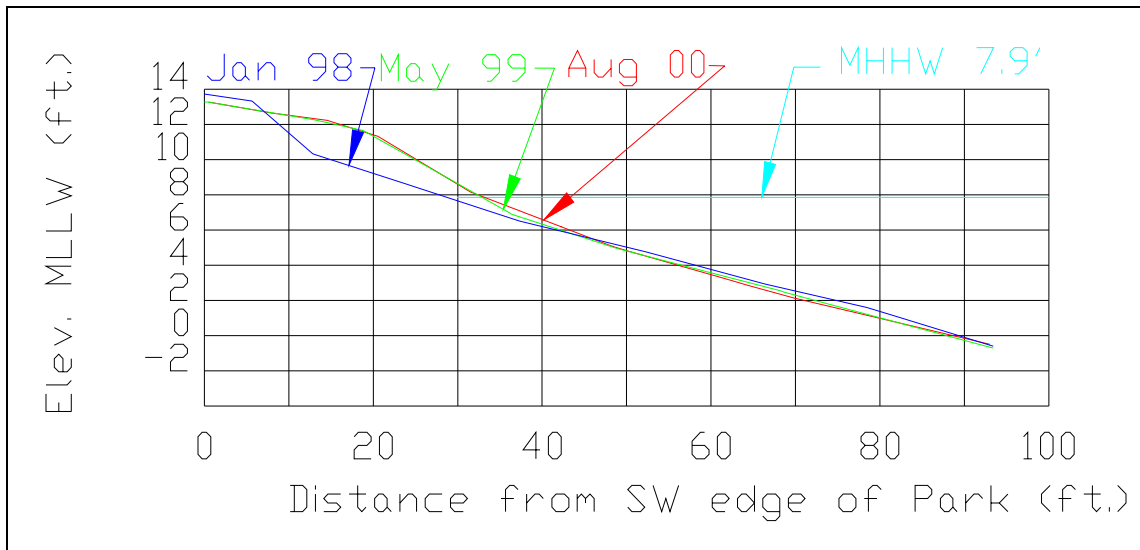
The second profile from the southern end, profile F, changed little from 1999 to 2000 (Figure 3). The high berm (created storm berm) remained approximately 10 ft waterward of the erosional scarp of the degraded 1998 beach. The beach below +5.5 ft MLLW was in the same position as in January 1998, after experiencing erosion in the severe winter of 1998-1999 and then nourishment in March 1999. The central and northwest portions of the project remained almost unchanged since 1999, having lowered generally 0.2 to 0.3 ft (vertically) between 0 and +6 ft MLLW. Most of this area was below the nourishment footprint. Berm gravel feathered into the preexisting lower beach (at +3.5 to +4.0 ft MLLW) but the point where this occurred could no longer be discerned in the field.

**Figure 3** Profile F, Driftwood Beach, Blakely Island.

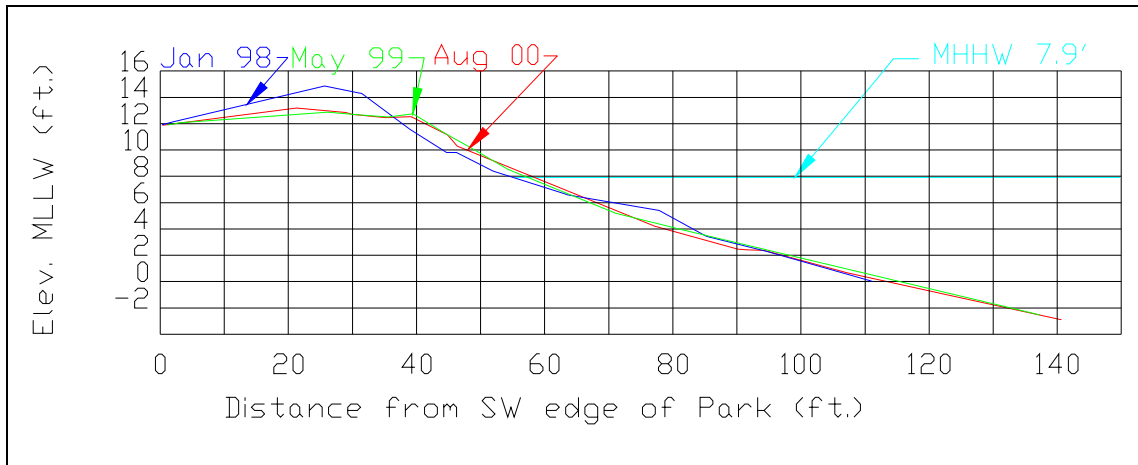
The upper beachface through the central and northwest portion of the project area, including profile C at the northern end, changed slightly since 1999 (generally less than 0.2 ft vertically) with approximately the same volume of material present (Figure 4). A small berm was located at approximately +10.5 ft MLLW. Minor additions of backshore sand and/or topsoil, along with vigorous vegetation growth (Figure 2), has raised the near-level backshore area very slightly since 1999.

**Figure 4** Profile C, Driftwood Beach, Blakely Island.

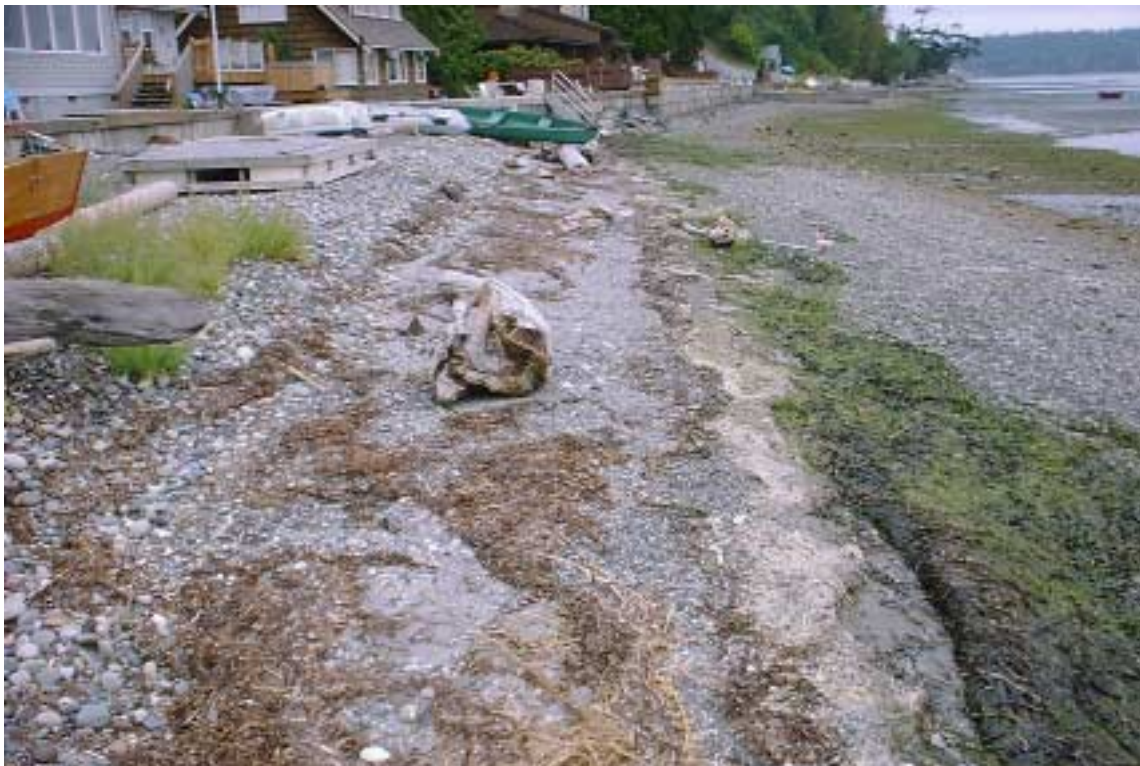
The photos below show the appearance of the beach at the end of the summer of 2000 (Figures 5 and 7). The berm crest is visible in the left-center of each photo. Backshore vegetation is visible (volunteer plants-*Rumex salicifolius*). The profile location is at the white tape and sediment sample bags are along the tape at the upper beachface. Note the berm gravel on the outer half of the berm top and the mixed sand and gravel beachface.

The berm top width throughout the 13-property project area was between 16.5 ft (Profile 3) and 24 ft (Profile 7) during September 2000. Similar widths were measured in August and March 2000. This can be compared to the 20-ft wide design berm top. The berm width decreased the most at Profile 3, where the initial width was 26 ft because of the placement of excess fish gravel to “get ahead” of eastward net-shore drift, and the September 2000 width was 16.5 ft. The berm crest at profiles 4 through 7 moved landward due to storm events in the winter of 1999-2000 that had wave runup in excess of the 1999 berm top elevations. The berm crest was between 20 and 24 ft waterward of the seawall at profiles 4 through 7. The berm crest elevation increased to between +10.6 and +10.8 ft MLLW by the high water storms. This was slightly above the original design elevation of +10.5 ft MLLW. A second reason for the landward translation of the berm crest was some amount of eastward transport of nourishment sediment. Sediment was transported away from the rounded beachface area at the western extent of the project (Profile 3) where excess fine gravel was originally placed. The western area was always expected to slowly erode. Most of the fish gravel has been transported away from the western 100 ft or so of the project area.

Figure 5 Profile 3, near west end (up-drift end) of Samish Island protective berm, looking west on 8/24/00.

A moderate amount of suitable surf smelt spawning area was reestablished by 2000 within the project area. Sand was deposited within the berm on the mid and upper intertidal beachface, although the occurrence of suitable sediment varied and was not continuous alongshore (Figures 5 and 7). Sediment samples have been collected from the upper intertidal zone (from elevation +7.0, +7.5, and +8.0 ft MLLW). These samples were all processed for grain size and results are summarized in Figure 9. Data reveal that the best potential spawning area was found at Profile 9. Three locations had fine gravel and sand approaching or exceeding 40 percent, indicating suitable surf smelt spawning habitat (Johannessen, 2000c).

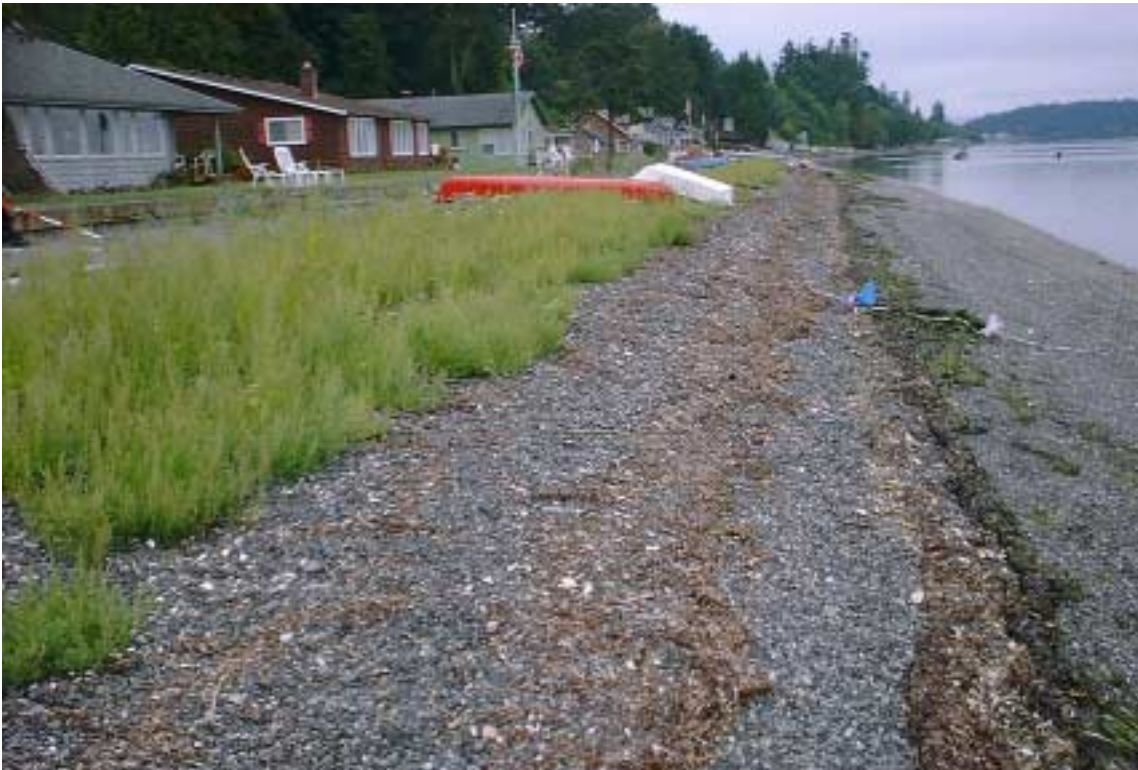
**Figure 7** Profile 9, near west end (down-drift end) of Samish Island protective berm, looking west on 8/24/00.

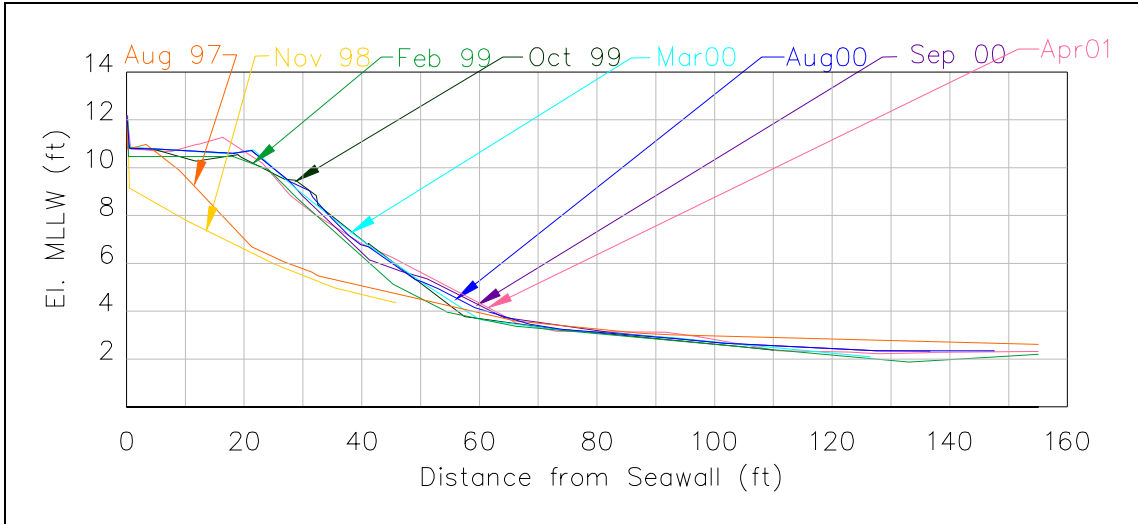
**Figure 8** Profile 9, near west end (down-drift end) of Samish Island protective berm, looking west.
