MERCURY MINE WASTE EROSION INVENTORY: RANCHO DE GUADALUPE AREA SIERRA AZUL OPEN SPACE PRESERVE

April 13, 2011
(Revised)

Midpeninsula Regional Open Space District
330 Distel Circle
Los Altos, CA 94022

TIMOTHY C. BEST, CEG
ENGINEERING GEOLOGY AND HYDROLOGY

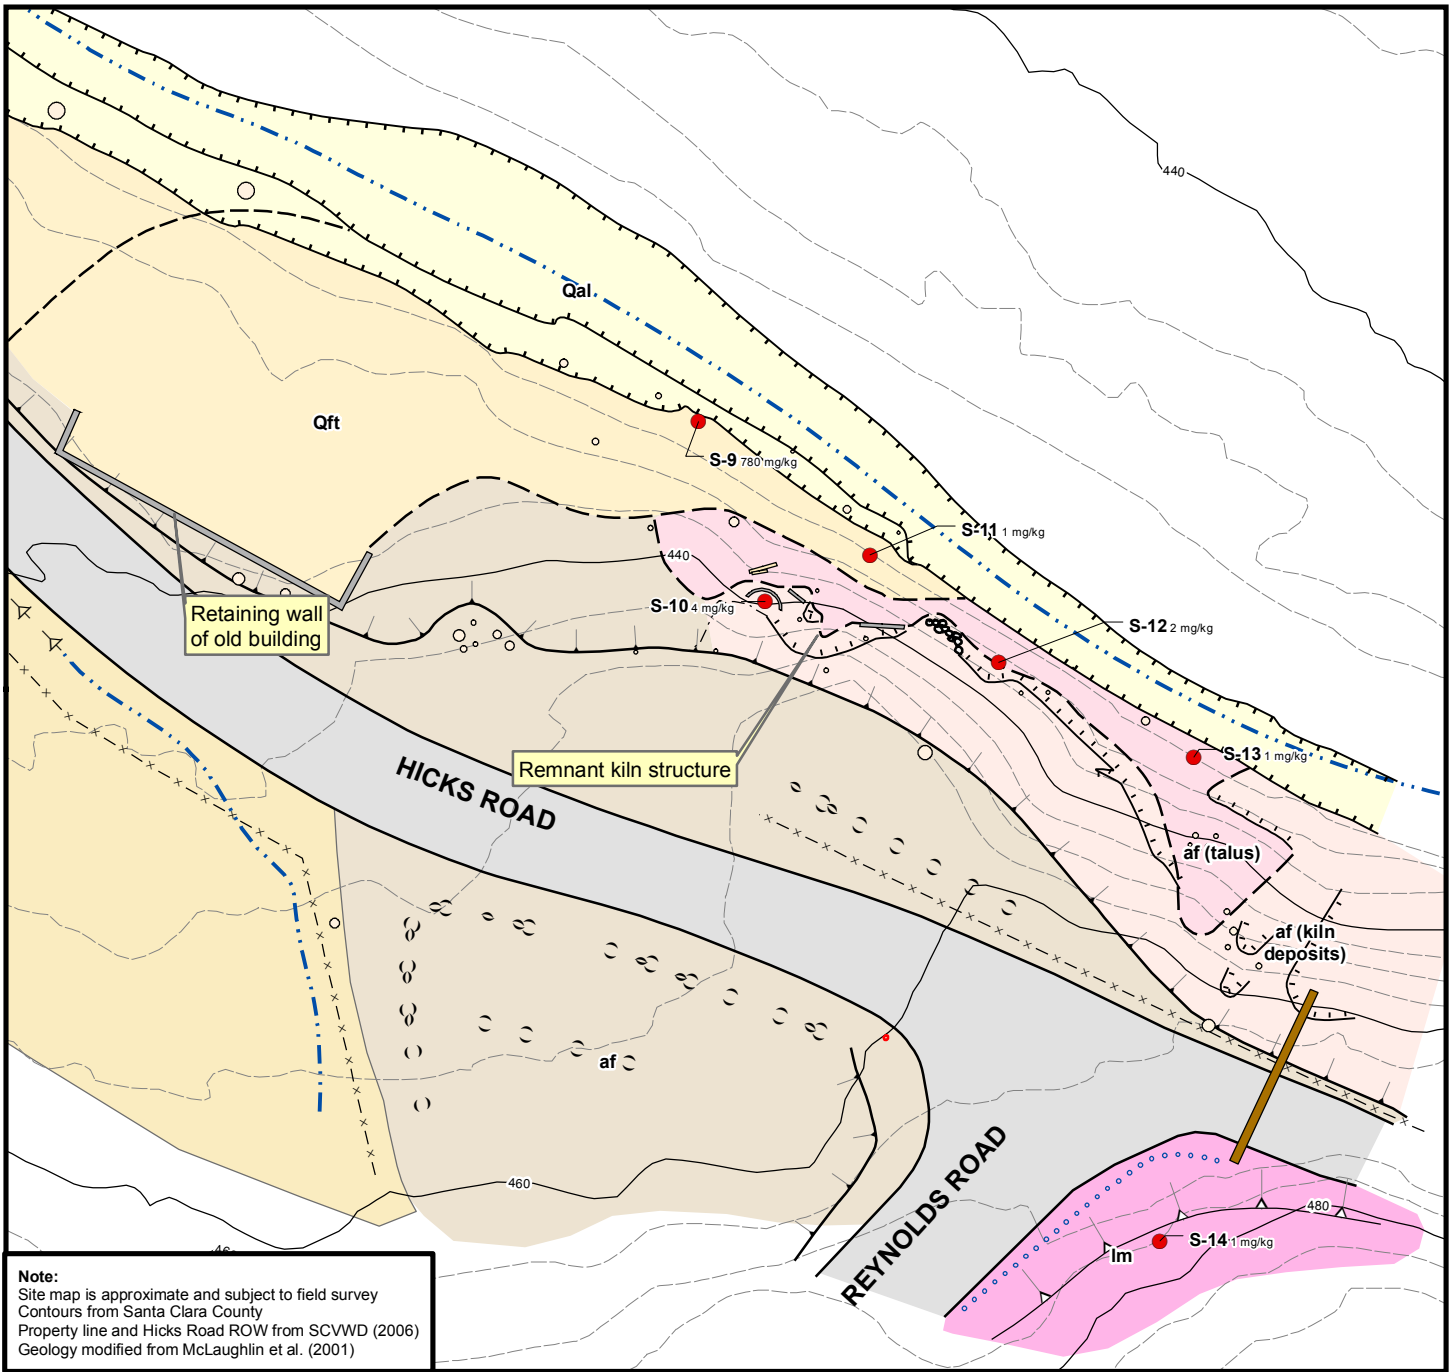
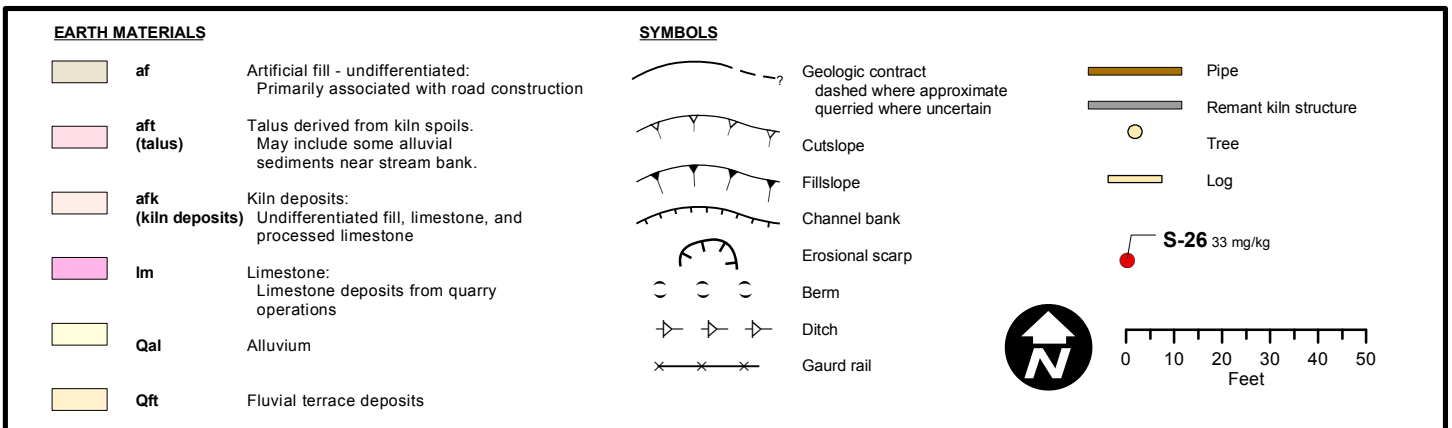
Downslope of the kiln is a heterogeneous deposit of cemented buff white processed limestone with fragments of darker grey limestone. This deposit extends along the Guadalupe Creek bank for about 50 feet downstream of the kiln. The deposit is visually similar to the in place material within the kiln and interpreted to be waste material from the kiln that was probably pushed into the stream after processing. There is no evidence of processed mine waste and similar deposits were not observed on the opposite (north) side of Guadalupe Creek.
