## Ecological and Morphological Significance of Old Growth Deadhead Logs in the Yellow River Donald Ray

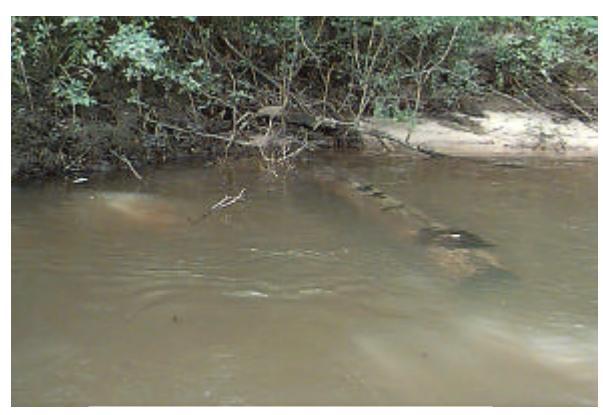
#1 Yellow River above US90, log anchored into the bank at 90.

The log pictured above (11.6 teet length and 14 inches in diameter) was anchored into the bank of the river at the site above U.S. Highway 90. The logs were located by finding markers left by the permit applicant. The #2 photograph below showed aquatic mosses, liverworts and algae attached to the log. These plants provided food and habitat for fish and wildlife in addition to the habitat value of the log. The other 2 logs in the middle

Bank instability (photograph #5) accelerates when woody debris is removed from the stream channel. This adds the to habitat smothering (photographs #3 & 6) that has already indicated severe sedimentation problems. Restoration of historic concentrations of woody debris at proper locations in the Yellow River would enhance fish and wildlife populations. This restoration would also improve channel stability/stream morphology as observed at the sampled log sites (i.e. photograph # 1).

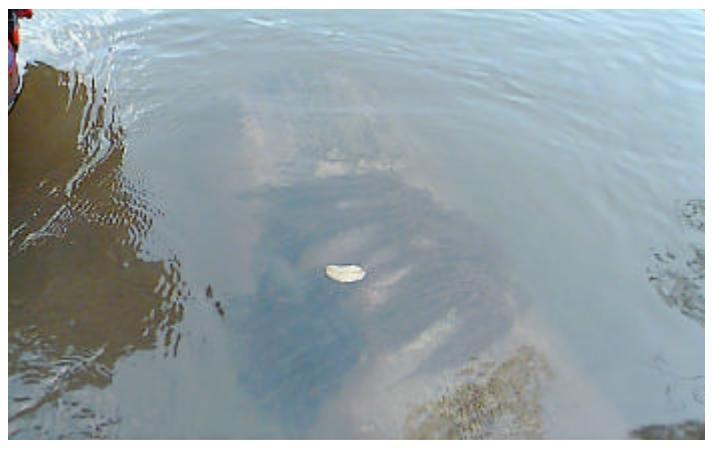
#2 Mosses, liverworts, and algae growth on log.

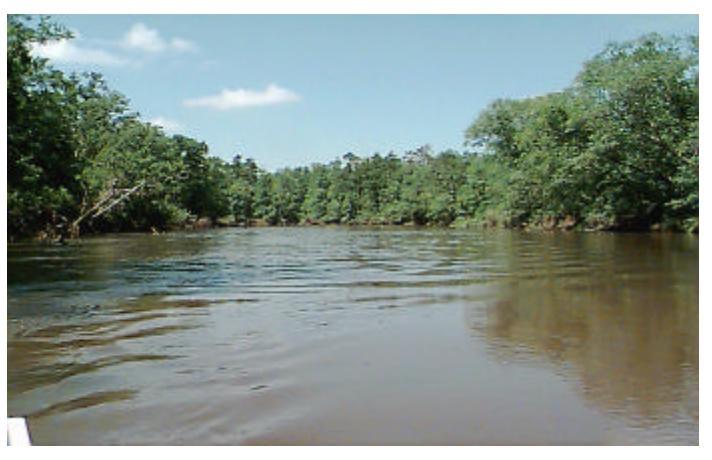
#3 Yellow River above U.S. 90 < 1 meter depth 75 meters wide. ~99% sand.

of the channel created fish habitats in an otherwise unproductive shallow sand bottom. The stream channel was much shallower and wider in areas without woody debris. Most of the 1 mile of river surveyed above Highway 90 was in this condition with approximately 1-% woody debris present (see photograph #3 above).

"when organic debris no longer enters a stream the banks become unstable, streamside erosion accelerates and the channel topography can be smothered from the filling of pools and flattening of riffles (see photograph #3). A 6-year study (Megahan 1982) concluded that logs were the most important type of obstruction in stream channels because of their longevity and the large volume of sediments trapped behind them. Megahan's study found only large stable obstructions remained in the channel during a high-flow year and fifteen times more sediment was stored behind obstructions than was delivered to the drainage outlets. Larger old growth timbers such as the deadhead logs remain in the water as habitat during high flow

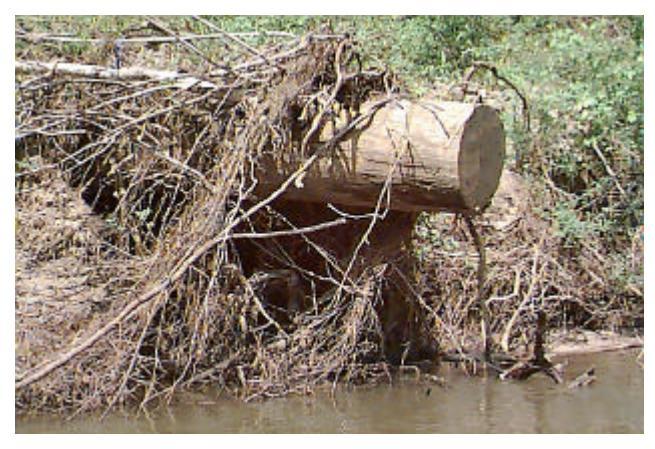
#4 Recently cut log.

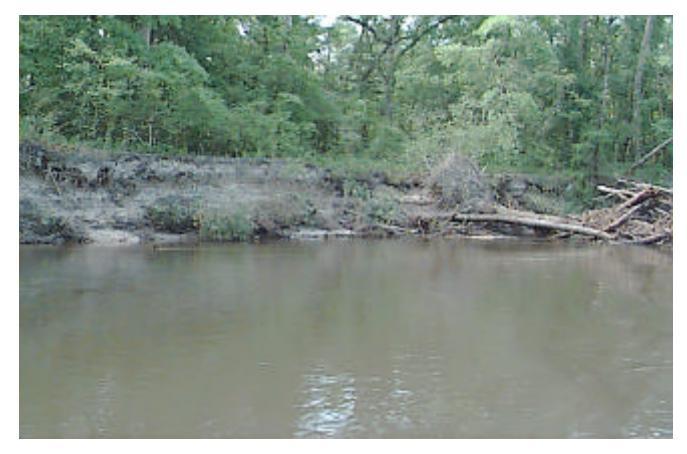
# 5 Recently fallen trees on a river bend.

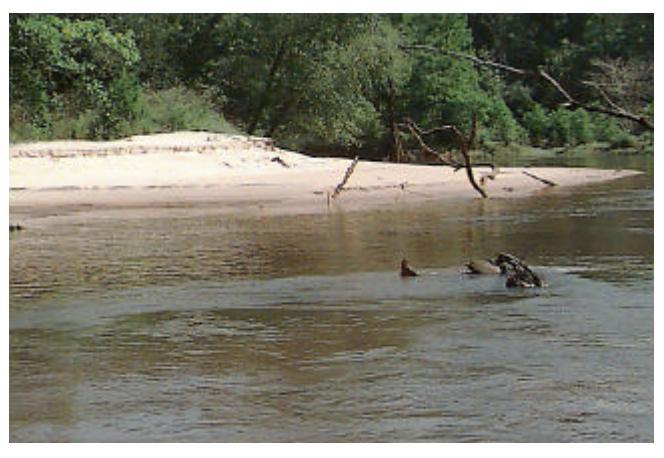
The Yellow River at the time of sampling was at low stage (2.25 ft.), and flow (523 ft3/s). The flood thresholds are 12-ft. (stage) and 12,900 ft3/s (flow) at US90. This winter and spring had near record drought conditions that resulted in a much lower stream stage height than normal. This low river stage made the conditions favorable for locating submerged logs. Some logs marked by the applicants were exposed by the low flow conditions and appeared to have been cut recently (photograph # 4). There was severe bank erosion on bends in the river above US90 (photograph #5). The severe erosion caused by increased runoff from silviculture, agriculture, and urban lands along with dam failures had created numerous large sandbars (photograph #6).

#6 New sediment.

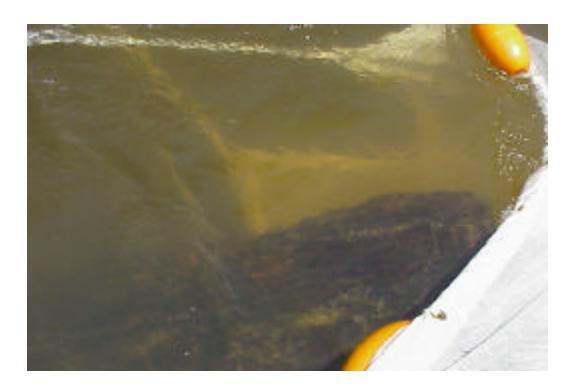
# 7 Driftnet deployed behind log.

To determine the invertebrate aquatic community a brush was used to dislodge the aquatic invertebrate into a driftnet (photograph #7). The sampling results from the logs indicated a highly productive and diverse aquatic macroinvertebrate community. The logs surpassed the thresholds established for a 4 sweep BioRecon of multiple productive habitats (FDEP 1996b). The logs also had a more diverse and productive fauna than that found in a 20 sweep Stream Condition Index (FDEP 1996b) at a Yellow River reference site near Holt. The biometric value comparisons of the logs, Holt reference site and western panhandle thresholds are as follows:

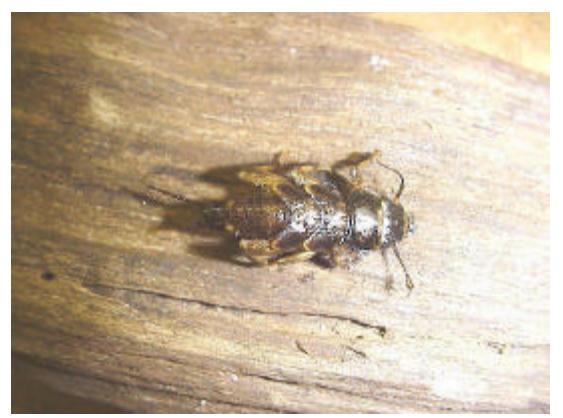
```
#8 Stonefly.
```

The log's healthy well-balanced aquatic communities were dominated by cleanwater indicators (photograph #8). Fish (darters, topminnows) were observed feeding on the logs. Fish and other invertebrate eggs including snails were observed attached to the logs and the vegetation growing on the wood. Wallace and Benke 1984 found wood is important to fishes, providing a rich source of invertebrate food, habitat, and cover. Benke et al (1979) reported several species of game fish forage almost exclusively on invertebrates associated with these woody substrates. Wood was found to be a major structural feature (43%) in a study of middleorder streams (fourth to seventh) of the southeastern Coastal Plain
