Kyle A. Crum, Jerri McMichael, and Miloslav Novak

Advances in Aluminum Relative to Ship Survivability

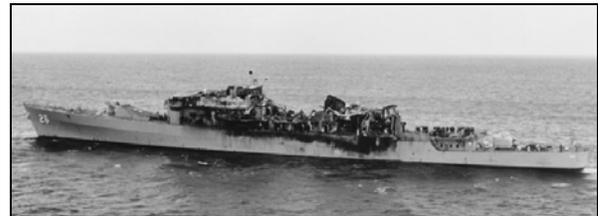
FIGURE 2 – *USS Belknap* (CG 26) heavily damaged by fire, after a collision with *USS John F. Kennedy* (CV 67) during night operations off Sicily on 22 November 1975.

USS Belknap's superstructure was constructed of aluminum. Many have seen post incident photos, FIGURE 2, and mistakenly assumed that the aluminum in the superstructure contributed to the fire. As described by the official Navy report this is not the case. The physical damage

of was a result of a combination of effects from the collision and fire. The fire, in this case, was fueled by two charged JP-5 risers on *Kennedy* that were severed in the collision. These two risers supplied approximately 1,045 gallons per minute of JP-5 fuel directly onto the open and damaged superstructure of *Belknap*. The subsequent fire melted the superstructure.

much lower temperature, meaning that an aluminum vehicle that has burnt will generally melt giving the appearance of burning. This is evidenced by FIGURE 2. Though this is the appearance, significant research, such as the Aluminum Association's Testing at Southwest Research, has shown aluminum does not participate in the combustion process under atmospheric conditions.

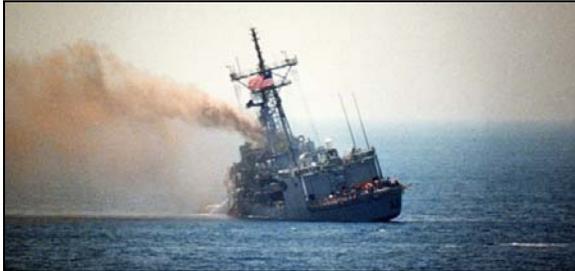
FIGURE 3 – *USS Stark* (FFG 31) listing after receiving damage from two Exocet anti-ship cruise missiles fired by an Iraqi F-1 Mirage fighter on 17 May 1987.

The Navy’s official report indicates that the immediate fire damage from the missile strike was caused by the rapid burning of the unexpended fuel from the two missiles. The report details that each missile injected approximately 300 pounds of unexpended propellant, calculating that 600 pounds of propellant resulted in a near instantaneous heat release of approximately 12 million BTUs. Furthermore, because the first missile’s warhead failed to detonate, it turned out to be more damaging because it injected its thermal energy (burning propellant) further into the ship’s structure. The second missile did detonate, allowing some of its thermal energy to escape back out through the exterior of the ship.

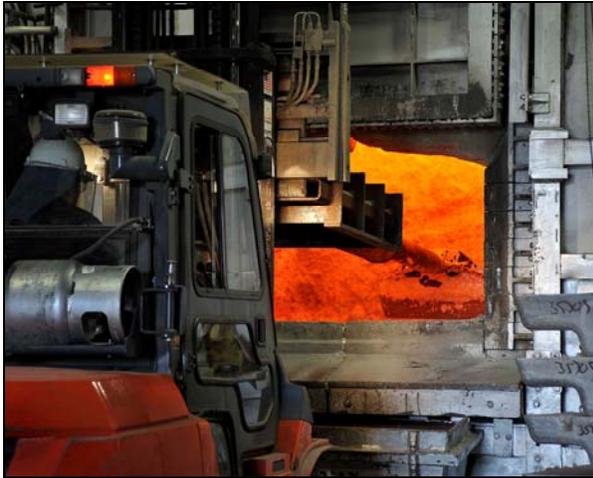
FIGURE 4 – Worker skimming molten aluminum during the manufacturing process.

Aluminum does not burn under atmospheric conditions, nor does it support or encourage combustion or flame spread. This is seen practically throughout industry. The welding process is commonly used in fabrication of aluminum components. This process utilizes an electric beam to melt filler wire and the base materials into a continuous joint. The process utilizes an inert shielding gas to protect the quality of the joint, not to preclude combustion. If the inert covering gas fails, the weld often will contain flaws as a result of the atmosphere’s interaction with the electron-beam, but this does not constitute combustion. In another practical manufacturing example, the casting practice heats material until it becomes liquid. Then the material is poured into a mold and allowed to cool, producing a desired shape. This process is often performed under no purging gas and in an open environment. Oxides resulting from materials interacting with the atmosphere are common, but combustion is not, see FIGURE 4.

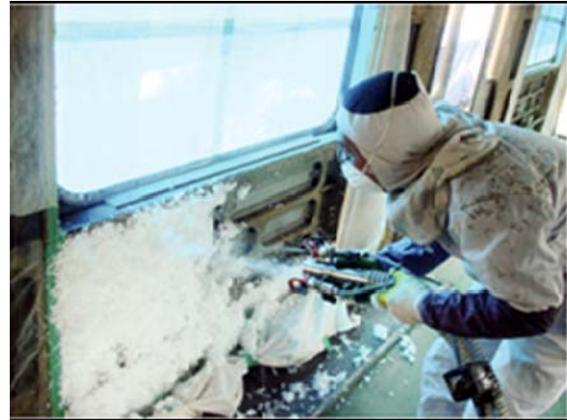
FIGURE 5 – Worker spray-coating aluminum structure with fire insulation.

Spray-on passive fire protection systems are used extensively in civil engineering and offshore applications. These coatings can be applied very cost-effectively and have the ability to easily vary thickness according to anticipated heat exposure, FIGURE 5. This insulation can be applied over complicated geometry with a minimum of labor, but does not typically appear in naval application because it does not adhere sufficiently to survive shock events.

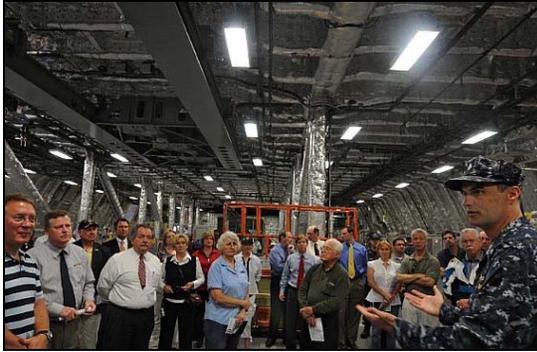
FIGURE 6 – CDR Curt Renshaw, commanding officer of USS Independence (LCS 2), addresses guests in ship's mission bay, 8 April 2010. Note the blanket type fire insulation protecting the aluminum structure.

Blanket type fire protection materials offer the shipbuilder flexibility in covering complicated stiffener geometry locating fasteners intermittently where convenient. Seen in FIGURE 6, these materials can be manufactured with reflective surface finishes allowing lower radiant heat gain from an adjacent fire.

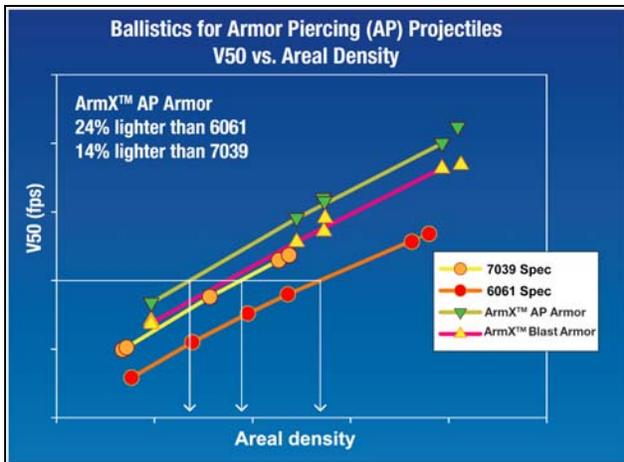
FIGURE 7 – Relative Ballistic Performance of 7085-T7E01 (ArmX™), 7085-T7E02 (ArmX™), 7039 and 6061 against the Armor Piercing Rounds

FIGURE 7 relatively compares the ballistic performance of 7085-T7E01 and 7085-T7E02 (ArmX™ AP Armor and Blast Armor) to 7039. 7085-T7E01 clearly exhibits a significant increase in ballistic protection against the threats tested. Test data has shown 7085-T7E01 up to 14% better than 7039-T64 and 24% better than 6061-T6 against AP threats. Additionally, the material has been shown to perform 5% better than 6061-T6 and 5083-H131 against FSP threats.

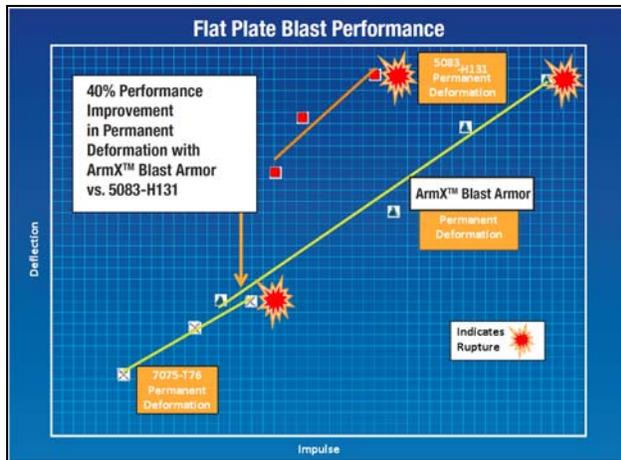
FIGURE 8 – Relative Blast Performance of 5083-H131, 7075-T76 and 7085-T7E02 (ArmX™)

In blast, the high strength of 7085-T7E02 results in low dynamic deflections, combined with high resistance to rupture. This makes 7085-T7E02 a growing choice for blast shield structures, often known as “C-Kits”. The relative performance of 7085-T7E02 against 5083-H131 and 7075-T76 is shown in FIGURE 8.
