USAARL Report No. 93-27

**Analysis of Injury Severity
Caused by Flight Motor Overpressure
of the Javelin Antiarmor Missile**

**United States Army Aeromedical Research Laboratory
Fort Rucker, Alabama 36362-5292**

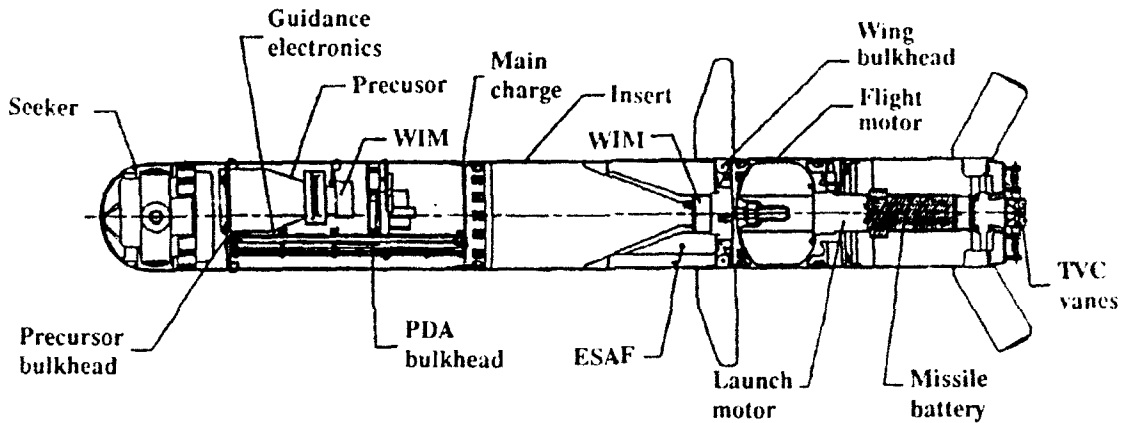
Figure 1. Javelin missile configuration.

The Javelin system consists of a command launch unit (CLU) and missile round. The CLU includes a sight system for surveillance, target identification, and target lockon. The missile round consists of the launch tube assembly, battery/coolant unit, and missile. The missile is shown in Figure 1. The battery/coolant unit supplies electrical power to initiate launch and cooling gas to precool the missile seeker before launch. Estimated system weights are presented in Table 1 (Texas Instruments, 1992).

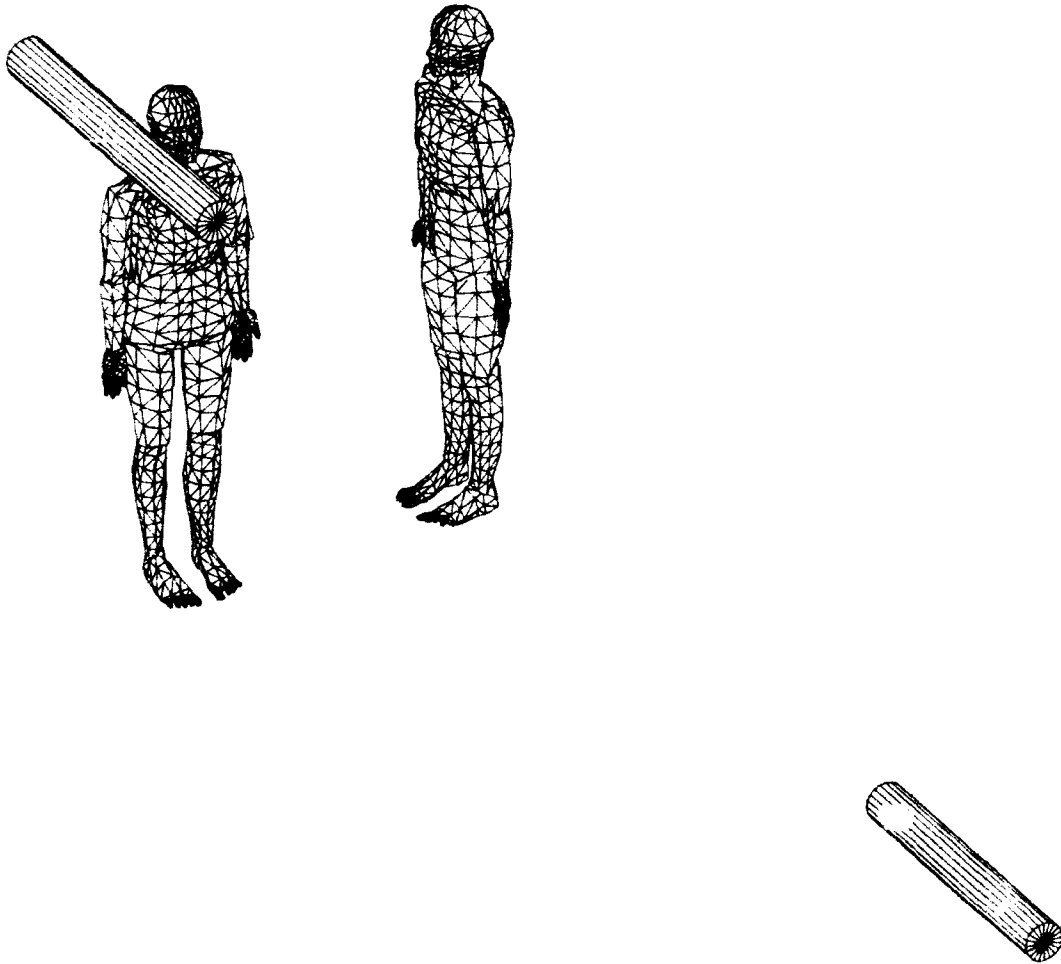
Javelin missile test firings showed the flight motor ignites 0.4 seconds after the missile is launched. At that time the missile was 1.5 meters above the ground, 4.6 m (15 feet) down range, and had achieved a forward velocity of 13.4 m/s (44 fps). Figure 7 shows the relative distance between the gunner, assistant gunner (possible position), and missile at the time of malfunction. The position of the assistant gunner during missile launch has not been decided, but it should not be closer to the missile than the gunner.

Figure 7. Schematic showing standing position for gunner, assistant gunner (exact duty position not yet decided), and missile at time of malfunction.

Malfunction simulations show only a small probability that the gunner will be struck by a piece of debris. In these tests, the launch motor and battery have gone to the right and left side of the gunner position, respectively. If the debris spreads randomly within a cone shaped area behind the missile (60 degrees wide by 60 degrees elevation), most debris items will strike the ground or miss the soldiers. The probability that a piece of debris will strike a soldier is estimated by dividing the surface area of the soldier by the surface area of the 15-foot (4.6 m) radius sphere contained within the impact cone. The probability of being struck by at least one large piece of debris is the sum of the probabilities for each single piece of debris.
