RE-START FROM STRAW

Abstract

This paper describes the concept and realization of an earthquake-proof prototype to verify the appropriateness of an orphanage to be built in Haiti. The construction system utilizes mainly natural and local materials like rice straw bales and bamboo.

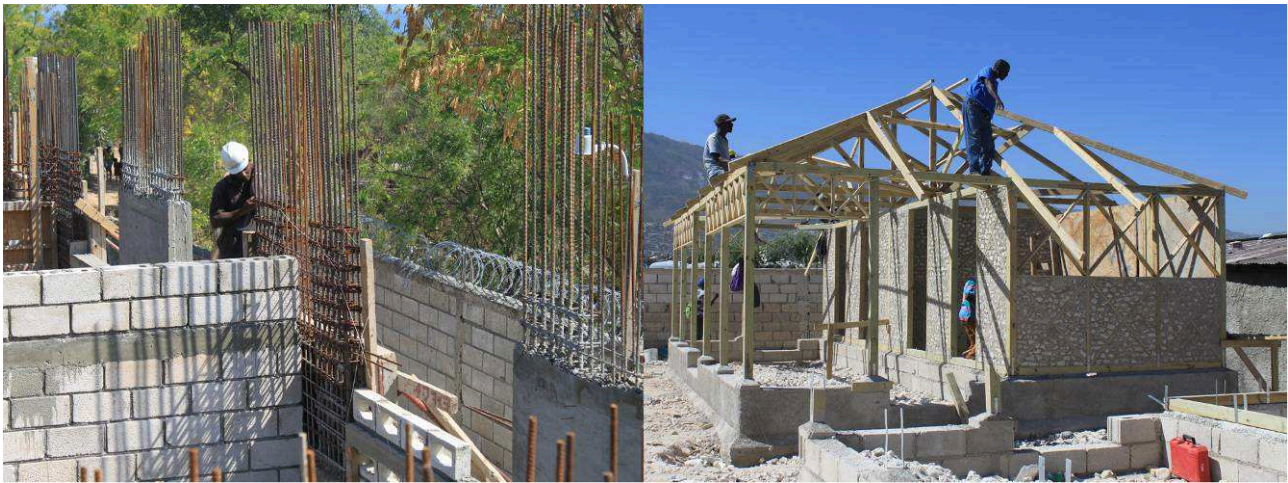
1. Usual reinforced concrete system and CRAterre system

Some NGOs have proposed new building systems that use an alternative materials instead of concrete. For example, CRAterre has built earthquake-resistant timber-frame buildings, with debris as infill. This new construction system is taught to workers on building sites. However, buildings made without concrete are mostly experimental (Fig. 1).

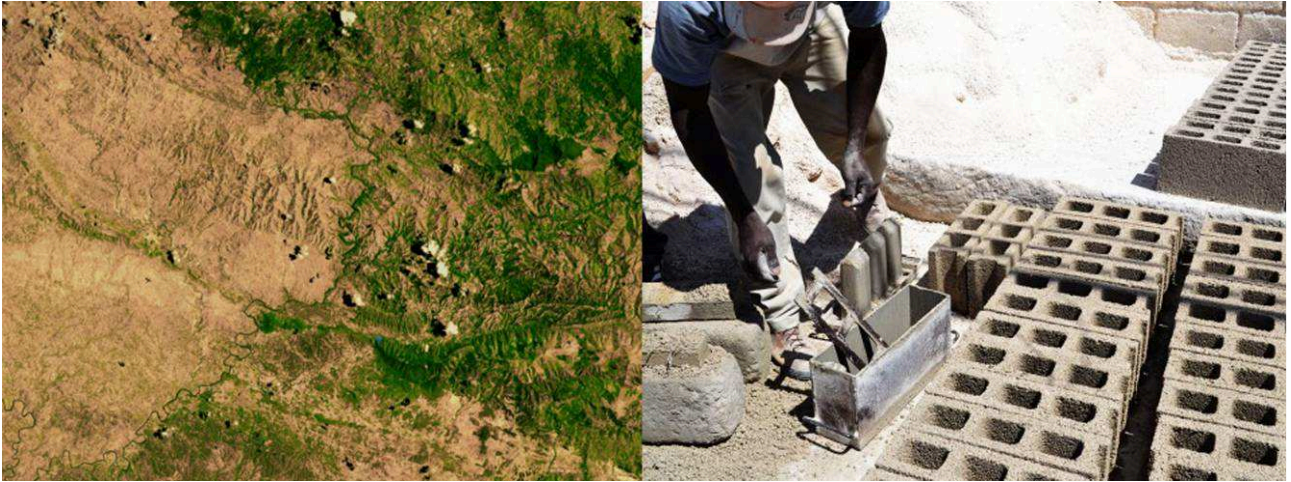
2. The boundary between Haiti and the Dominican Republic shows the high deforestation. On the right the production of cement blocks

Using wood is not possible in Haiti. Felling of trees both to obtain export-grade lumber and to produce charcoal for cooking resulted in the disappearance of forests at the end of the 19th century (Fig. 2). Up to that time, the species most commonly used in construction were Caribbean pine and fir. Currently though, wood must be imported. The biggest exporters are the United States and Canada, which provide poor quality timber. Nevertheless, timber is very expensive because of transport.

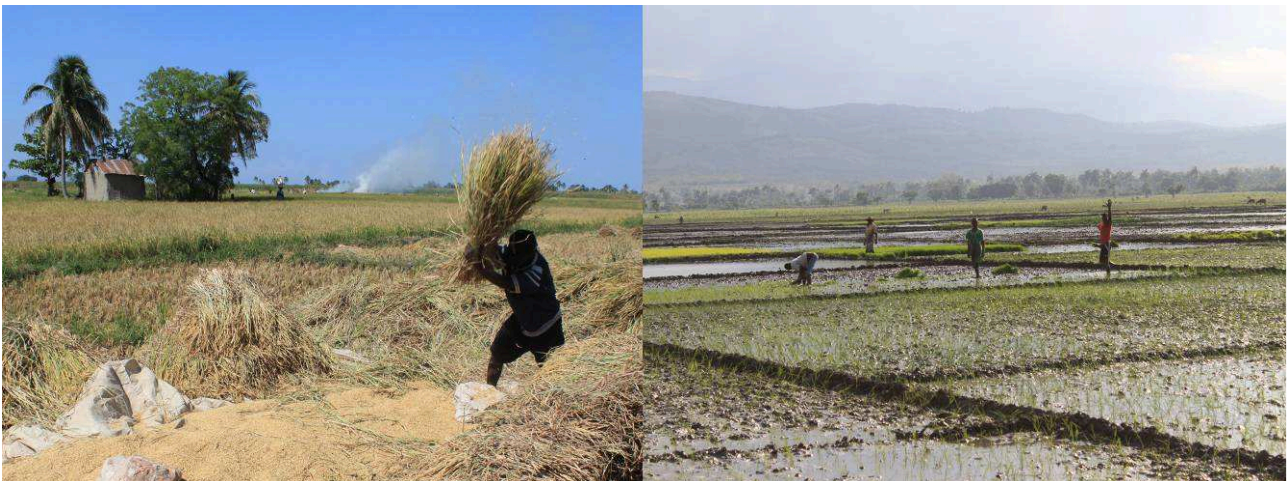
3. Artibonite valley

Rice crops grow on the mountains and in swamps. Mountain fields are small, subsistence cultivations close to Cap Haitien and between Léogâne and Jacmel. Swamp rice is more common and is mainly cultivated in Artibonite valley, where 80% of national rice is produced (Fig. 3).

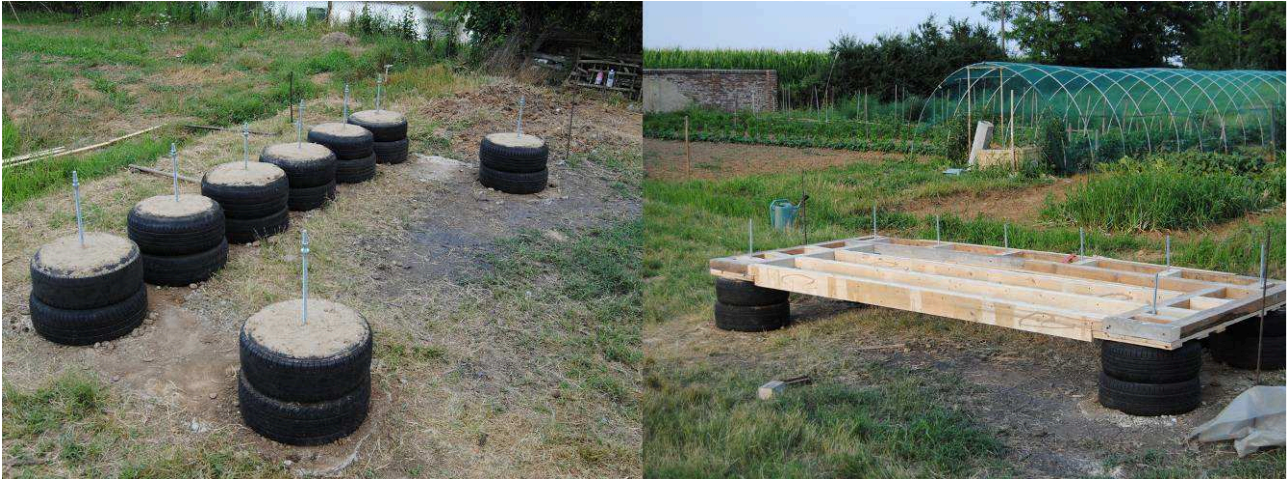
5. Foundations

The reinforced concrete curb thickness depends on the characteristics of the soil on which the building stands. In Poirino, we dug into the ground to a depth related to the type of soil in St.-Marc. The width, however, was determined by the diameter of the salvaged tires which rest on it. These are stacked in pairs, joined with iron wire, and filled with pressed earth and gravel. On top of such piers lays a system of timber beams which support the wooden floor. The latter is made integral with the previous two through a threaded metal rod, which – after having been embedded in cast concrete – is fixed with a nut.

This basement has a double function: it not only protects the building from water falling on the ground during heavy rains, but it aims to insulate the building from ground motion during earthquakes. In such an event, in fact, the concrete curb would move with the ground, whereas the elasticity of tires would disconnect the displacement of the ground from that of the building. In this way the construction would oscillate at a period longer than that of the structure, thus reducing the seismic acceleration, which depends on the building mass. Knowing the mass of the construction it is possible to determine the stiffness of the isolator to be used for a specific building – but here, as opposed to current building products, the exact stiffness of tires is not known. In order to verify the appropriateness of this earthquake-resistant system one should carry out tests beyond the prospects of this work. However, it is possible to conceptually compare the behavior of a seismic isolator made in this way with a elastomeric isolators commonly used in industrialized countries. Rammed earth in salvaged tires and the rubber of the tires themselves create a highly elastic structure able to dissipate the energy of the earthquake in the same manner as the elastomeric material used for more conventional insulators.

The baseplate structure, made of wooden planks and joists, which rest on tires, has been dimensioned to support the load of roof and walls. Beams supporting the floor planks have been verified so that their bending is two hundred times smaller than their length (Fig. 5).

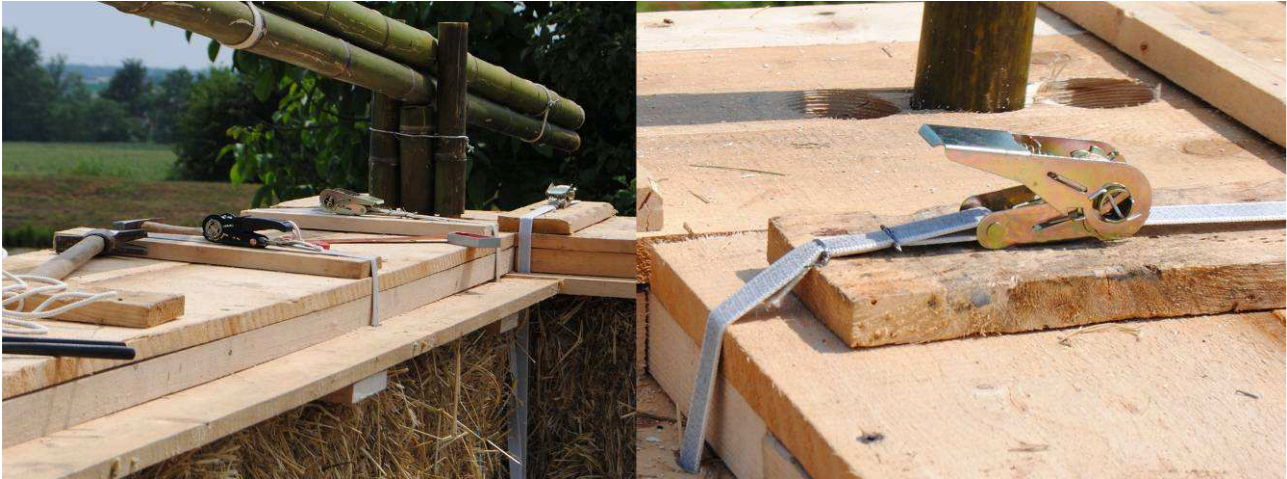
6. *Wooden structure at the top of straw bales walls*

A “roofplate”, consisting of two beams sandwiched between two planks, rests on the seventh and last row of straw bales, as showed in Barbara Jones's book [11] (Fig. 6).

This distributes over the entire wall the pressure exerted by 8 polyethylene straps that connect the baseplate with the “roofplate”. A ratchet allows to tension the belts which pre-compress the walls. In this way, the solidity of the structure is greatly increased. The height of the straw bale walls was reduced by almost 10 cm. After the construction of the walls we started to assemble the roof-supporting system. This structure was built entirely with struts and beams made of bamboo with mechanical joints. First, four pillars were constructed: each element consisted of three bamboo poles.

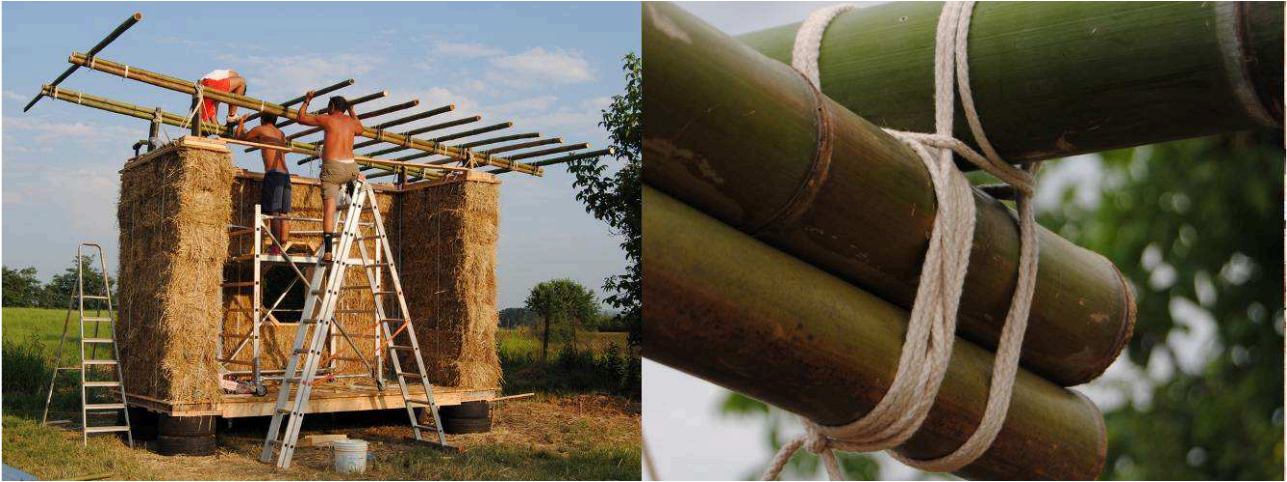
7. Structures

These pillars were sunk into the walls through circular holes in the wooden top beam described above. The bayonet joints at the top end of each pillar allows to insert the joists. These are two: each one is composed of two 6.2 m long bamboos joined by rope connections and two threaded rods which hold them together with two metal nuts. The secondary framework is composed of 15 bamboo poles, 3.85 m long and fixed to the two joists with rope connections.

The analysis of roof beams has been developed according to ISO / DIS 22156 and 22157 and ISO/wg9. Data provided by ISO standards were used to dimension main and secondary beams, verifying that both could resist the action of Haitian wind. A wind speed of 118 km/h was assumed, which is a very high value compared with the average on the island. Assuming a form factor (C_p) of 2.1, a 1.41 kN/m^2 wind pressure was obtained, which corresponds exactly to the snow load to be considered (with the sign changed) for the prototype built in Italy.

The secondary frame has to be composed of 8-cm-diameter bamboos, and joists have to be put at 40 cm. Joists are made of two 10-cm-diameter bamboos. It was also verified that the weight of the entire construction, including foundations, was heavier than the lifting force originated by the wind, so there was no risk of the wind tearing off the roof (Fig. 7).

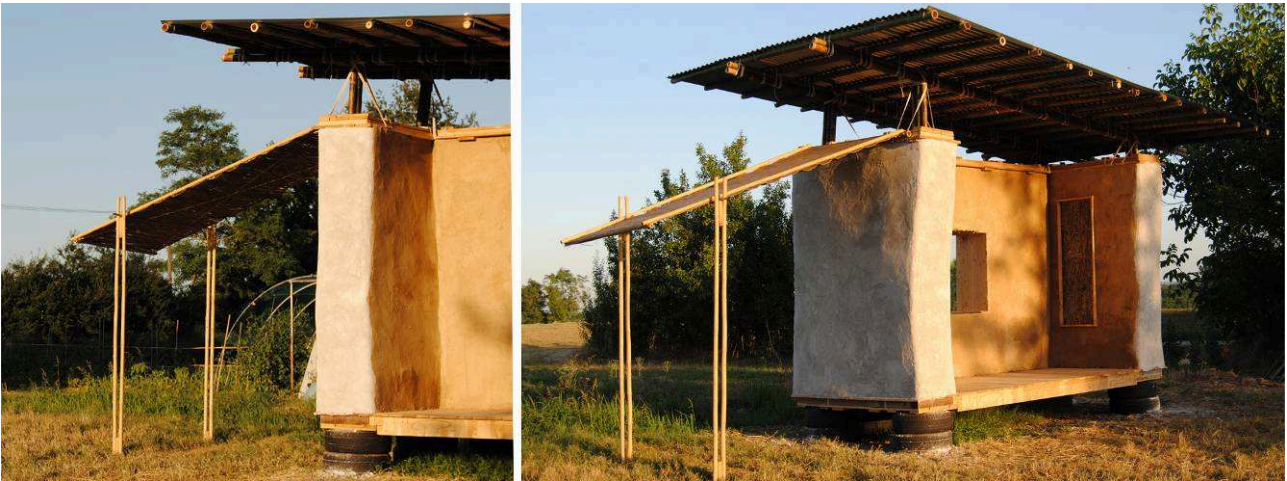
8. Final prototype, movable shade

As a final step, a movable shade system was built on one of the two short facades. This is made of a bamboo frame which supports a vegetal mat. This element rotates along the upper part of the wall and hooks in two bamboo poles plunged in front of the façade. The movement allows to open the veranda to shade the adjacent portion of the wall, therefore creating a protected outdoor sitting area. The same system allows to lay the shade against the wall during a storm or strong wind in order not to damage it (Fig. 8).

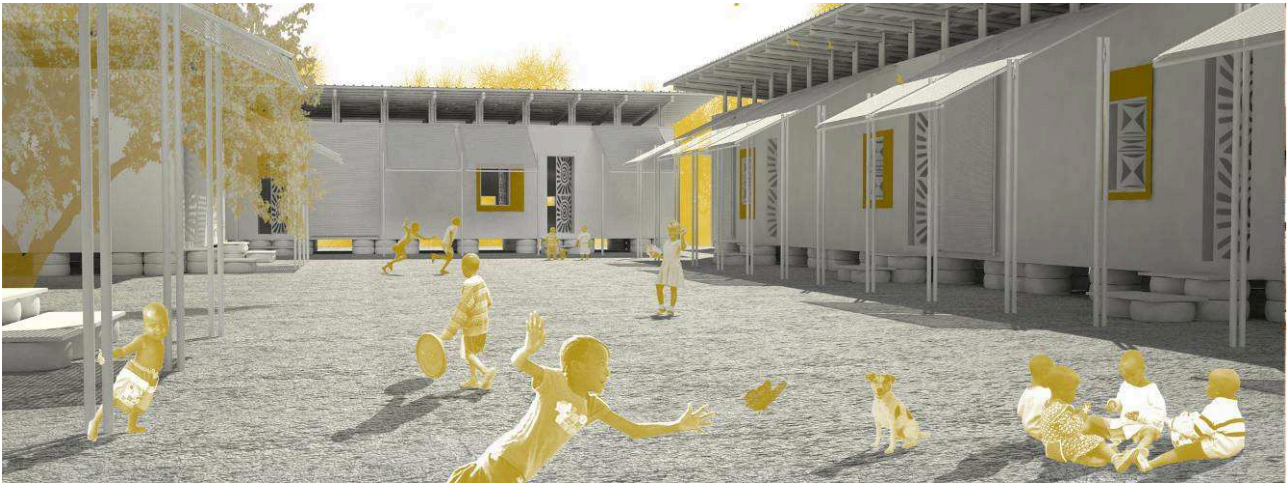
9. Rendering of the orphanage
